LIMITED ACCIDENT INVESTIGATION REPORT
--

Reference Number	CA18/2/3/10044						
Classification	Accident	Date	22 September 2021	Time	1608Z		
Type of Operation	Private (Part 94)						
Location							
Place of Departure	Private Strip Jan Kempdorp, Northern Cape Province		Place of Intended Landing	New Tempe (FATP), Free State Province			
Place of Accident	New Tempe (FATP), Free State province						
GPS Co-ordinates	Latitude	S29°2.77'	Longitude	E26°9.62'	Elevation	4547feet	
Aircraft Information							
Registration	ZU-JAK						
Model/Make	VDM L21A (Serial Number: VDM 01)						
Damage to Aircraft	Minor	Total Aircraft Hours			223		
Pilot-in-command							
Licence Type	Private Pilot Licence	Gender	Male	Age	50		
Licence Valid	Yes						
Total Hours on Type	48.35		Total Flying Hours	1590.5			
People On-board	1 + 0	Injuries	0	Fatalities	0	Other (on ground)	0
What Happened							
<p>On Wednesday, 22 September 2021, a pilot on-board a VDM L21A with registration ZU-JAK was on a private flight from a private airstrip in Jan Kempdorp, Northern Cape Province, to New Tempe Aerodrome (FATP), Free State Province. The flight was conducted under visual flight rules (VFR) by day.</p> <p>The pilot stated th

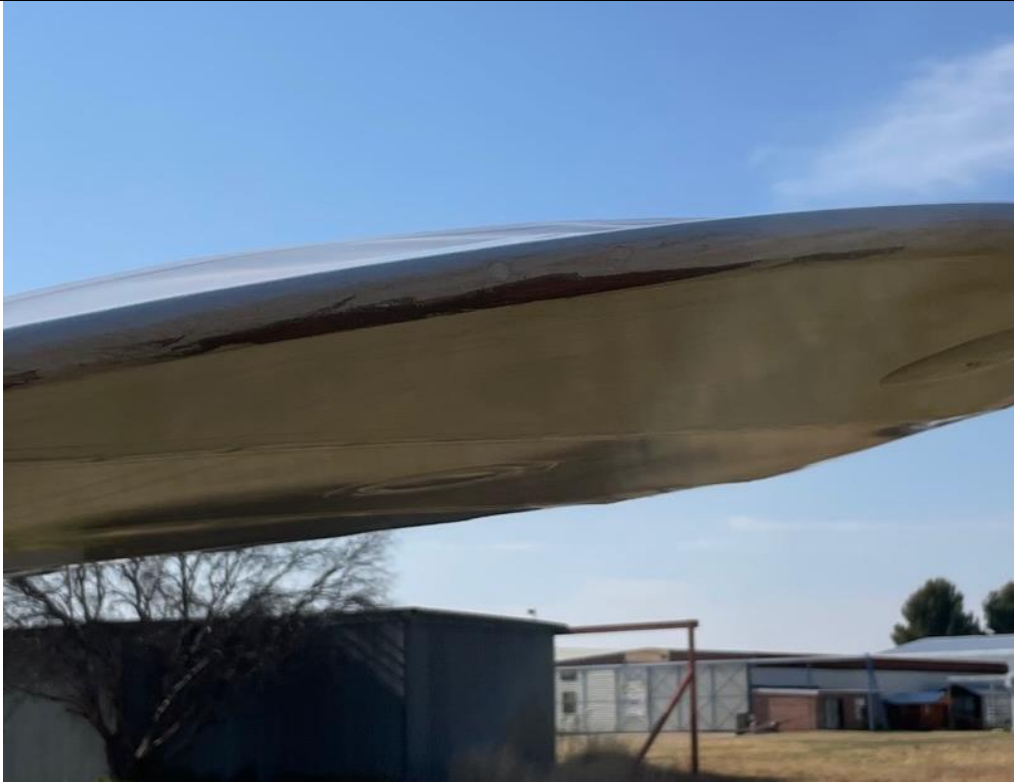
Figure 1: Damage to the leading edge. (Source: Pilot)

The pilot touched down hard and lost directional control, which resulted in the aircraft ground looping and impacting the ground with the right-side wing.

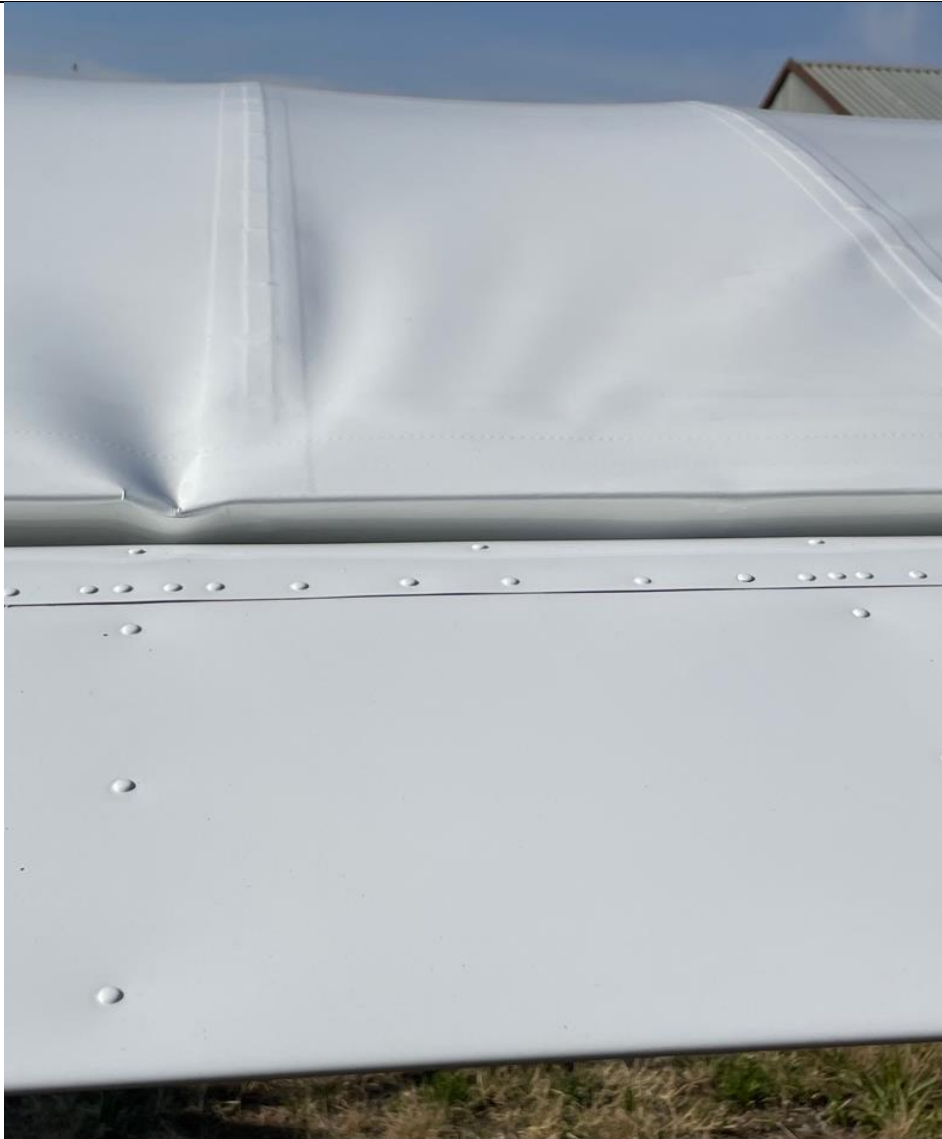
Figure 2: Damage to the trailing edge. (Source: Pilot)
