LIMITED ACCIDENT INVESTIGATION REPORT
--

Reference Number		CA18/2/3/10045					
Classification	Accident	Date	27 September 2021		Time	1445Z	
Type of Operation		Training (Part 141)					
Location							
Place of Departure		Nelspruit Aerodrome (FANS), Mpumalanga Province		Place of Intended Landing		Nelspruit Aerodrome (FANS), Mpumalanga Province	
Place of Incident		Nelspruit Aerodrome (FANS), Taxiway					
GPS Co-ordinates	Latitude	S 25°30'07"	Longitude	E 30°54'40"	Elevation	2900ft	
Aircraft Information							
Registration		ZS-EPO					
Model/Make		Cessna 172H					
Damage to Aircraft		Substantial		Total Aircraft Hours		7362.5	
Pilot-in-command							
Licence Valid		Yes		Gender		Male	
						Age	
						48	
Licence Type		Student Pilot Licence (Aeroplane)					
Total Hours on Type		10.4		Total Flying Hours		57.6	
People On-board	1 + 0	Injuries	0	Fatalities	0	Other (On ground)	0
What Happened							
<p>On Monday, 27 September 2021, a student pilot intended to conduct a solo training flight on a Cessna 172H aircraft with registration ZS-EPO from Nelspruit Aerodrome (FANS) to the general flying area (GFA) when the accident occurred.</p> <p>The student pilot, under supervision of a flight instruc

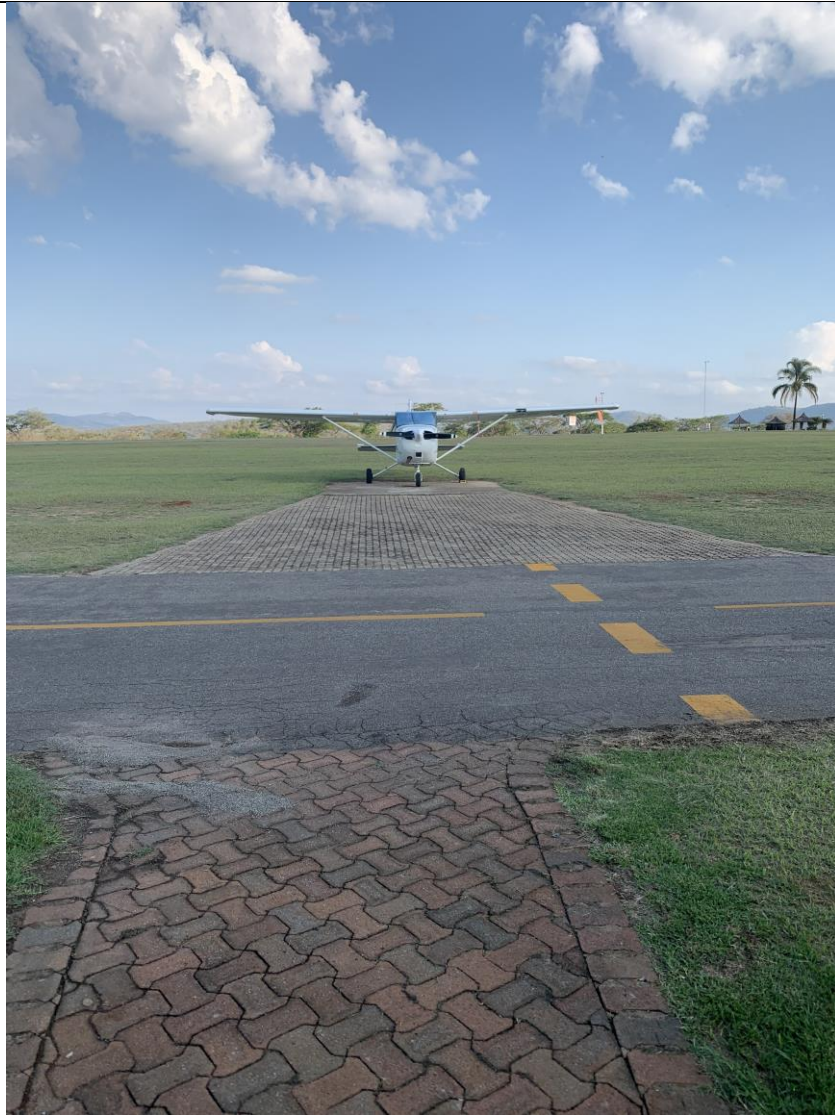
Figure 1: The aircraft at a parking bay. (Source: ATO)

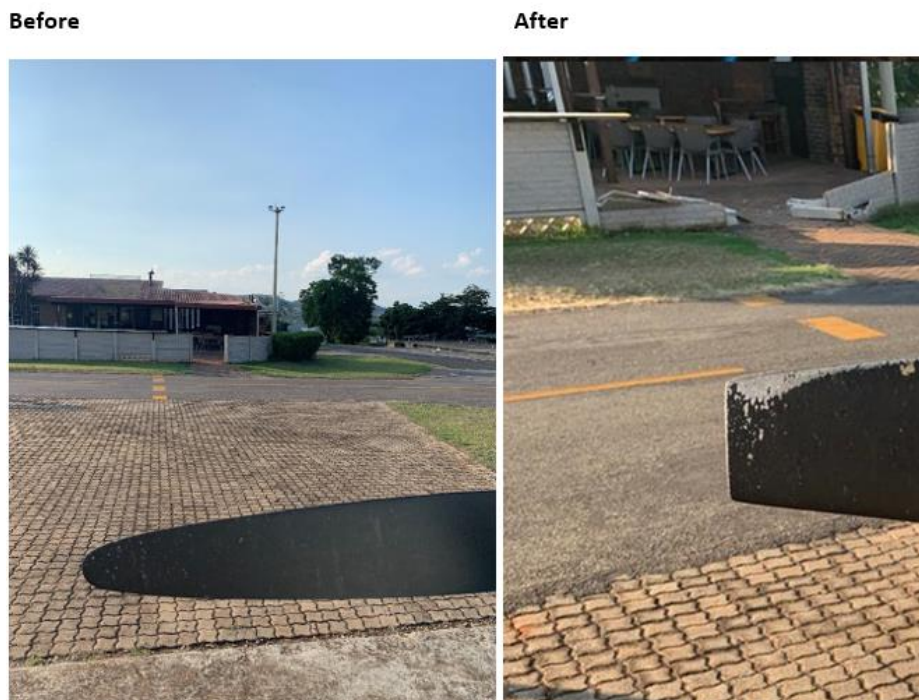
unsuccessful. While preoccupied with the toe brakes, the student pilot did not notice the aircraft's proximity to the concrete wall ahead. The aircraft hit the concrete wall with the nose section and the left wing (see Figures 3 and 4), causing substantial damage to the nose and the left-side wing. The student pilot was not injured during the accident.

Figures 3 and 4: The wall before impact (left picture); the wall after impact (right picture). (Source: ATO)

The cause of the accident was due to the student pilot not applying sufficient pressure on the toe brakes.

The student pilot had a theory Lesson 5 remedial training, which is "Taxiing", and thereafter, conducted the practical aspects of Lesson 5.
