**LIMITED ACCIDENT INVESTIGATION REPORT**

<b>Reference Number</b>	CA18/2/3/10046						
<b>Classification</b>	Accident	<b>Date</b>	6 October 2021	<b>Time</b>	1338Z		
<b>Type of Operation</b>	Private (Part 94)						
<b>Location</b>							
Place of departure	Upington Airfield, Northern Cape Province		Place of intended landing		Mossel Bay Airfield, Western Cape Province		
<b>Place of Incident</b>	Karoo Gateway Airport (FABW), Northern Cape Province						
GPS Co-ordinates	Latitude	S32°17'56.97"	Longitude	E22°40'22.83"	Elevation	2929ft	
<b>Aircraft Information</b>							
Registration	ZU-SMP						
Model/Make	Jabiru 430 (Serial Number: 437)						
Damage to Aircraft	Substantial		Total Aircraft Hours		817		
Pilot-in-command							
Licence Valid	Yes	Gender	Male		Age	22	
Licence Type	Commercial Pilot Licence (Aeroplane)						
Total Hours on Type	26.9		Total Flying Hours		273.2		
People On-board	1 + 2	Injuries	0	Fatalities	0	Other (On ground)	0
<b>What Happened</b>

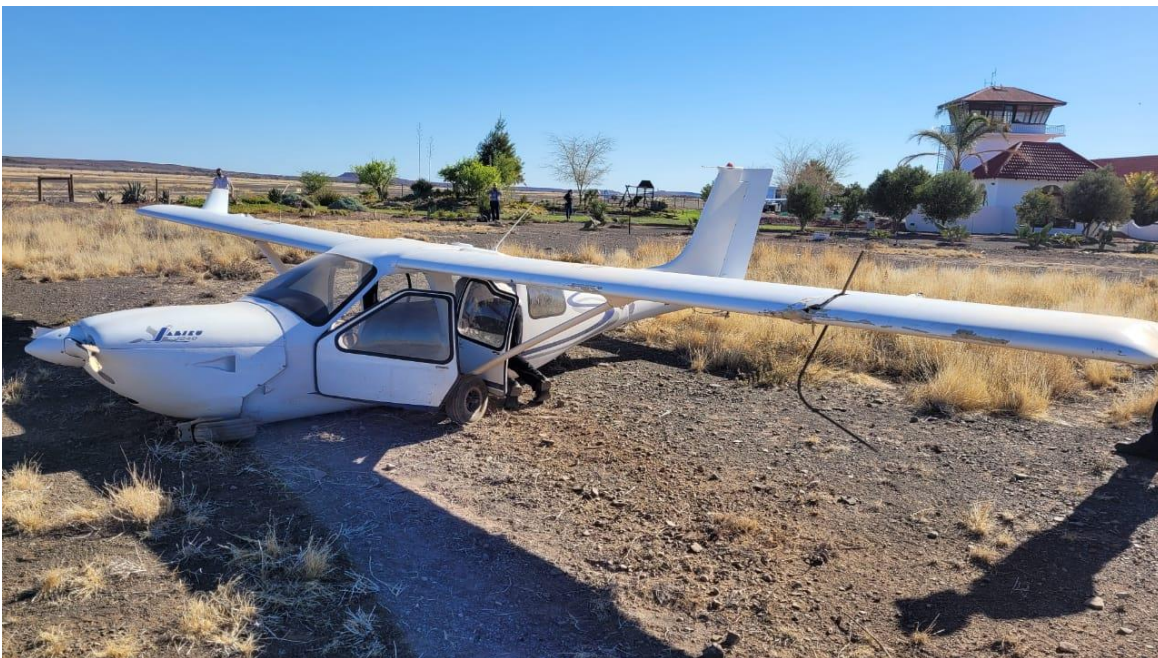
Runway 08 (RWY08). The pilot then started the take-off run and when the speed had passed 65 knots (kts) approaching 75 kts, the aircraft rotated. When the aircraft was approximately 50 feet (ft) off the ground, the left wing dropped, and the aircraft drifted off to the left. The pilot tried to level the wings. However, the pilot realised that the aircraft was not going to climb further, and he closed (cut-off) the power and opted to land on a field near the runway. During the landing process, the aircraft impacted the ground (left wing first) and spun around, coming to rest facing a southerly direction.

**Figure 1:** Aircraft at its resting position after the accident. (Source: Pilot)

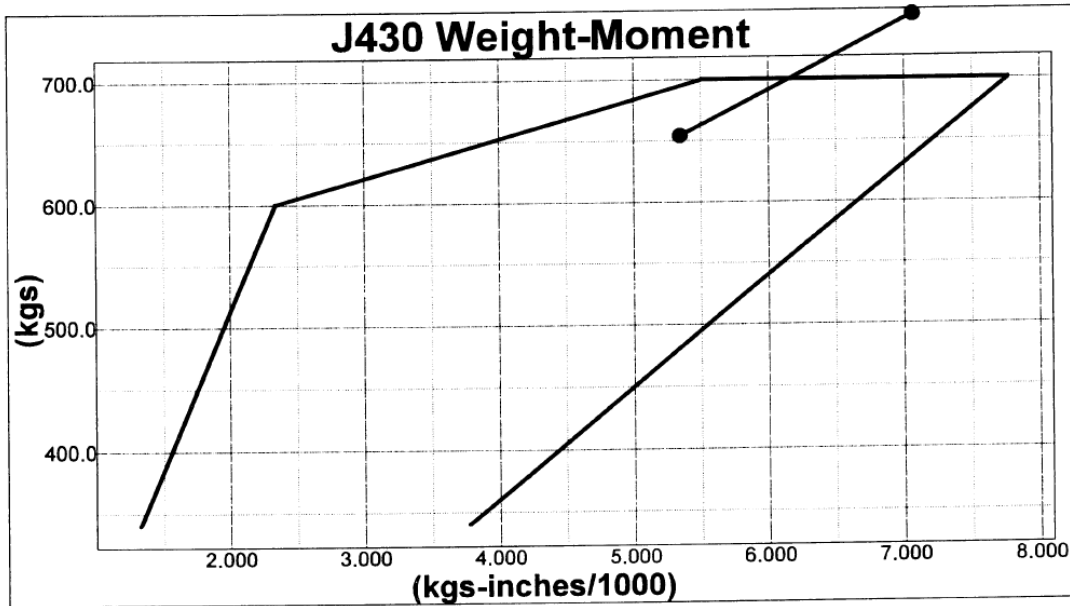
On the day of the accident, the aircraft's weight was 751 kilograms (kg) and the maximum take-off weight (MTOW) is 700kg, according to the Pilot's Operating Handbook. The weight and balance calculation moment graph was calculated (as shown in Figure 3) and indicated a centre of gravity (CoG) outside the recommended envelope.

**Graph 1:** Data of the weight and moment of the aircraft on the accident date. (Source: Pilot)

<b>Probable cause:</b>	
The pilot took-off with the aircraft at 51kg above its MTOW, which ultimately caused the aircraft to not achieve a positive rate of climb and, subsequently, descended back towards the ground.	
<b>Safety Action/s</b>	
None.	
<b>Safety Message and/or Safety Recommendation/s</b>	
Pilots need to take head of their mass and balance calculations prior to undertaking/engaging in operations.	
<b>Purpose of the Investigation</b>	
<i>In terms of Regulation 12.03.1 of the Civil Aviation Regulations (CAR) 2011, this report was compiled in the interest of the promotion of aviation safety and the reduction of the risk of aviation accidents or incidents and <b>not to apportion blame or liability</b>.</i>	
<b>About this Report</b>	
<i>Decisions regarding whether to investigate, and the scope of an investigation are based on many factors, including the level of safety benefit likely to be obtained from an investigation. For this occurrence, no investigation has been conducted, and the Accident and Incident Investigations Division (AIID) has relied on the information submitted by the affected person/s and organisation/s to compile this brief report. The report has been compiled using information supplied in the initial notification, as well as follow-up information to bring awareness of potential safety issues to the industry in respect of this occurrence, as well as possible safety action/s that the industry might want to consider in preventing a recurrence of a similar accident.</i>
