LIMITED ACCIDENT INVESTIGATION REPORT
--

Reference Number		CA18/2/3/10047					
Classification	Accident	Date	6 October 2021	Time	1413Z		
Type of Operation	Private (Part 91)						
Location							
Place of Departure	Potchefstroom Aerodrome (FAPS), Gauteng Province		Place of Intended Landing	Potchefstroom Aerodrome (FAPS), Gauteng Province			
Place of Accident	Runway (RWY 03), Potchefstroom Aerodrome (FAPS)						
GPS Co-ordinates	Latitude	26°40'16" S	Longitude	027°4'48.54" E	Elevation	4456ft	
Aircraft Information							
Registration	ZS-GSW						
Model/Make	S10, Stemme GMHB & Co KG (Serial Number: 10-17)						
Damage to Aircraft	Substantial		Total Aircraft Hours	1195.65			
Pilot-in-command							
Licence Valid	Yes	Gender	Male	Age	60		
Licence Type	Glider Pilot Licence						
Total Hours on Type	±802.31		Total Flying Hours	2192.8			
People On-board	1 + 1	Injuries	0	Fatalities	0	Other (on ground) 0	
What Happened							
<p>On 6 October 2021 at approximately 1011Z, the pilot accompanied by a passenger on-board a S10 powered glider aircraft with registration ZS-GSW was engaged in an air race competition in Potchefstroom Aerodrome (FAPS). The flight was conducted in visual meteorological con

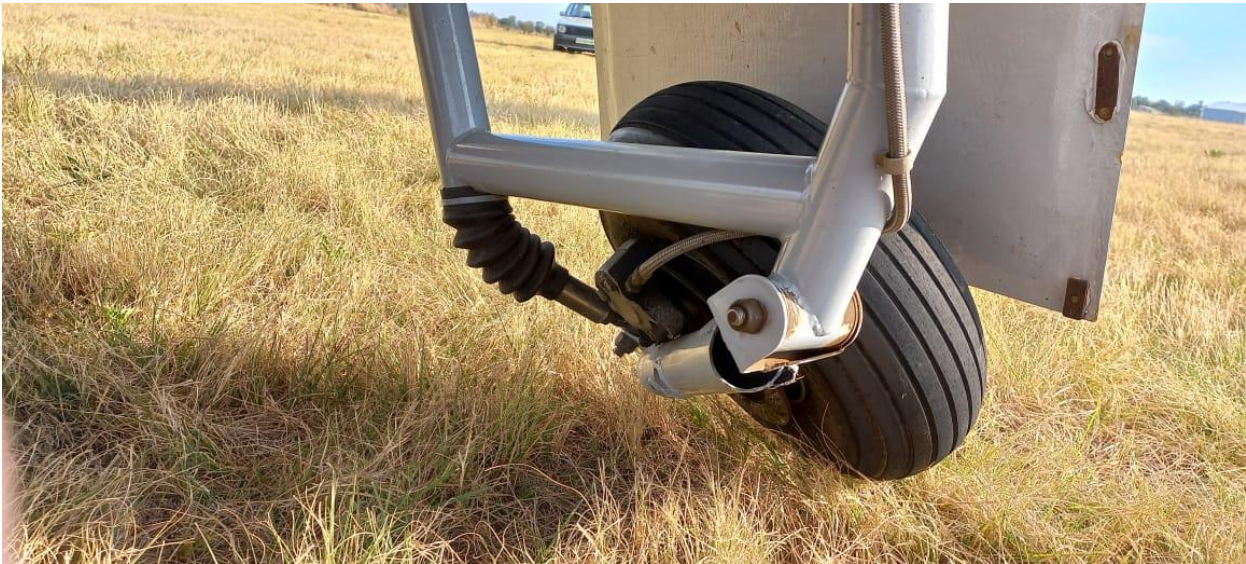
Figure 1: Damage on the left main gear.

During an approach for landing whilst close to the ground, the glider experienced a gust of wind which caused the left main gear to contact the runway surface hard, resulting in the fracture of the main-tube assembly and the damage (bent) of the shock absorbers.
