LIMITED ACCIDENT INVESTIGATION REPORT
--

Reference Number	CA18/2/3/10048						
Classification	Accident	Date	8 October 2021	Time	1230Z		
Type of Operation	Private (Part 94)						
Location							
Place of Departure	George Airport (FAGG), Western Cape province			Place of Intended Landing	John Weston Airfield (FAZR), Northern Cape province		
Place of Accident	0.5nm from John Weston Airfield (FAZR), Northern Cape Province						
GPS Co-ordinates	Latitude	S 28° 44' 46"	Longitude	E 24° 40' 00"	Elevation	3950 ft	
Aircraft Information							
Registration	ZU-EFW						
Model/Make	Jabiru J430						
Damage to Aircraft	Substantial			Total Aircraft Hours	2378.1		
Pilot-in-command							
Licence Valid	Yes		Gender	Male		Age	48
Licence Type	Private Pilot Licence (PPL) Aeroplane						
Total Hours on Type	82.7			Total Flying Hours	329.1		
People On-board	1 + 3	Injuries	0	Fatalities	0	Other (On Ground)	0
What Happened							
<p>On 8 October 2021, a pilot and three passengers on-board a Jabiru J430 aircraft with registration ZU-EFW took off on a cross-country private flight from George Airport (FAGG) in the Western Cape province with the intention to land at John Weston Airfield (FAZR) in the Northern C

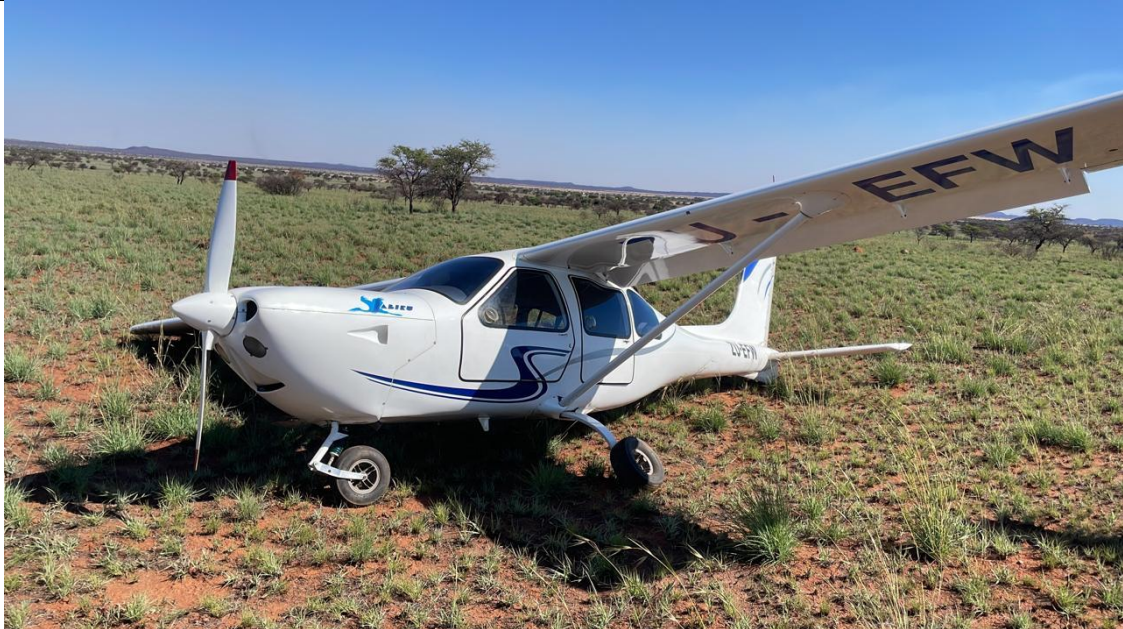
The aircraft sustained substantial damage to the undercarriage, right wing and right-wing elevator. The pilot and the passengers were not injured during the accident sequence.

Figure 2: The aircraft at the accident site. (Source: Pilot)

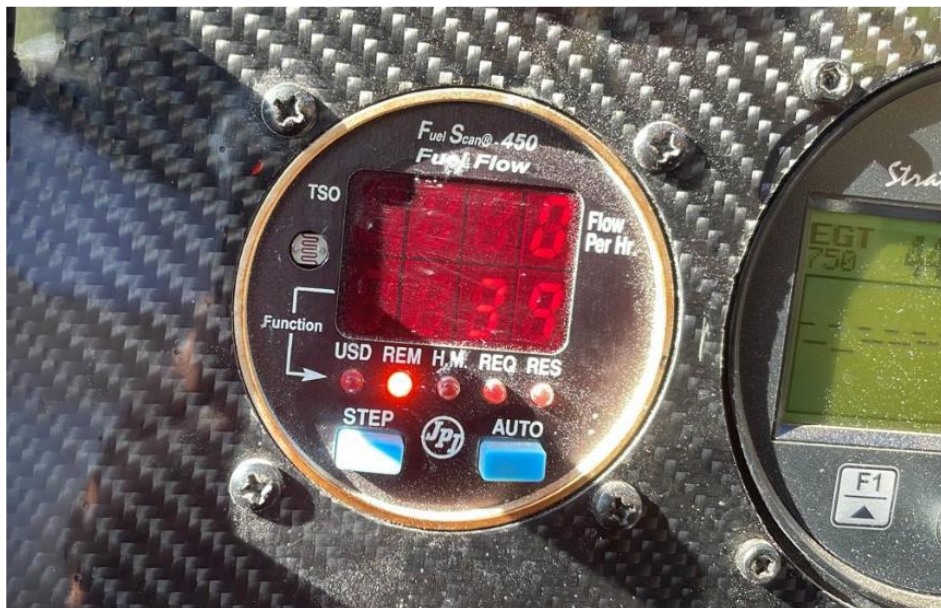
- The pilot took a photograph of the fuel gauge on the day of the accident to confirm that there was 39 litres of AVGAS on-board remaining post-accident.

Figure 3: Picture showing fuel gauge instrument after the accident. (Source: Pilot)

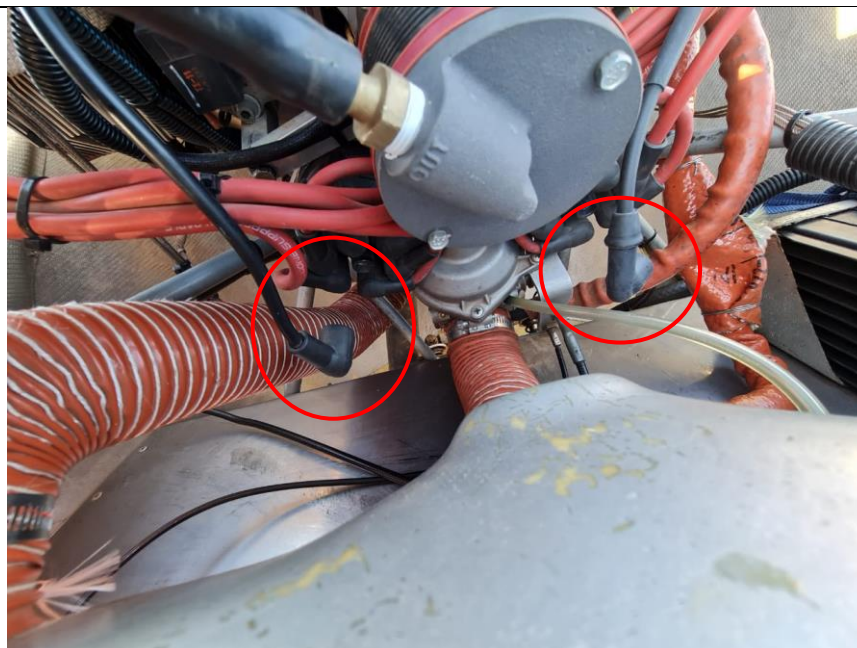
- Post-accident inspection of the engine revealed that both ignition coil leads had disconnected in-flight as a result of not being properly secured to cable ties.

Figure 4: Disconnected ignition coil leads. (Source: Pilot)

- The last maintenance inspection of the aircraft was conducted earlier on the accident day, 8 October 2021. The aircraft was test run and it met all the parameters. It is probable that the Approved Person (AP) carrying out the maintenance reconnected both ignition coil leads but did not secure them in place with cable ties.

It is likely that the aircraft lost forward speed which led to loss of height and a hard impact with the ground during a forced landing after an engine stoppage in-flight, caused by disconnected ignition coil leads.

It is likely that there was inadequate maintenance as the ignition leads were not properly secured to the spark plugs or that the ignition lead clips were not properly inspected to ensure that they were secured to the spark plugs.
