LIMITED ACCIDENT INVESTIGATION REPORT
--

Reference Number		CA18/2/3/10049					
Classification	Accident	Date	9 October 2021	Time	0720Z		
Type of Operation	Training Flight (Part 141)						
Location							
Place of Departure	Wonderboom Aerodrome (FAWB)		Place of Intended Landing	Wonderboom Aerodrome (FAWB)			
Place of Accident	Runway 29 at FAWB, Gauteng Province						
GPS Co-ordinates	Latitude	S25° 39'11.28"	Longitude	E028°13'28.04"	Elevation	4 071 feet	
Aircraft Information							
Registration	ZS-CBB (Serial Number 28-5694)						
Model/Make	Piper 28-180						
Damage to Aircraft	Substantial		Total Aircraft Hours	11 423.16			
Pilot-in-command							
Licence Type	Student Pilot Licence (Aeroplane)	Gender	Male		Age: 18		
Licence Valid	Yes						
Total Hours on Type	22		Total Flying Hours	23			
People On-board	1 + 0	Injuries	0	Fatalities	0	Other (on ground)	0
What Happened							
<p>On 9 October 2021 at approximately 0600Z, an instructor and a student pilot on-board a Piper 28-180 with registration ZS-CBB were engaged in circuit-and-landing exercises at Wonderboom Aerodrome (FAWB) for a solo consolidation check. This was a training flight conducted under the provisions of Part 141 of the C

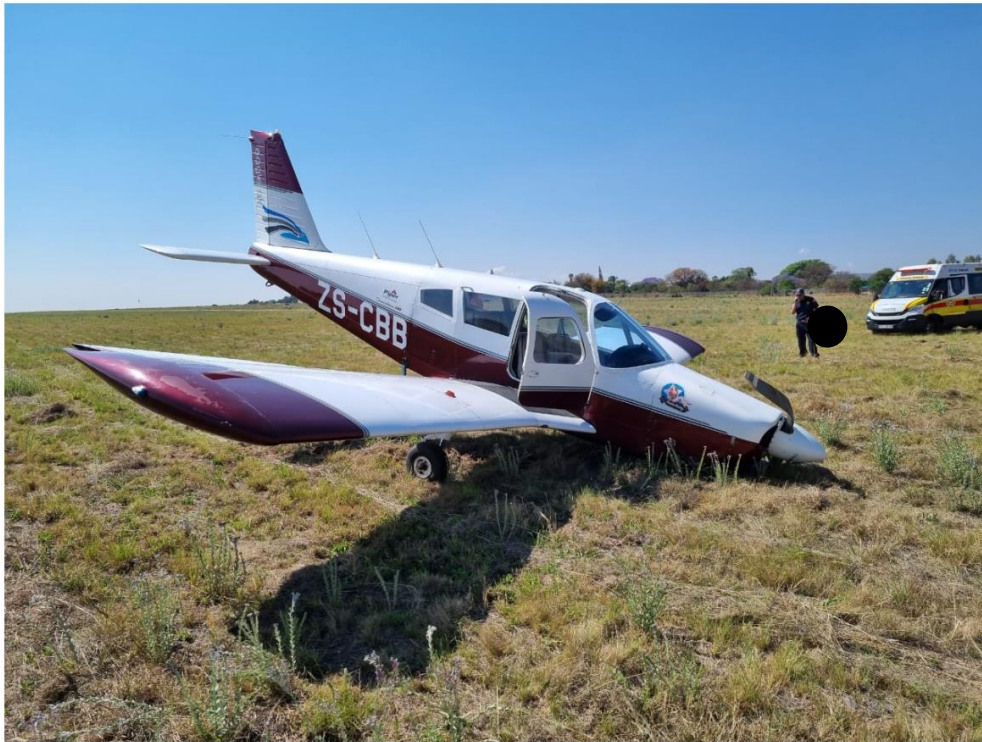
off as the aircraft came to a stop on the grass, some distance from the edge of the runway (near the intersection of Runway 24 and 29). The aircraft sustained substantial damage; however, there were no injuries reported.

Figure 1: Final resting position of the aircraft. (Source: Chief Flight Instructor)

- 1) Propeller was damaged.
- 2) Engine to undergo a shock load inspection.
- 3) Engine cradle was bent and had cracked.
- 4) Nose gear oleo tube had broken off from the nose gear fork and torque links were damaged.
- 5) Right-side wing ribs were found cracked.
- 6) Right-side main gear trunnion had cracked.
- 7) Both main landing gear axles had cracked.
- 8) Lower engine cowling was damaged.
