**LIMITED ACCIDENT INVESTIGATION REPORT**

<b>Reference Number</b>	CA18/2/3/10050						
<b>Classification</b>	Accident	<b>Date</b>	9 October 2021	<b>Time</b>	0710Z		
<b>Type of Operation</b>	Private (Part 94)						
<b>Location</b>							
<b>Place of Departure</b>	Van Wyk Vlei, Northern Cape Province		<b>Place of Intended Landing</b>		Calvinia (FACV), Northern Cape Province		
<b>Place of Accident</b>	39nm south-west of Van Wyk Vlei, Northern Cape Province						
<b>GPS Co-ordinates</b>	<b>Latitude</b>	S 30°43'57.9"	<b>Longitude</b>	E 021°12' 28.4"	<b>Elevation</b>	3444 ft	
<b>Aircraft Information</b>							
<b>Registration</b>	ZU-ETK						
<b>Model/Make</b>	Autogyro MT03						
<b>Damage to Aircraft</b>	Destroyed		<b>Total Aircraft Hours</b>		408.6		
<b>Pilot-in-command</b>							
<b>Licence Type</b>	National Pilot Licence (NPL)		<b>Gender</b>	Male		<b>Age</b>	64
<b>Licence Valid</b>	Yes						
<b>Total Hours on Type</b>	236		<b>Total Flying Hours</b>		649

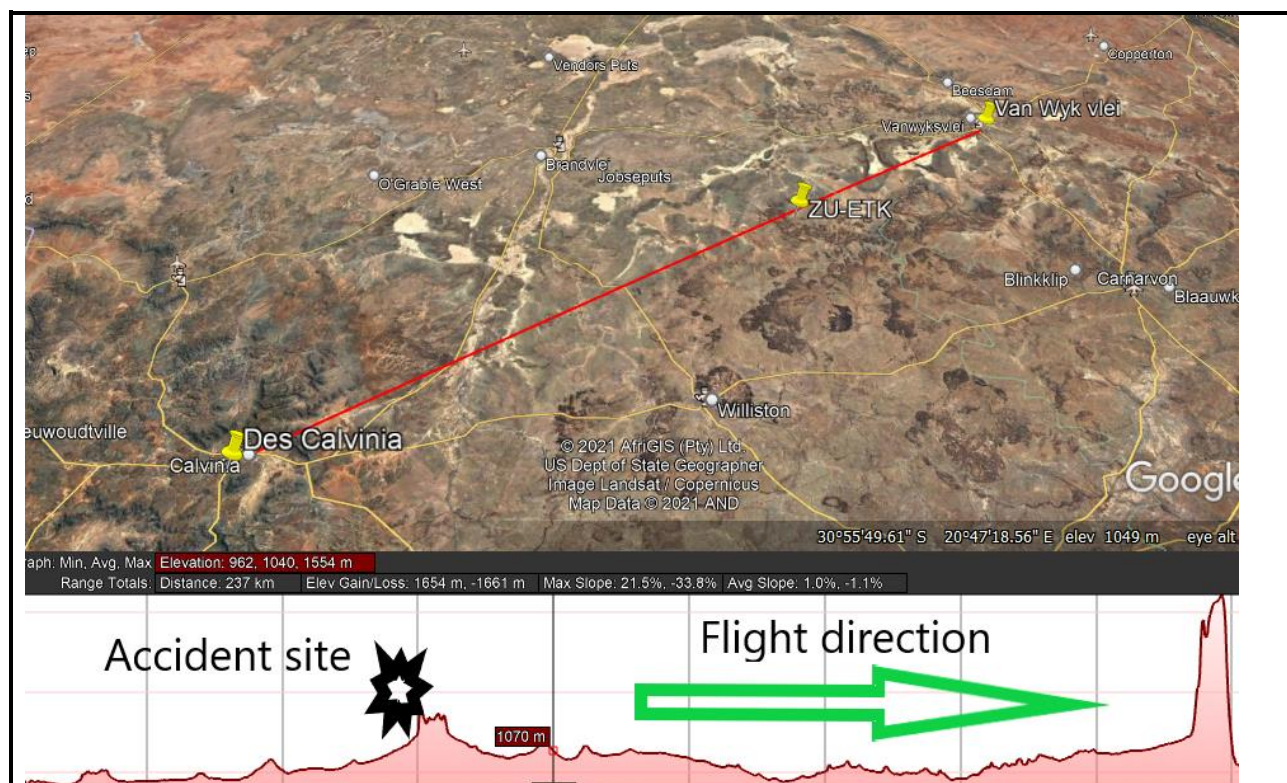
**Figure 2:** The rising terrain at the accident site. (Source: Google Earth)

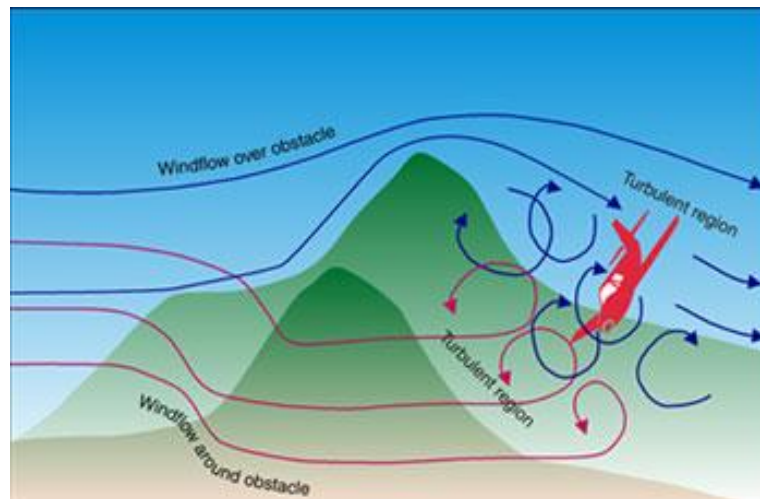
*Mountain waves are a different phenomenon to the mechanical turbulence found in the lee of mountain ranges and can exist as a smooth undulating airflow or may contain clear air turbulence in the form of breaking waves and 'rotors'. Mountain waves are defined as 'severe' when the associated downdrafts exceed 600 ft/min and/or severe turbulence is observed or forecast.*

**Figure 3:** Turbulence on the lee side of the mountain.

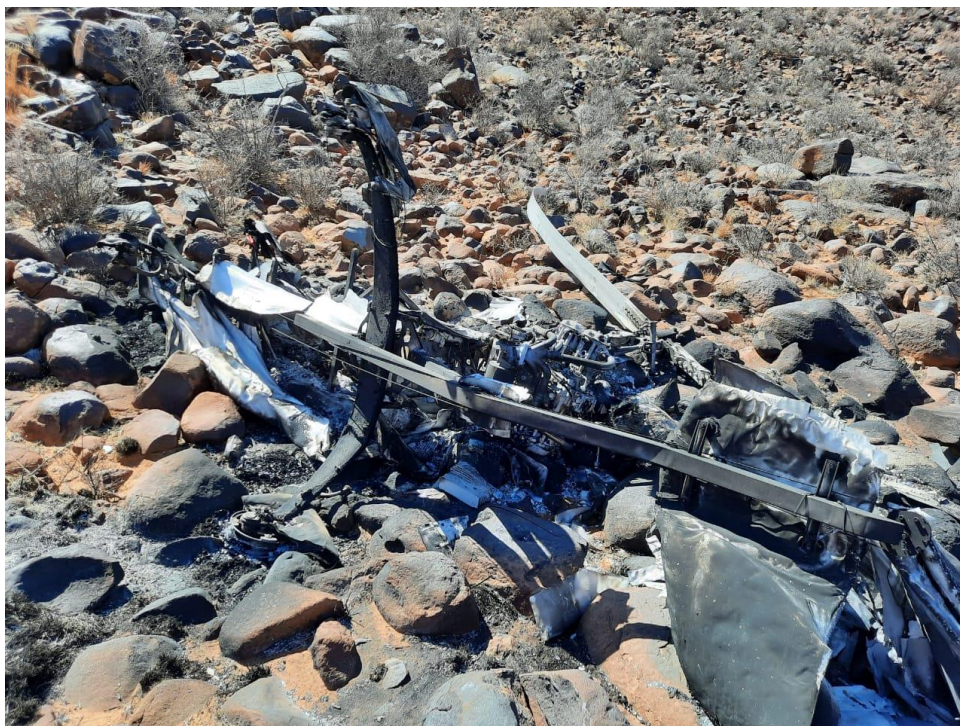
**Figure 4:** The burnt gyrocopter laying on its right-side at the accident site. (Source: Pilot)

<b>Probable causes:</b>	
The gyrocopter encountered a strong downdraught, and the pilot was unable to recover, resulting in the gyrocopter impacting the rocky surface hard, followed by the post-impact fire that ensued and destroyed it; downdraught.	
<b>Safety Action</b>	
None.	
<b>Safety Message</b>	
Pilots who wish to fly low and close to mountain ridges must familiarise themselves with the dangers of downdraughts or thermal sink, and how to get out of such a situation.	
<b>Purpose of the Investigation</b>	
<i>In terms of Regulation 12.03.1 of the Civil Aviation Regulations (CAR) 2011, this report was compiled in the interest of the promotion of aviation safety and the reduction of the risk of aviation accidents or incidents and <b>not to apportion blame or liability</b>.</i>	
<b>About this Report</b>	
<i>Decisions regarding whether to investigate, and the scope of an investigation are based on many factors, including the level of safety benefit likely to be obtained from an investigation. For this occurrence, no investigation has been conducted, and the Accident and Incident Investigations Division (AIID) has relied on the information submitted by the affected person/s and organisation/s to compile this brief report. The report has been compiled using information supplied in the initial notification, as well as follow-up information to bring awareness of potential safety issues to the industry in respect of this occurrence, as well as possible safety action/s that the industry might want to consider in preventing a recurrence of a similar accident.</i>
