<b>LIMITED ACCIDENT INVESTIGATION REPORT</b>
--

<b>Reference Number</b>	CA18/2/3/10052						
<b>Classification</b>	Accident	<b>Date</b>	10 October 2021	<b>Time</b>	0800Z		
<b>Type of Operation</b>	Private (Part 94)						
<b>Location</b>							
<b>Place of Departure</b>	Morningstar Aerodrome, Western Cape Province		<b>Place of Intended Landing</b>	Altona Farm Private Airstrip, Western Cape Province			
<b>Place of Accident</b>	Altona Farm Private Airstrip						
<b>GPS Co-ordinates</b>	<b>Latitude</b>	33°42'27" S	<b>Longitude</b>	018°38'47" E	<b>Elevation</b>	400 ft	
<b>Aircraft Information</b>							
<b>Registration</b>	ZU-CGH						
<b>Model/Make</b>	Zodiac 601 UL (Serial Number: RGN-01-22)						
<b>Damage to Aircraft</b>	Minor		<b>Total Aircraft Hours</b>	1201.1			
<b>Pilot-in-command</b>							
<b>Licence Valid</b>	Yes	<b>Gender</b>	Male	<b>Age</b>	63		
<b>Licence Type</b>							
<b>Total Hours on Type</b>	47.9		<b>Total Flying Hours</b>	1473.4			
<b>People On-board</b>	1 + 0	<b>Injuries</b>	0	<b>Fatalities</b>	0	<b>Other (On Ground)</b>	0

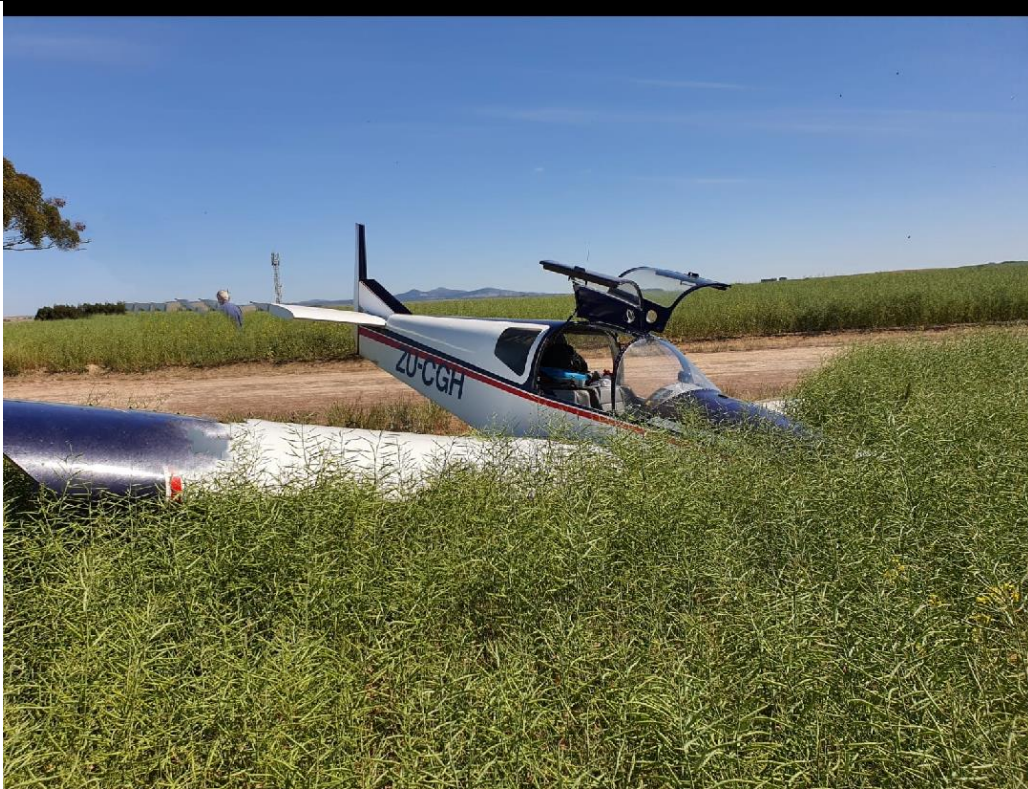
<b>What Happened</b>							
<p>On 10 October 2021, a pilot flying solo on-board a Zodiac 601 UL with registration ZU-CGH took off from Morning Star Airfield with the intention to land at Altona Farm private airstrip. Fine weather conditions prevailed at the time of the accident. This was a private flight conducted under the provisions of Part 94 of the Civil Aviation Regulations (CAR) 2011 as amended.</p> <p>According to the pilot, during landing while positioned in an easterly direction, the aircraft veered off to the right of the runway. The pilot was unable to maintain direction of the aircraft and it rolled onto the vegetation (crops) before coming to a halt. The pilot stated that during the walk-around after the runway excursion, he noticed a deflated right-side tyre.</p> <p>The aircraft sustained damage to the propeller and nose gear. There were no injuries sustained by the pilot.</p>

**Figure 1:** The aircraft as it came to rest on the canola field. (Source: Pilot)

The pilot lost control of the aircraft during the landing roll due to a deflated right-side tyre. The aircraft subsequently veered off to the right-side of the runway.
