LIMITED ACCIDENT INVESTIGATION REPORT
--

Reference Number		CA18/2/3/10053					
Classification	Accident	Date	10 October 2021	Time	0831Z		
Type of Operation	Training (Part 141)						
Location							
Place of Departure	Mosselbay Aerodrome (FAMO), Western Cape Province			Place of Intended Landing	FAMO, Western Cape Province		
Place of Accident	Runway (RWY) 28 FAMO						
GPS Co-ordinates	Latitude	34°9'21.96" S	Longitude	22°3'20.52" E	Elevation	526 ft	
Aircraft Information							
Registration	ZU-STB						
Model/Make	Sling 2 (Serial number: 244)						
Damage to Aircraft	Substantial		Total Aircraft Hours	2009.7			
Pilot-in-command							
Licence Valid	Yes	Gender	Male	Age	19		
Licence Type	Student Pilot Licence (Aeroplane)						
Total Hours on Type	25.3		Total Flying Hours	25.3			
People On-board	1+0	Injuries	0	Fatalities	0	Other (On Ground)	0
What Happened							
<p>On Sunday morning, 10 October 2021, a student pilot on-board a Sling 2 aircraft with registration ZU-STB took off on a training flight from Runway 28 (RWY 28) at Mosselbay Aerodrome (FAMO) in the Western Cape province. The training flight, which was intended to be conducted at FAMO, was a solo consolidation of circuit-and-land

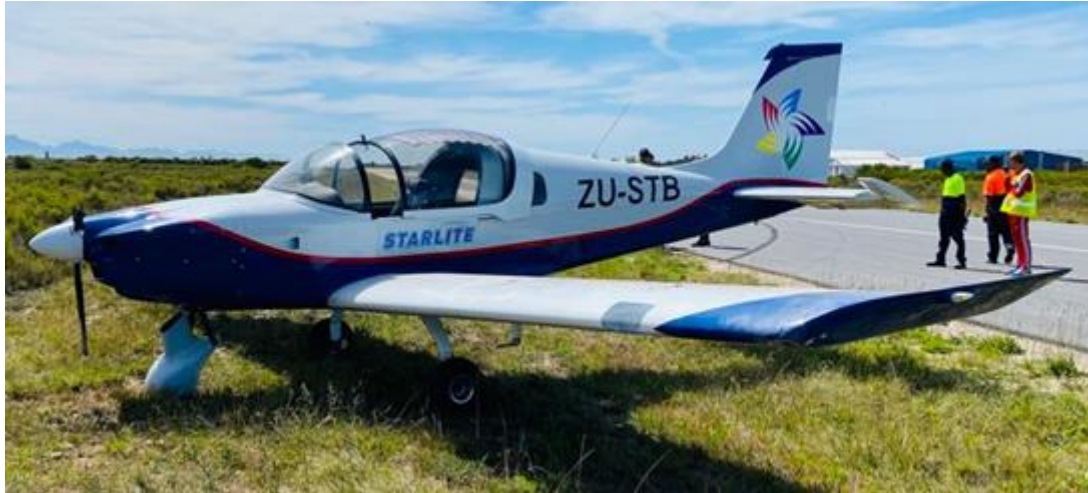
runway and the aircraft skidded off to the left-side and came to a stop 5 metres (m) from the runway edge on the grass. The student pilot had a total of 23 dual hours and 2.3 solo hours at the time of accident.

Figure 1: Photo of the aircraft after it came to a stop. (Source: Pilot)

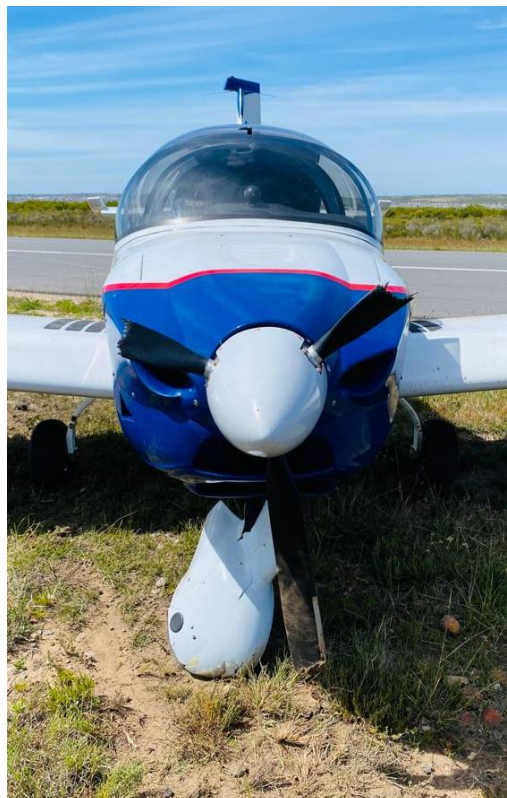
The student pilot did not sustain any injuries; the aircraft sustained substantial damage to the nose gear, the left-wing tip and the propeller blades.

Figure 2: Front view of the aircraft showing damage to the propeller and nose landing gear. (Source: Pilot)

- The aircraft was initially issued an Authority to Fly (ATF) on 7 August 2017 with an expiry date of 31 August 2022.
- The approach was unstable which resulted in the aircraft touching down with the nose gear first instead of the main gears; the aircraft bounced three times. The nose gear bent, the propeller struck the runway and the aircraft veered off the runway before it stopped on the grass.

During landing, the aircraft bounced three times on touch down, causing the nose wheel to bend and the pilot to lose control of the aircraft.
