| AIRCRAFT ACCIDENT REPORT AND EXECUTIVE SUMMARY |

| | | | | Reference | | CA18/2/3/10054 | |
| Aircraft Registration | 9H-VJM | Date of Accident | 13 October 2021 | | Time of Accident | 0518Z | |
| Type of Aircraft | BD-700-1A10 (Global 6000) | | Type of Operation | | Private (Part 91) | | |

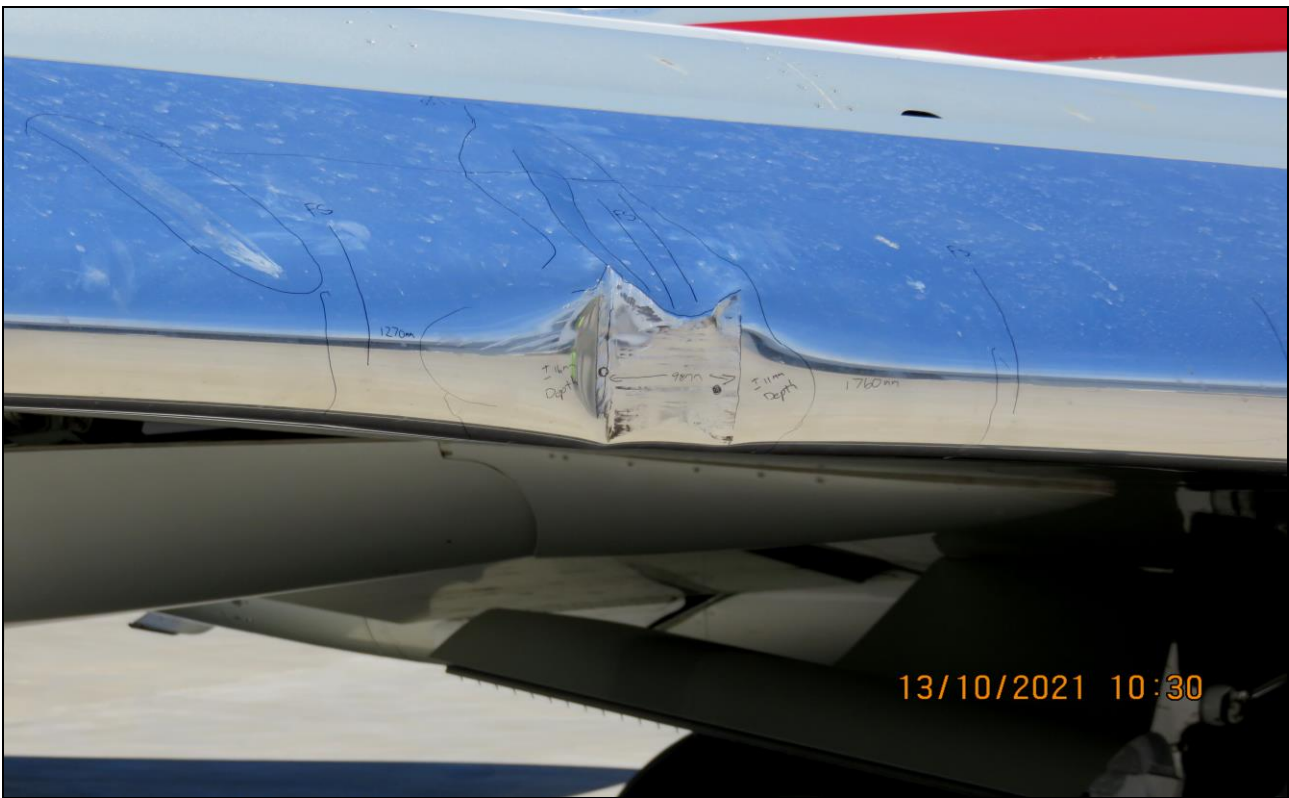
1.3.1 The number 2 leading edge slat on the right wing was substantially damaged.

Figure 3: Deformation of the number 2 leading-edge slat on the right wing.

1.16.1 No tests were carried out on the aircraft; however, damage assessment was conducted on the right-side leading slat, which was recommended for repair/replacement. The repair was

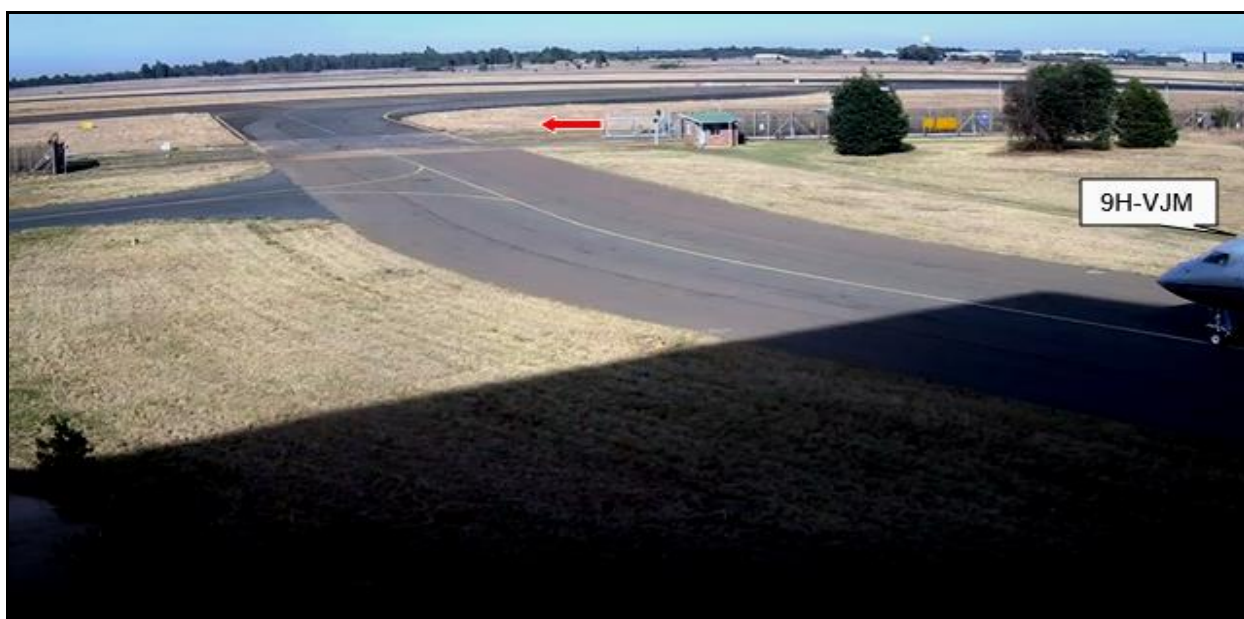
The total video footage duration is 1 minute and 19 seconds. The event leading to the accident was approximately 53 seconds. The footage starts with the ZS-AAK aircraft already passing through the Echo gate into FAOR airside (seen between the two large trees and moves out of frame 9 seconds later, see Figure 6). The gate moves towards the close position 6 seconds later after the ZS-AAK is out of frame. Thereafter, the 9H-VJM aircraft appears 7 seconds later on the Denel CCTV camera which was 120 metres away from the gate; the gate is still moving towards close position.

Figure 7: In this screenshot, the 9H-VJM aircraft approaches the gate, which had already started to close.

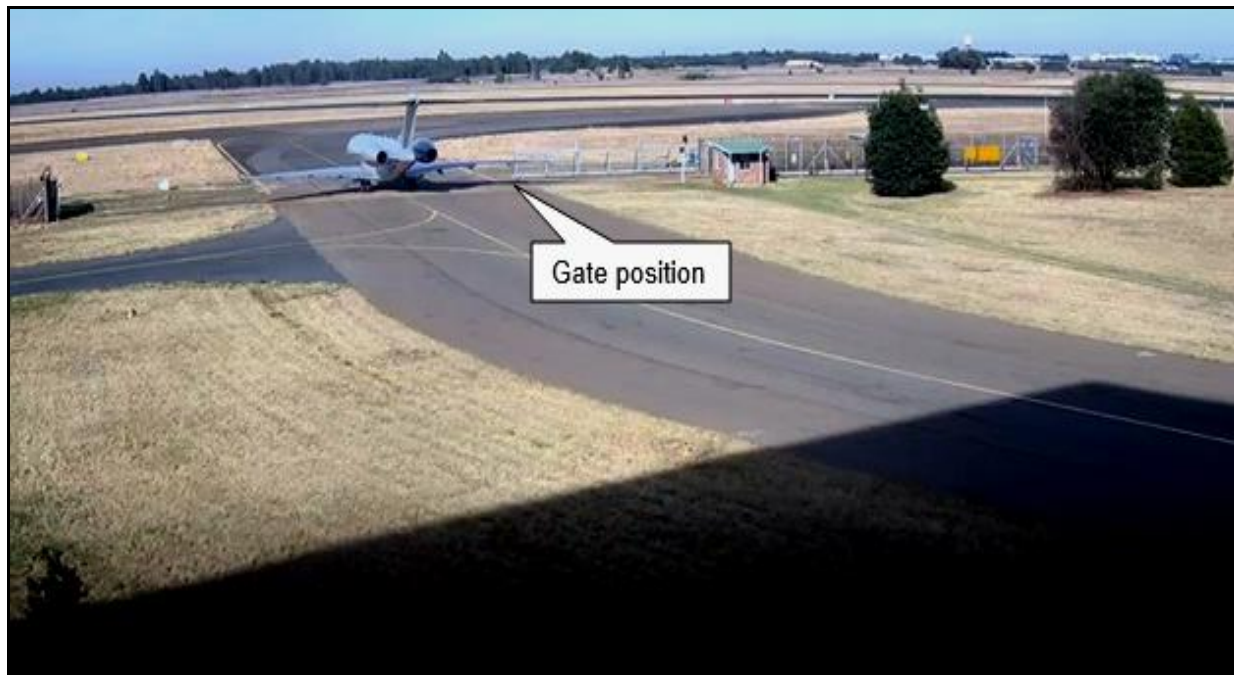
The 9H-VJM aircraft covers a distance of 120m in approximately 20 seconds and veers off to the left before it stops with its mid-section of the fuselage on the gate rail. (See Figure 8). After appearing on the CCTV frame, the aircraft travels approximately 21 seconds before it stops.

Figure 8: In this screenshot, the 9H-VJM aircraft stops after an attempt to veer off to the left.

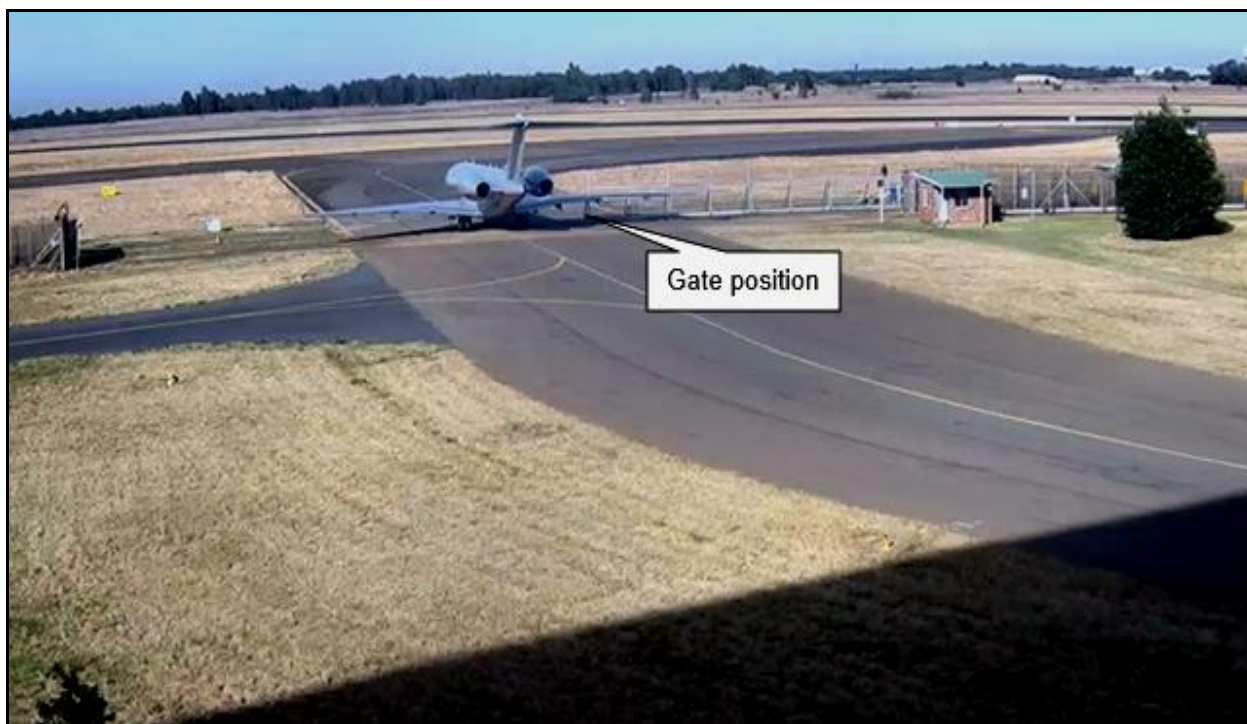
The crew notices that the gate is coming towards the aircraft (closing) from the right-side and they veer off to the left and stop as the gate is already too close to the wing, but has not yet impacted the aircraft. The gate continues to move towards the aircraft for approximately 11 seconds until it impacts the aircraft's right-side wing leading edge on the number 2 slat and stops (see Figure 9).

Figure 9: In this screenshot, the gate stops moving after colliding with the right wing leading slat.

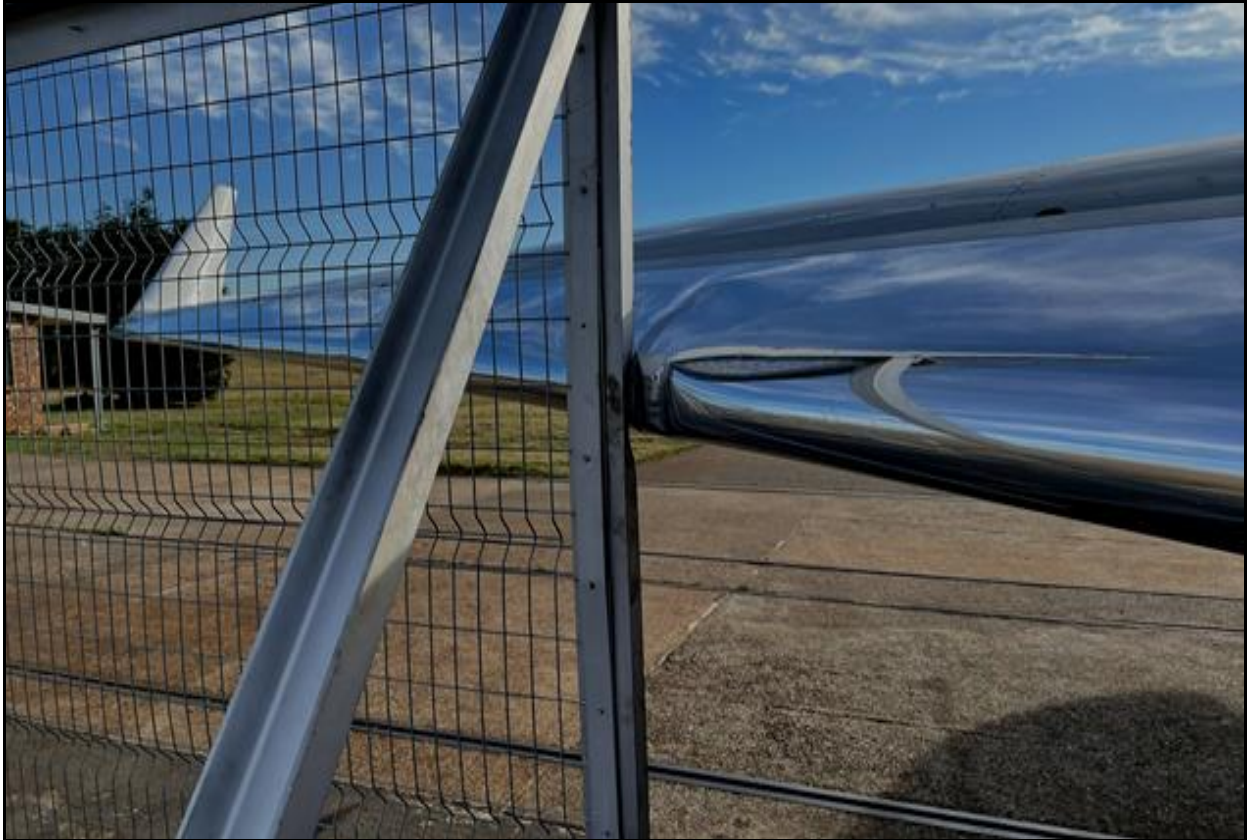
Figure 10: The gate whilst in contact with the leading-edge slat. (Source: Fireblade Aviation)

Figure 10 (above) was taken by the first responders to the accident scene. It illustrates the position of the gate relative to the damage on the leading edge slat, which was deployed at 20° as per the requirement during take-off.

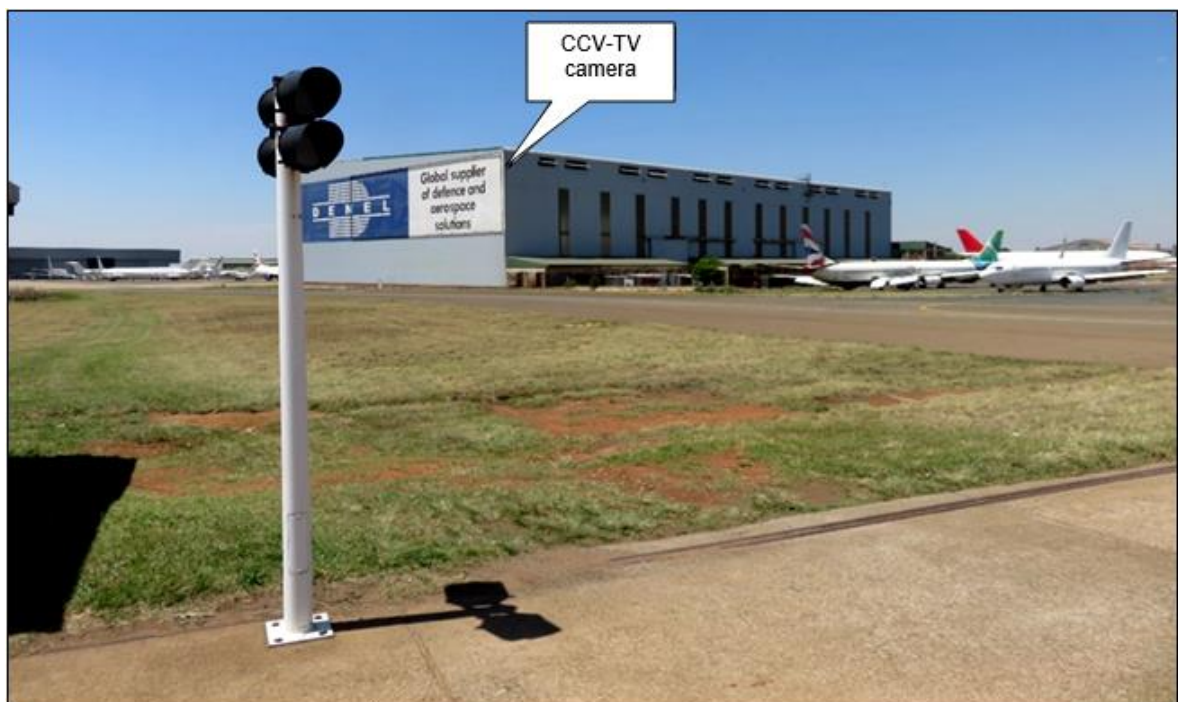
The traffic signal lights for this gate are located on both sides of the Apron taxiway on the Denel Campus side. According to the 9H-VJM cockpit voice recordings (CVR), the crew stated that they noticed the illuminated green light at the time of their approach. However, these lights were not working properly (out of service) during the initial visit of the investigation team due to the electrical power outage (load shedding) that was scheduled from 0500Z in the area on the day of the accident. These traffic lights are not connected to an alternate power supply in case of power failures/outages.

Figure 13: The Denel Campus gate traffic light.

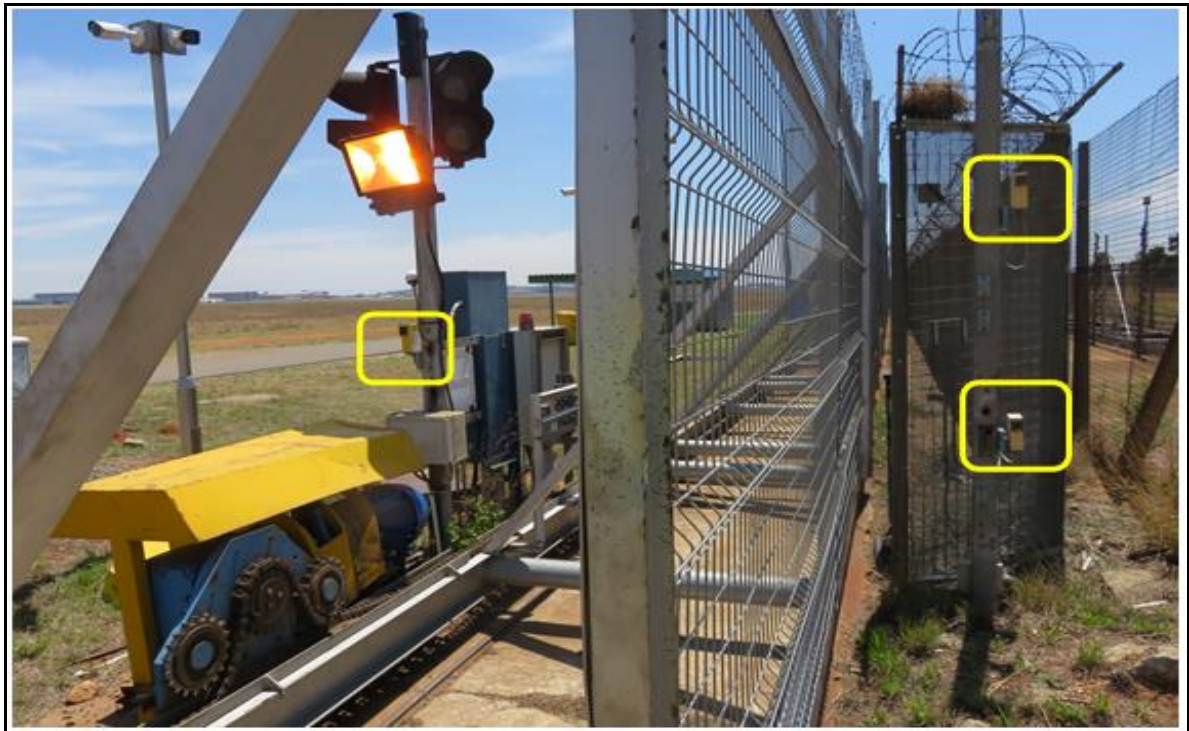
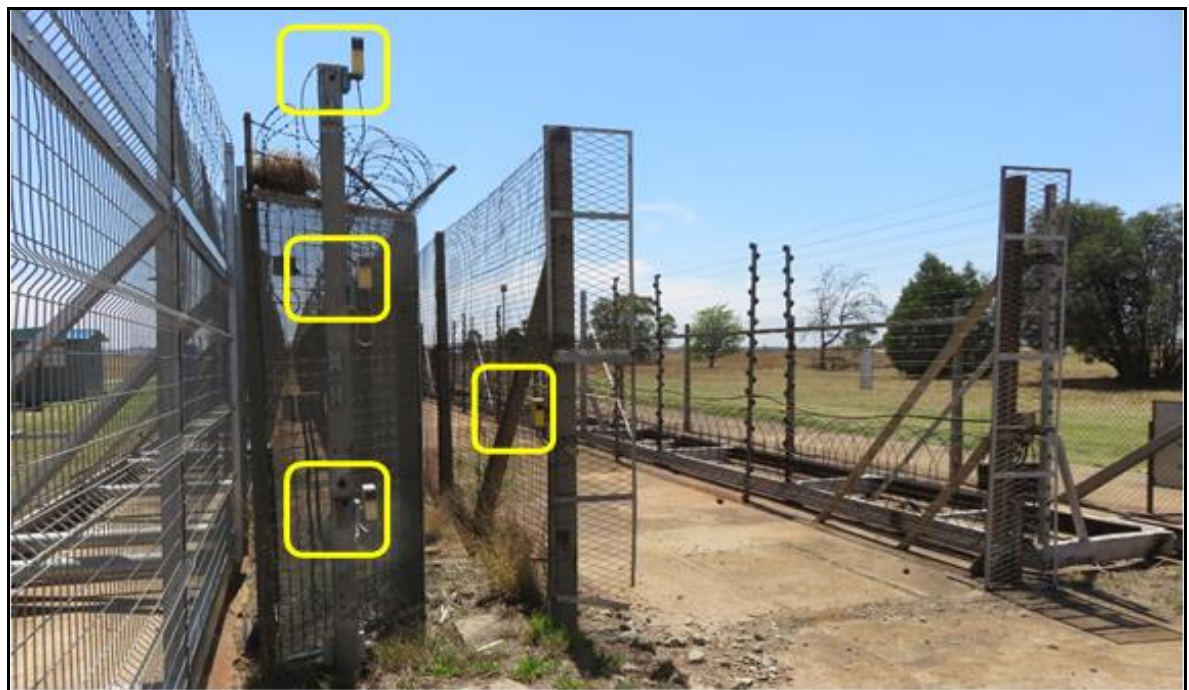
The aerodrome gate (ACSA/Echo gate) was functional at the time of the investigation's team visit, and it was being controlled remotely. The gate is equipped with safety barrier sensors, which failed in operation on the day of the accident. At the gate, five safety beams are installed on each end of the gate. When the gate is in motion and one of these beams is obstructed by an aircraft's fuselage, a vehicle or any similar type of object, this gate should stop automatically. The fuselage of the 9H-VJM aircraft obstructed all five safety beams, yet the gate did not stop; it continued to close for another 11 seconds after impacting the right wing of the aircraft before it finally stopped.

Figure 14: The Echo gate with three of the safety beams visible in the yellow windows.

Figure 15: The Echo gate with four of the safety beams visible in the yellow windows.

- (v) The fact that none of the five safety beams installed at the Echo gate activated to bring the gate to a stop was found to be a significant factor in this accident. The safety beams failed to operate.

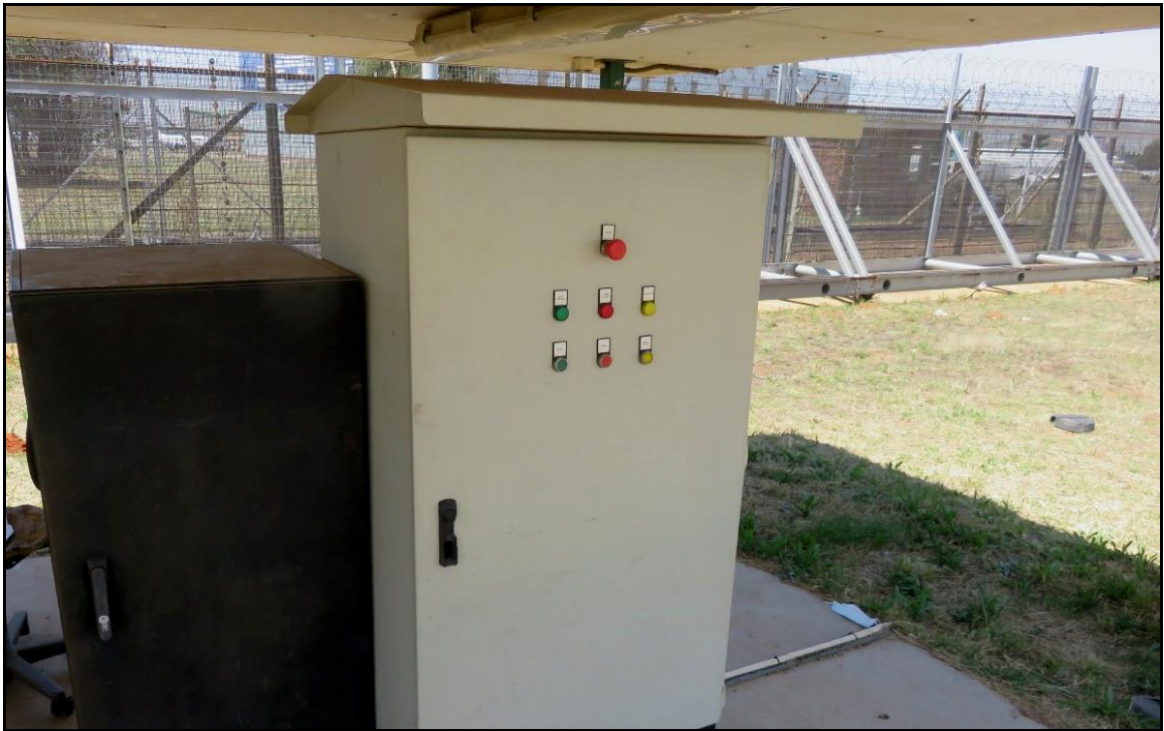
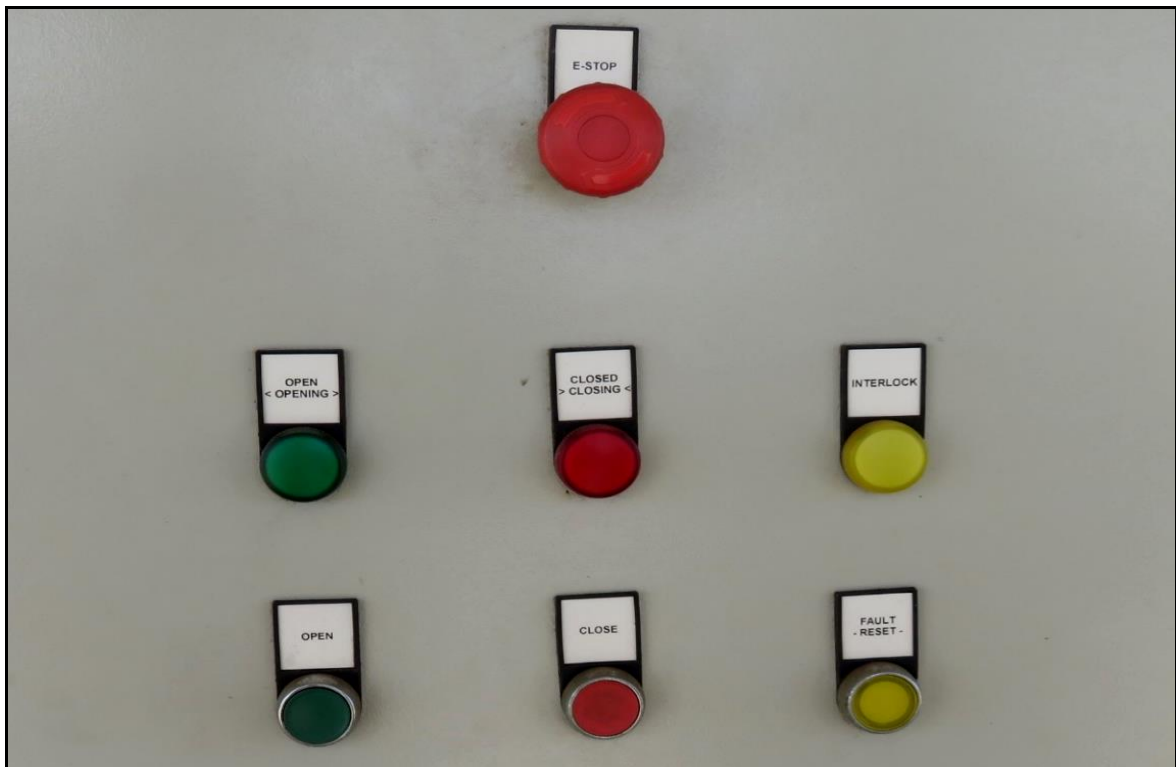
A gate control box with seven buttons is installed near the guard house at the Echo gate on the airside (see Figures 16 and 17). The top red knob is the E-STOP (Emergency stop), which could be activated in case of an emergency, and thus, bring the gate to an immediate stop. The security guard, who was the only person at this station at the time, was not allowed to interfere with the operation of the gate and, therefore, did not activate the E-STOP knob. By the time this report was concluded, it was not clear who, and in what capacity was this person allowed to activate the E-STOP button.

Figure 16: Gate control box installed at the guard house at the Echo gate.

Figure 17: Gate control box showing the E-STOP button at the top.

- (vi) Another significant safety barrier that failed was the Emergency STOP (E-STOP) button that was installed at the guard house. The guard on duty who witnessed the accident was not permitted to touch the knob. It is not clear what the procedures were with regards to the E-STOP as it was a safety barrier that failed the system. The investigation team could not get clarity on this matter.

- d) It is recommended that ACSA consider empowering security guards at the gate by reviewing their SOPs to allow them to activate the E-STOP (Emergency Stop) button at the control box at the guard house should they witness any potential risk which might result in an incident or accident.

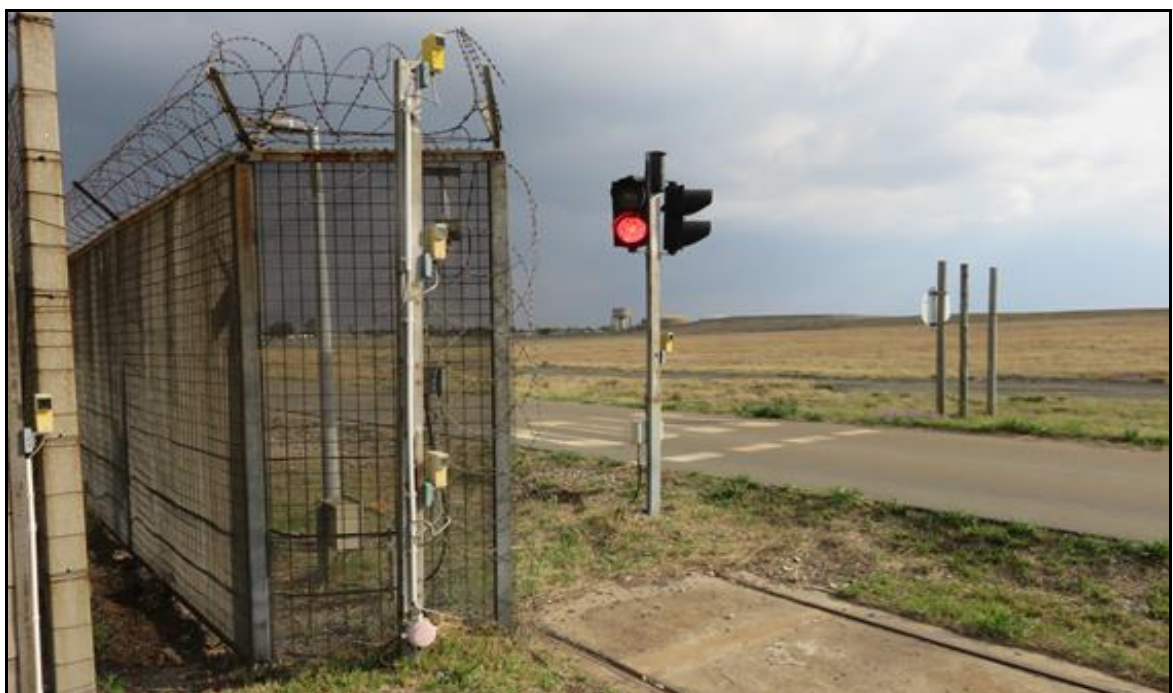
However, these lights were working at the time of the accident, as the traffic light on the 'gate close side' was visible on the CCTV footage. The light was green while the gate was in open position; as soon as the gate started to move towards 'close' position, the green light switched off.

Figure 19: The ACSA/Echo gate traffic light in the gate 'close' position.

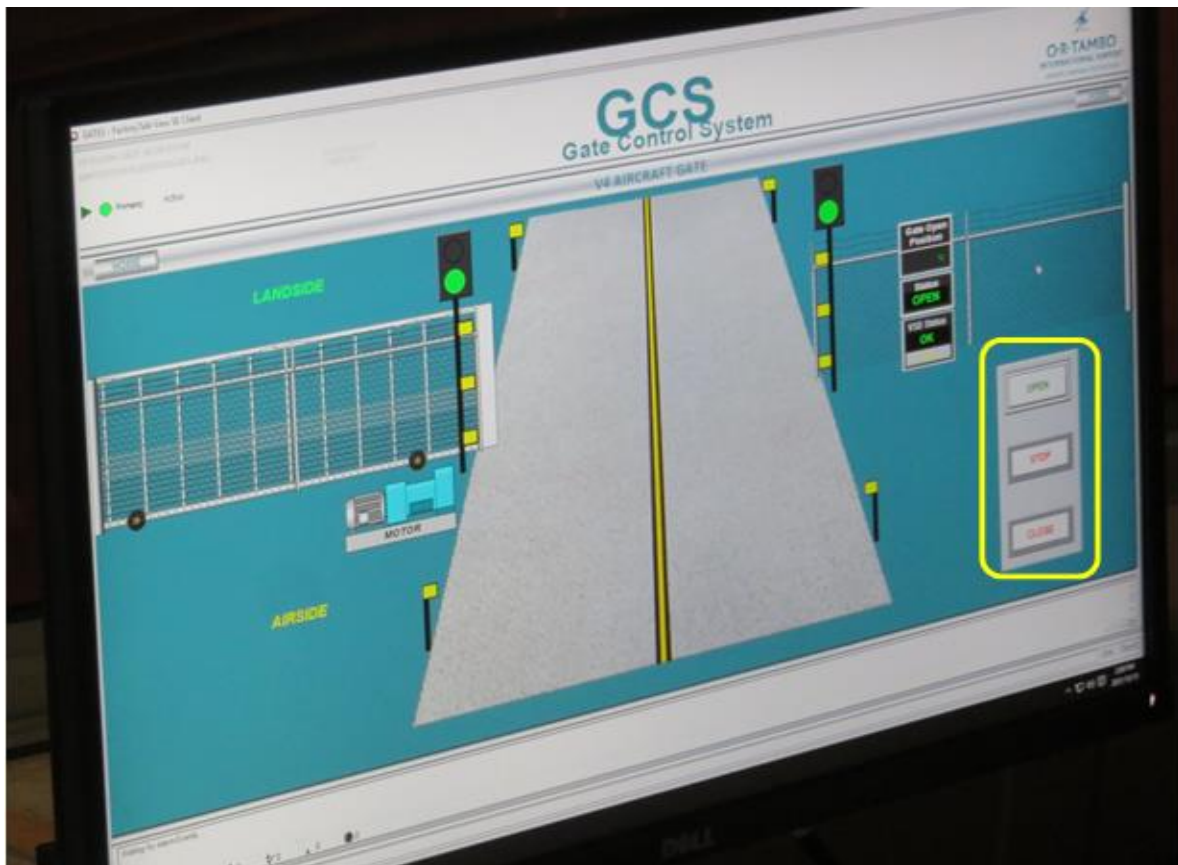
OPEN, CLOSE or STOP window (see Figure 23). Should the operator want to view the status of the gate via CCTV footage, he/she needs to select a second screen and monitor the gate movement accordingly. This does not mean that the person is looking at live CCTV footage to see if the gate is closing or not, and/or if there is any aircraft approaching the gate. What the investigating team observed during their visit to the control room was that there are some pilots who are “tail gating” other aircraft in front of them and bypass communicating with AMC. In Figure 24, the aircraft in question is at the gate (footage). This is the view the personnel in the control room would have had access to. *This photograph is the playback footage on the day of the accident, taken by the investigation team during their visit to the control.*

Figure 23: The gate control screen that the controller uses to OPEN, STOP or CLOSE the gate.

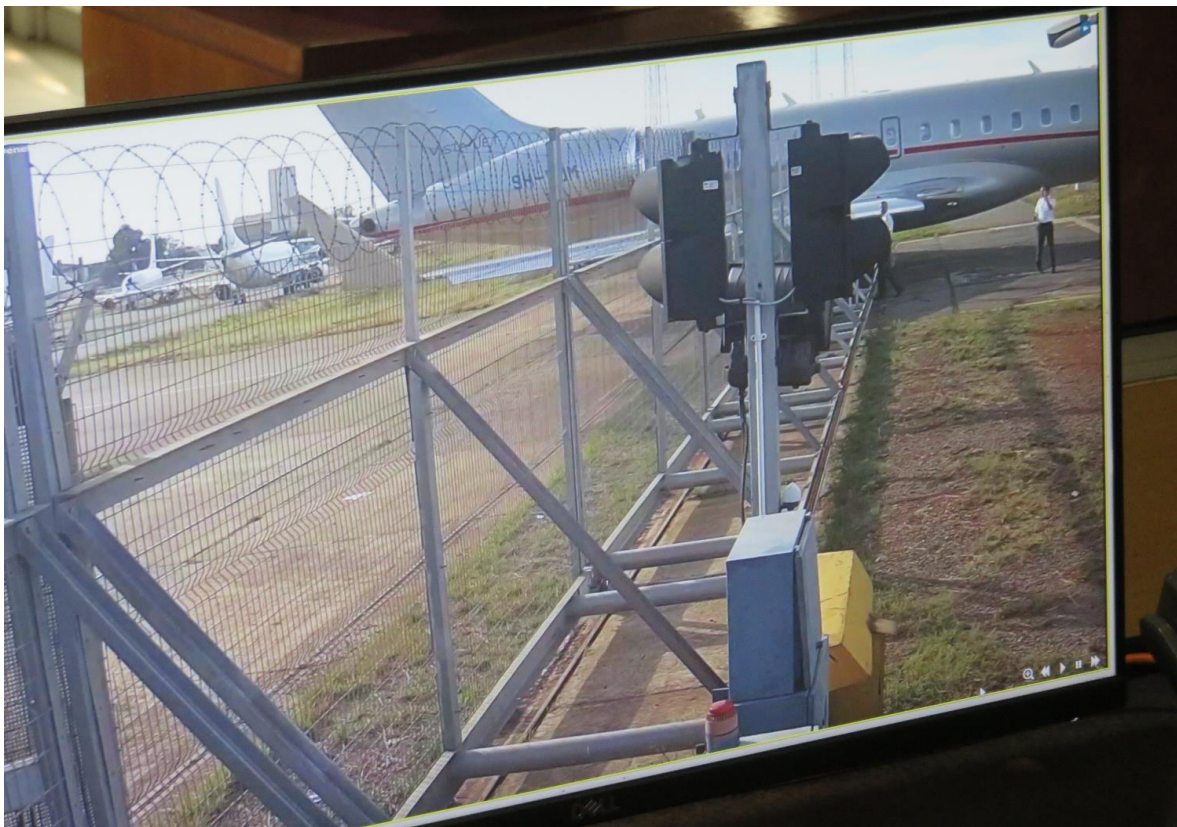
Figure 24: The CCTV footage view of the gate from the control room.

- (iv) Fundamental failures in this accident were the fact that the gate controller was not monitoring the CCTV camera screen as he/she did not take any action to STOP the gate before it collided with the aircraft. If the gate controller was vigilant and was monitoring the CCTV camera, he/she could have been able to prevent this accident.
