LIMITED SERIOUS INCIDENT REPORT

Reference Number	CA18/2/3/10055					
Classification	Serious Incident	Date	18 October 2021	Time	0630Z	
Type of Operation	Private (Part 91)					
Location						
Place of Departure	Botlierskop Game Reserve, Western Cape Province		Place of Intended Landing	Botlierskop Game Reserve, Western Cape Province		
Place of Occurrence	Boggomsbaai next to a beach, Western Cape Province					
GPS Co-ordinates	Latitude	S34° 16'.13. 4"	Longitude	E21°54'.47.5"	Elevation	45 feet
Aircraft Information						
Registration	ZS-PWH					
Model/Make	Robinson R44 Raven II (Serial No: 11760)					
Damage to Aircraft	Minor		Total Aircraft Hours	1738.8		
Pilot-in-command						
Licence Valid	Yes	Gender	Male	Age	51	
Licence Type	Private Pilot Licence (PPL)					
Total Hours on Type	7.2		Total Flying Hours	630.8		
People On-board	1 + 2	Injuries	0	Fatalities	0	Other (On Ground) 0
What Happened						
<p>On Monday morning, 18 October 2021, a pilot accompanied by two passengers on-board a Robinson R44 Raven II helicopter with registration ZS-PWH were on a private flight from Botlierskop Game Reserve, situated between Mossel Bay and George in the Western Cape Province, with the intention to re

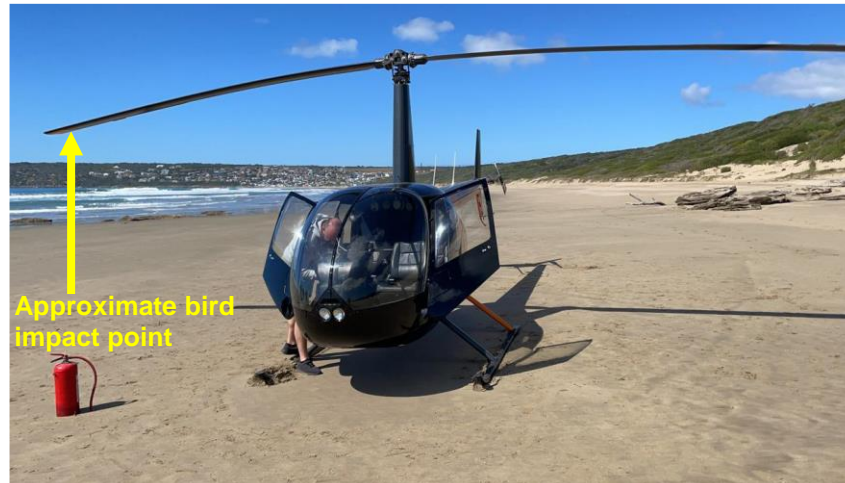
The pilot flew the helicopter in the south westerly direction towards Boggomsbaai area. En route, he heard a loud bang and felt a vibration on the controls. According to the pilot, the engine indications remained within limits. He then decided to execute a precautionary landing on the beach. During landing, the pilot appeared to have flared the helicopter incorrectly. This caused the aluminium main rotor to diverge, resulting in one (first) of the main rotor blades (Part no: C016-7, Serial no: 11818) striking the top part (monocoque shell) of the tail boom and damaging it; the tail-boom shaft remained intact. After the helicopter had settled on the ground, the pilot switched off the engine and the electrics. The helicopter sustained minor damages; no injuries were reported.

Figure 1: The helicopter after landing. (Source: Operator)

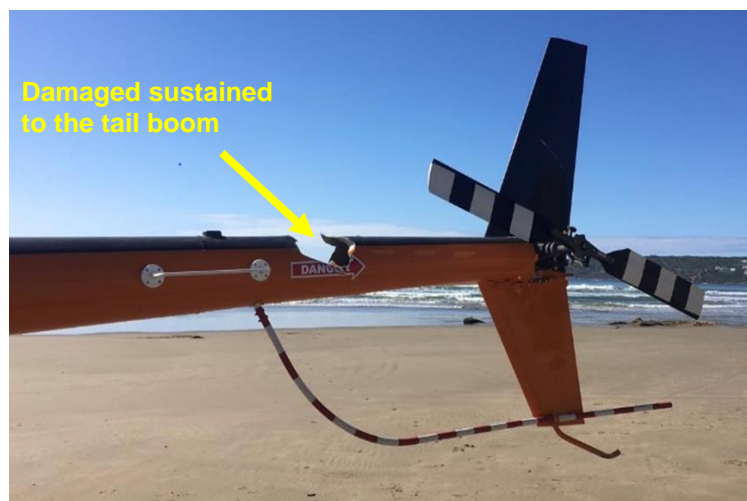
Figure 2: The severed tailboom skin. (Source: Operator)

Precautionary landing was carried out after a loud bang and vibration due to a bird strike, resulting in the tail boom being struck by the number 1 main rotor blade.

The pilot flared the helicopter too high during precautionary landing.

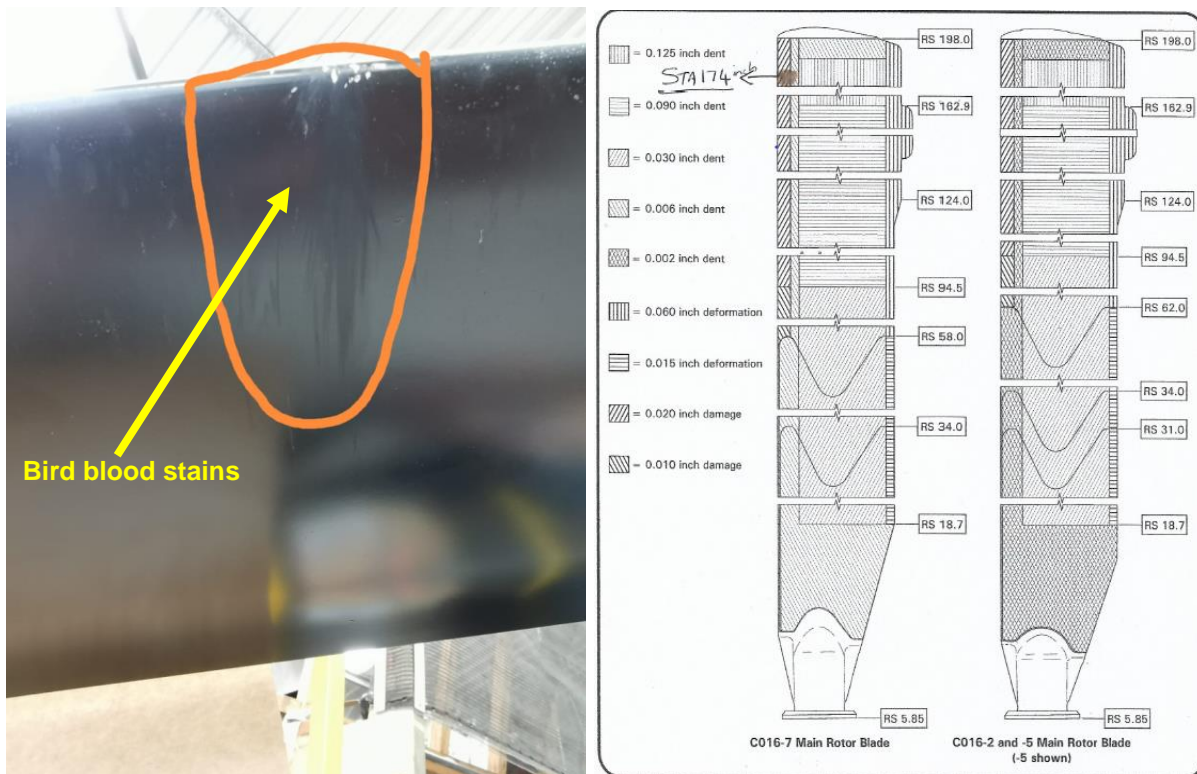
During a walk-around inspection, there was evidence of a bird strike (blood stain) on the other (second) blade's lower section (Serial no: 11824, station No: 174), near the blade tip area. The bird that struck the blade was not found; therefore, the pilot could not tell the species of the bird. Inspection on the blades indicated no damage to the spars or skin-to-spars joint areas and disbonding or buckling on the aerofoil areas. The blade set was, thus, not replaced.

Figures 3 and 4: Bird impact point (left picture). The main rotor blade info from the aircraft maintenance manual (AMM) indicating the main rotor blade locations. (Source: Operator)
