LIMITED ACCIDENT INVESTIGATION REPORT

Reference Number		CA18/2/3/10057					
Classification	Accident	Date	23 October 2021	Time	0530Z		
Type of Operation	Private (Part 94)						
Location							
Place of Departure	Bathawk City Aerodrome, Nelspruit, Mpumalanga Province		Place of Intended Landing	Bathawk City Aerodrome, Nelspruit, Mpumalanga Province			
Place of Occurrence	About 2 nautical miles (nm) north of Bathawk City Aerodrome						
GPS Co-ordinates	Latitude	S25° 33' 28 .6"	Longitude	E30°52'56.4"	Elevation	2392 feet	
Aircraft Information							
Registration	ZU-CYK						
Model/Make	Bantam B22J (Serial No: 03-0216)						
Damage to Aircraft	Substantial		Total Aircraft Hours	408.9			
Pilot-in-command							
Licence Valid	Yes	Gender	Female	Age	60		
Licence Type	National Pilot Licence (NPL)						
Total Hours on Type	11.7		Total Flying Hours	60.6			
People On-board	1 + 1	Injuries	0	Fatalities	0	Other (On Ground)	0
What Happened							
<p>On Saturday morning, 23 October 2021, a pilot on-board a Bantam B22J aircraft with registration ZU-CYK was on a private flight from Bathawk City Aerodrome in Nelspruit, Mpumalanga Province, with the intention to land at the same aerodrome. The aircraft i

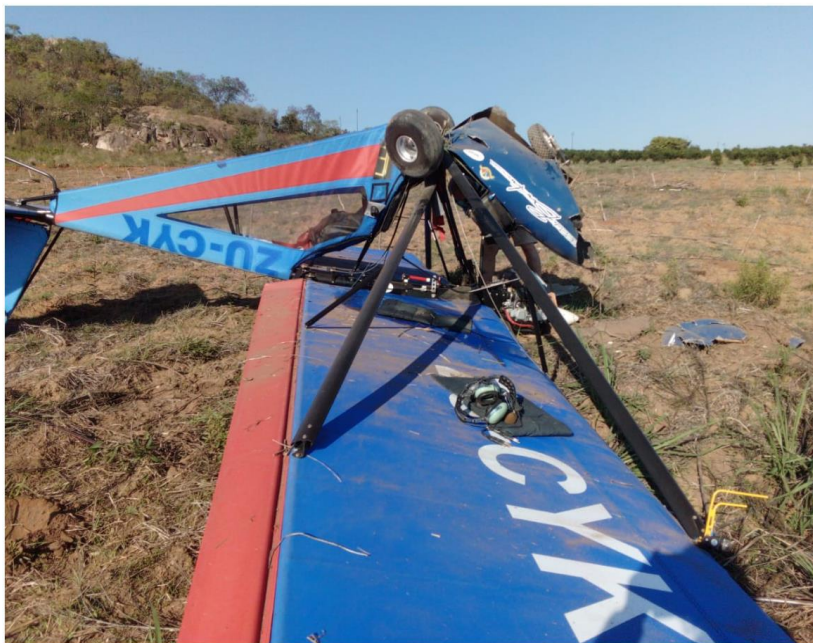
After approximately 4 minutes into the flight, the engine revolutions per minute (rpm) dropped from 2600 to 2300. The pilot reported that she tried to regain the engine power by adjusting the throttle setting, but this did not improve the situation. She then decided to return to the aerodrome with insufficient engine power available. In less than a minute, the engine rpm indication started to oscillate, and the pilot decided to execute a forced landing on an open field which was approximately 2 nautical miles (nm) north of the aerodrome. The pilot stated that she lowered the nose to maintain airspeed and the landing was uneventful for the first part, but then the nose wheel hit an anthill and the aircraft nosed over and came to rest in an inverted position. After switching off the electrics, the pilot and her partner loosened their safety harnesses and vacated the aircraft. The aircraft sustained substantial damage and the two occupants were unharmed. The flight lasted about 0.5 hours.

Figure 1: The aircraft at the accident site. (Source: Operator)

The aircraft was powered by a Jabiru 2200A four-cylinder four-stroke horizontally opposed air-cooled engine with serial No:22A1492. The engine develops 80 horsepower (hp) at 3300rpm driving a fixed-pitch wooden carbon fibre propeller. The wreckage was recovered to the approved aircraft maintenance organisation (AMO) in Bathawk City Aerodrome for further examination by the approved person (AP). Both wings showed severe chordwise damage. There was no evidence of an in-flight structural wing failure.

During the forced landing, the nose gear wheel hit an anthill which caused the aircraft to nose over.

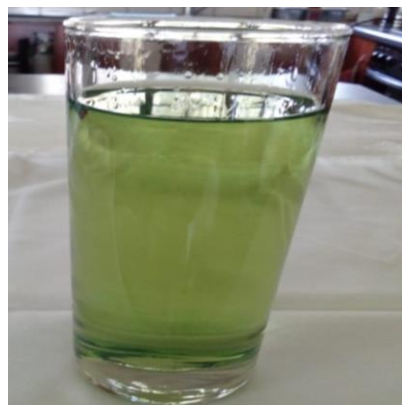
During wreckage examination, the AP noticed that the master fuse was blown, and that the wiring harness was damaged during the accident sequence. The master fuse was replaced to enable the engine to be started while still installed in the airframe. Fuel had leaked from the tank as the aircraft was in an inverted position after the accident. Fuel from the engine carburettor bowl and the fuel-filter had leaked, meaning that no fuel was available for examination on the aircraft. The temperature was recorded at 22° Celsius around the time of the flight which made the possibility of carburettor-icing condition unlikely. During consultation with the owner, he indicated that he bought more fuel than what was required to refuel the aircraft and that about 10 litres remained in the container at his facility. The owner shared a sample of the Unleaded 95 octane fuel, which was found to be free of contaminants.

Figure 2: Fuel sample from the owner. (Source: Owner)

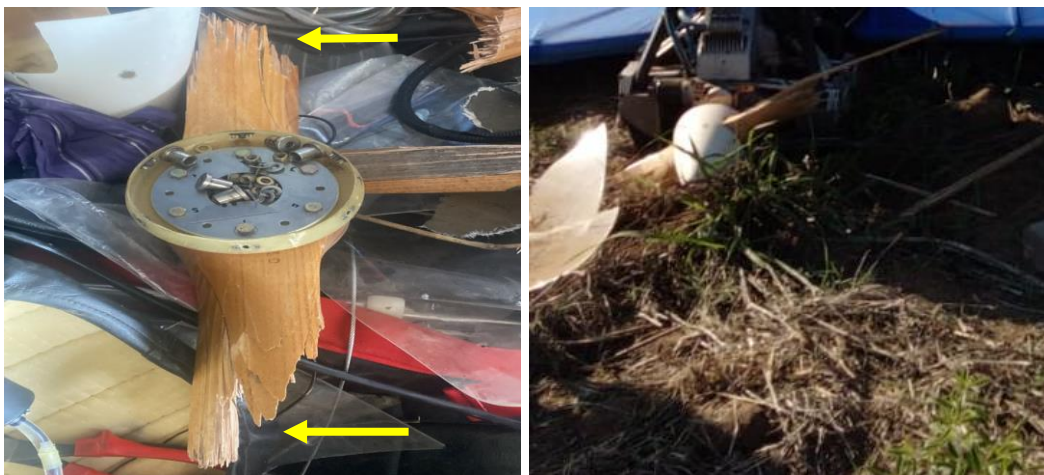
All extremities and control surfaces were accounted for at the site. Although flight control cable runs were disrupted by impact forces, pre-accident control integrity was established. The engine had remained attached to its mounting point and the wooden carbon fibre and glass weave covered P-prop propeller had also remained attached to the hub. The propeller blades had shattered, and the distribution of fragments indicated that the propeller was turning at the time of the accident.

Figures 3/4: Damaged propeller blades. (Source: AP)
