LIMITED ACCIDENT INVESTIGATION REPORT

Reference Number	CA18/2/3/10059						
Classification	Accident	Date	23 October 2021	Time	1436Z		
Type of Operation	Private Flight (Part 91)						
Location							
Place of Departure	Rand Aerodrome (FAGM), Gauteng Province		Place of Intended Landing	Tedderfield Aerodrome (FATA), Gauteng Province			
Place of Accident	Runway 29 FATA, Gauteng Province						
GPS Co-ordinates	Latitude	26°21'07.02"S	Longitude	27°58'10.96"E	Elevation	5177 feet	
Aircraft Information							
Registration	ZS-AVB						
Model/Make	Cessna T210L, Centurion (Serial number: 210-59976)						
Damage to Aircraft	Substantial		Total Aircraft Hours	2407.2 Hobbs			
Pilot-in-command							
Licence Type	Private Pilot Licence (PPL)	Gender	Male		Age: 70		
Licence Valid	Yes						
Total Hours on Type	1707.3		Total Flying Hours	1815.25			
People On-board	1 + 0	Injuries	0	Fatalities	0	Other (on ground)	0
What Happened							
<p>On Saturday, 23 October 2021 at approximately 1424Z, a pilot flying solo on a Cessna T210L aircraft with registration mark ZS-AVB took off from Rand Aerodrome (FAGM) with the intention to land at Tedderfield Aerodrome (FATA). This was a private flight and was conducted u

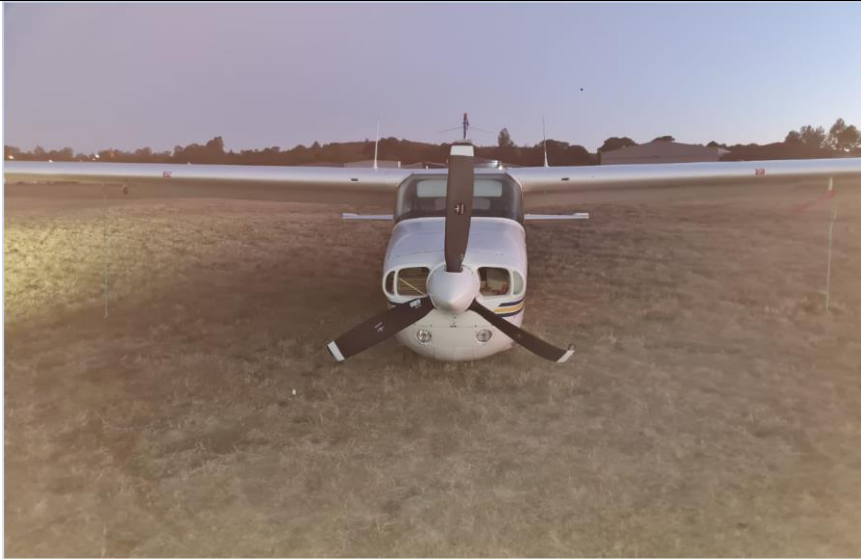
Figure 1: The aircraft after landing on its belly. (Source: Pilot)

The aircraft was landed on its belly due to the pilot forgetting to lower the landing gear during landing.

Pre-landing checklist was not followed.

Safety Message and/or Safety Recommendation/s	
Safety message: Pilots are reminded to always ensure that they adhere to the requirements of the POH checklist to minimise the risk of damage to property and/or injuries to persons.	
Purpose of the Investigation	
<i>In terms of Regulation 12.03.1 of the Civil Aviation Regulations (CAR) 2011, this report was compiled in the interest of the promotion of aviation safety and the reduction of the risk of aviation accidents or incidents and not to apportion blame or liability.</i>	
About this Report	
<i>Decisions regarding whether to investigate, and the scope of an investigation are based on many factors, including the level of safety benefit likely to be obtained from an investigation. For this occurrence, no investigation has been conducted, and the Accident and Incident Investigations Division (AIID) has relied on the information submitted by the affected person/s and organisation/s to compile this brief report. The report has been compiled using information supplied in the initial notification, as well as follow-up information to bring awareness of potential safety issues to the industry in respect of this occurrence, as well as possible safety action/s that the industry might want to consider in preventing a recurrence of a similar accident.</i>

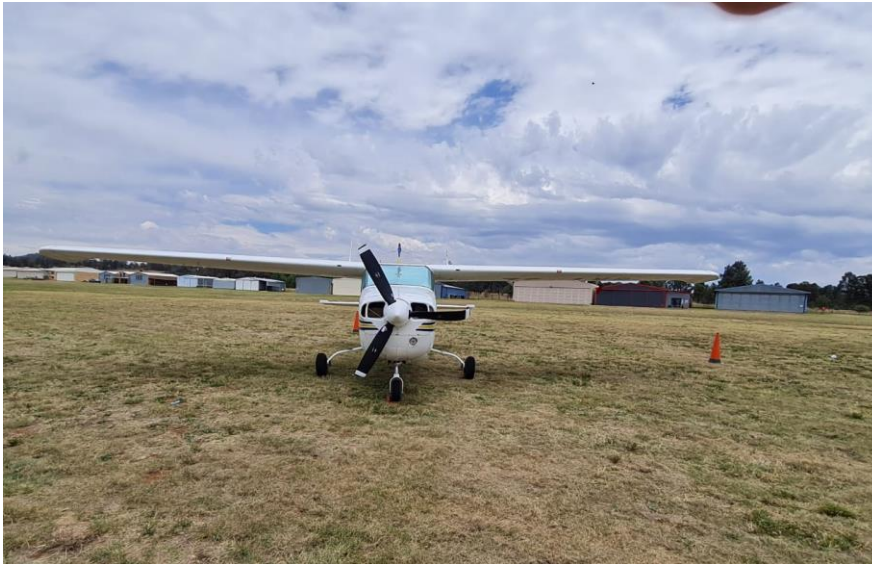
Figure 2: The aircraft after the landing gear was extended. (Source: Pilot)

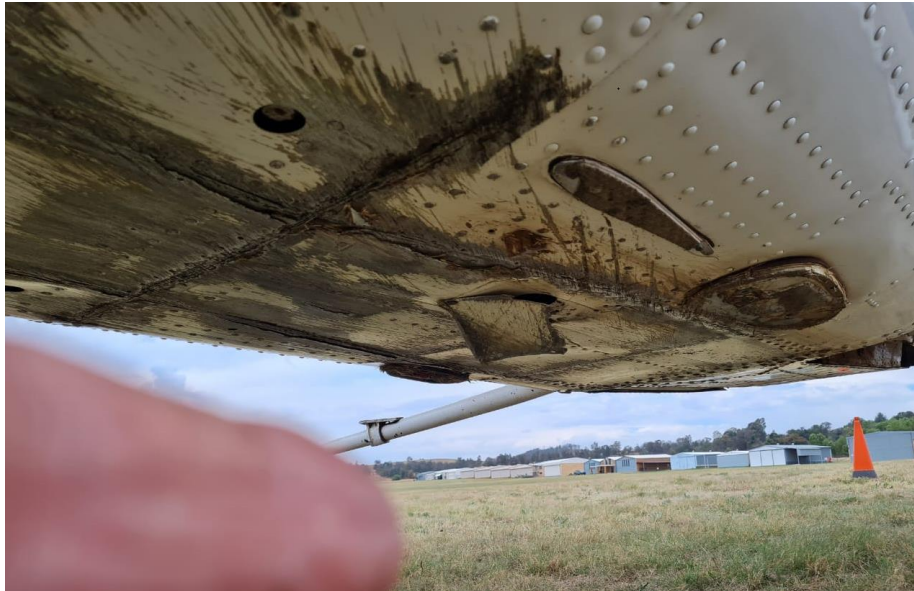
The aircraft sustained substantial damage to the underbelly and the propeller blade tips. The pilot was not injured during the accident sequence.

Figure 3: The damaged underbelly of the aircraft. (Source: Pilot)
