LIMITED ACCIDENT INVESTIGATION REPORT
--

Reference Number	CA18/2/3/10060						
Classification	Accident	Date	27 October 2021	Time	1349Z		
Type of Operation	Commercial (Surveillance) Part 101						
Location							
Place of Departure	Graspan, Mpumalanga Province		Place of Intended Landing	Graspan, Mpumalanga Province			
Place Accident	Graspan, Mpumalanga Province						
GPS Co-ordinates	Latitude	S25° 46" 48'	Longitude	E029° 21" 46'	Elevation	5160 feet	
Aircraft Information							
Registration	ZT-UVW						
Model/Make	Mavic 2 Pro						
Damage to Aircraft	Destroyed		Total Aircraft Hours	286			
Pilot-in-command							
Licence Type	RPAS	Gender	Male	Age 37			
Licence Valid	Yes						
Total Hours on Type	35		Total Flying Hours	608			
People On-board	0	Injuries	0	Fatalities	0	Other (on ground)	0
What Happened							
<p>On 27 October 2021, the pilot operating a drone, the Mavic 2 Pro, with registration mark ZT-UVW was recording an organised blast at Graspan near Middleburg. The operator reported that the accident occurred during the fourth flight (1378) of the day. The remotely piloted aircraft system (RPAS) drone was stationary at 400 feet (ft) above ground level (AGL), above the blasting bloc

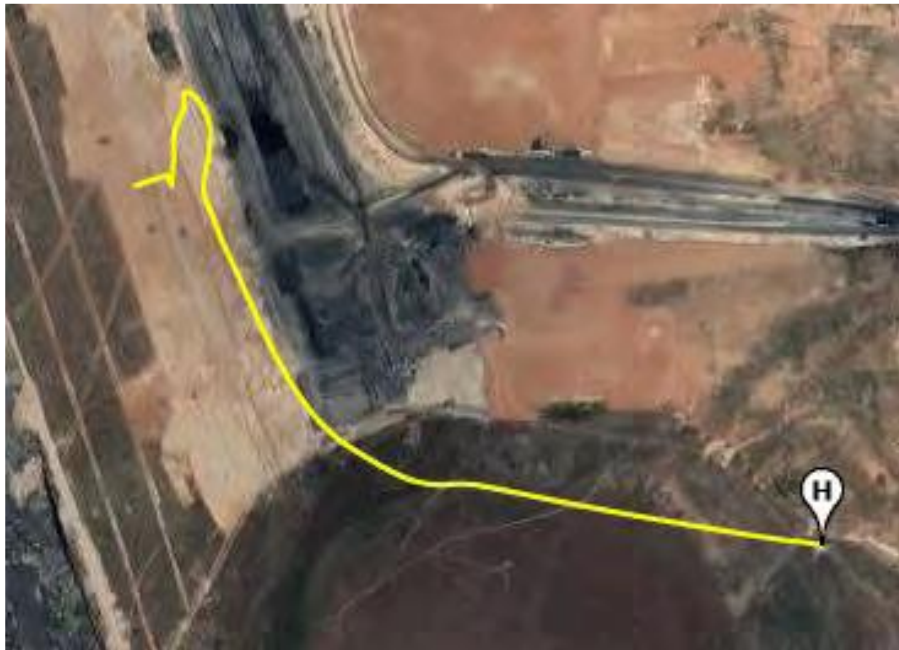
Figure 1: The drone flight path. (Source: Operator)

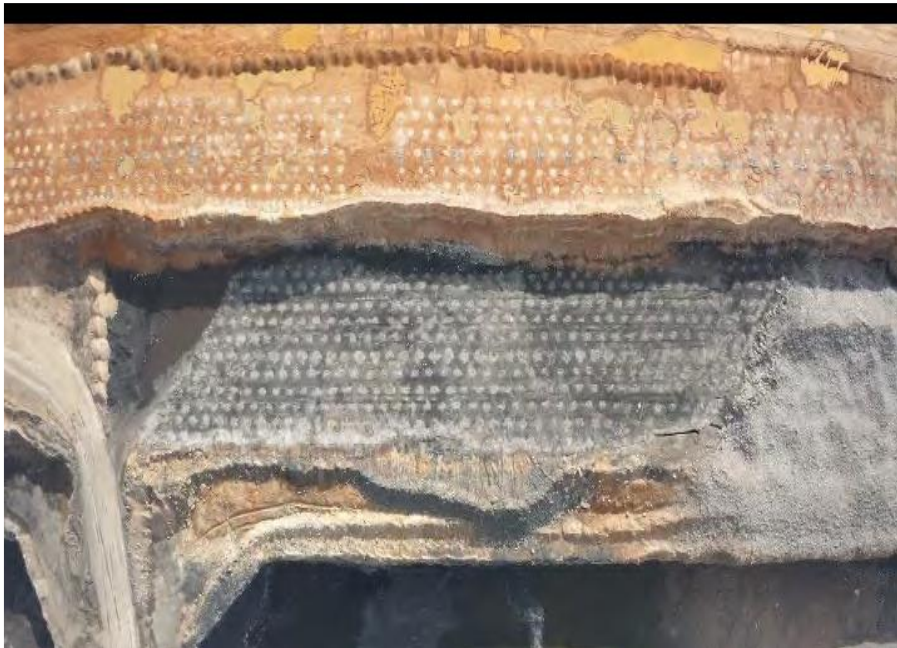
Figure 2: The video footage (still) from the drone while it was still stationary above the blasting block, before blasting operation started. (Source: Operator)

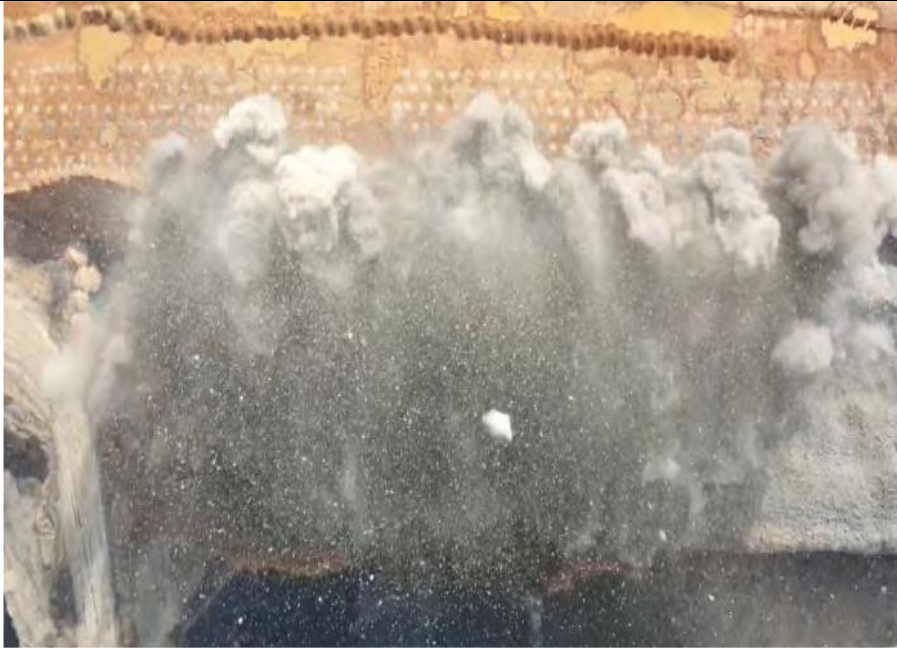
Figure 2: The last (still) image of the drone recording before it was struck by a rock. (Source: Operator)

The rock, propelled by the blast, struck the drone during a rock blast operation. This resulted in the drone falling into the blasting block rubble and likely got buried under the blasted material.

<p>Contributing factor: The drone operator misjudged the drone's safe vertical distance from blast debris.</p>	
<p>Safety Action/s</p>	
<p>None.</p>	
<p>Safety Recommendations</p>	
<p>Drone operators must determine the safe distance (vertical and horizontal) from any possible unsafe areas of operation.</p> <p>The Director of Civil Aviation (DCA) to include the requirement in CAR 2011 Part 101 requiring the determination and recording of safe operating distances from areas of possible unsafe operations, unless an authorisation has been granted by the DCA to deviate.</p>	
<p>Purpose of the Investigation</p>	
<p><i>In terms of Regulation 12.03.1 of the Civil Aviation Regulations (CAR) 2011, this report was compiled in the interest of the promotion of aviation safety and the reduction of the risk of aviation accidents or incidents and not to apportion blame or liability.</i></p>	
<p>About this Report</p>
