AIRCRAFT ACCIDENT REPORT AND EXECUTIVE SUMMARY

Reference:		CA18/2/3/10061	
Aircraft Registration	ZS-UKU	Date of Accident	28 October 2021		Time of Accident	1035Z	
Type of Aircraft	Rand KR-2		Type of Operation		Private (Part 94)		
Pilot-in-command Licence Type	Private Pilot Licence		Age	53	Licence Valid	Yes	
Pilot-in-command Flying Experience	Total Flying Hours		1809.5		Hours on Type	40	
Last Point of Departure	Kitty Hawk Aerodrome (FAKT), Gauteng Province						
Next Point of Intended Landing	Kitty Hawk Aerodrome (FAKT), Gauteng Province						
Damage to Aircraft	Destroyed						
Location of the accident site with reference to easily defined geographical points (GPS readings if possible)							
On higher ground at Tierpoort farm, approximately 0.57 nautical miles (nm) south of FAKT Runway 01 at Global Positioning System (GPS) co-ordinates determined to be S25° 52' 22.6" E28° 27' 13.1" at an elevation of approximately 4 708ft.							
Meteorological Information	Wind direction: 140°; Wind speed: 5 knots; Temperature: 20°C; Dew point: 13°C; Visibility: 10km; QNH:1026hPa

Reference Number : CA18/2/3/10061
Name of Owner/Operator : Dick Jacobs
Manufacturer : Rand Robinson Engineering
Model :

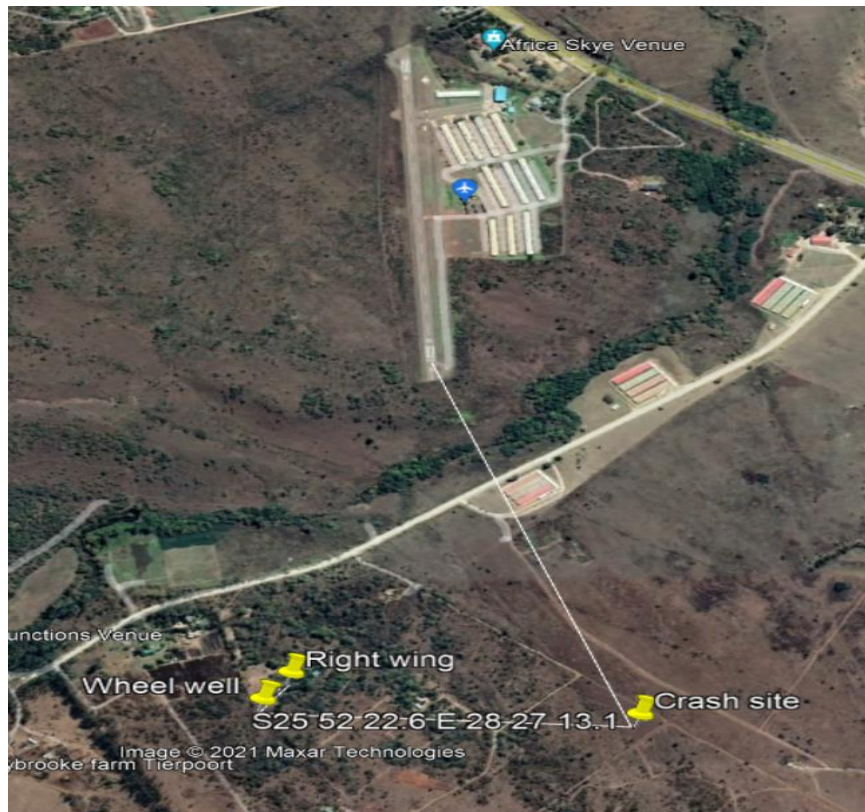
Figure 6: The right wing and the right gear wheel well/fairing positions, as well as the accident site.

1.12.2 The failed right wing and the right main landing gear wheel well/fairing were found at two different locations on the farm, approximately 750 metres south of the accident site. The failure occurred at the forward wing spar area underneath the pilot’s seat outboard right main gear mount.

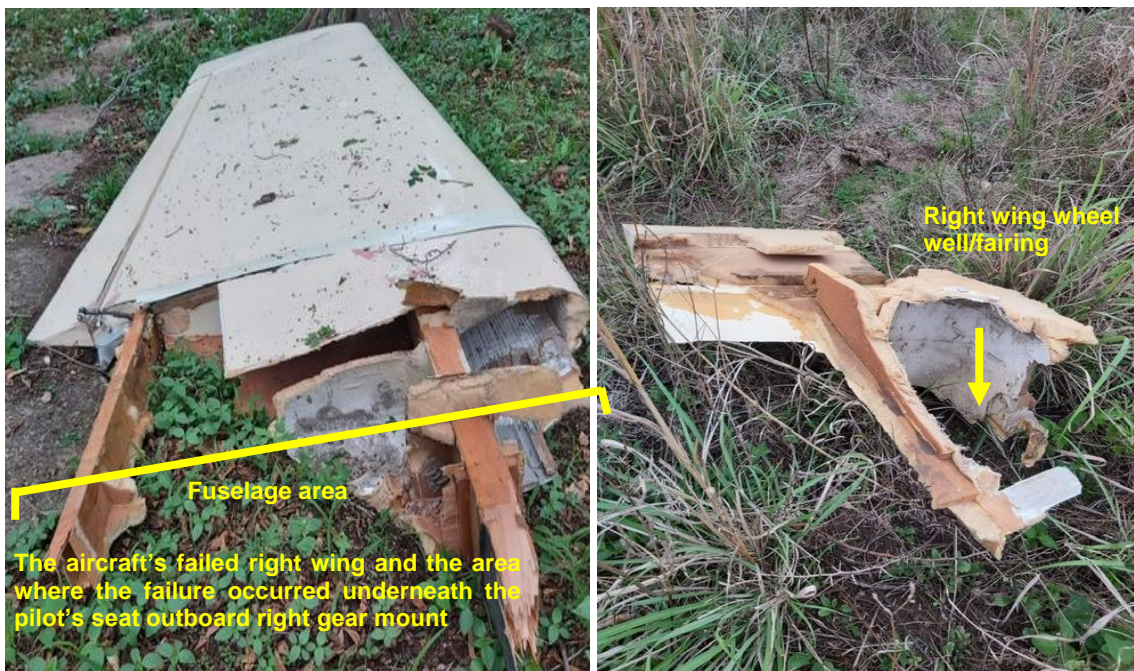
Figures 7/8: The right wing was found in an inverted position (left picture). The right gear wheel well/fairing at the accident site (right picture).

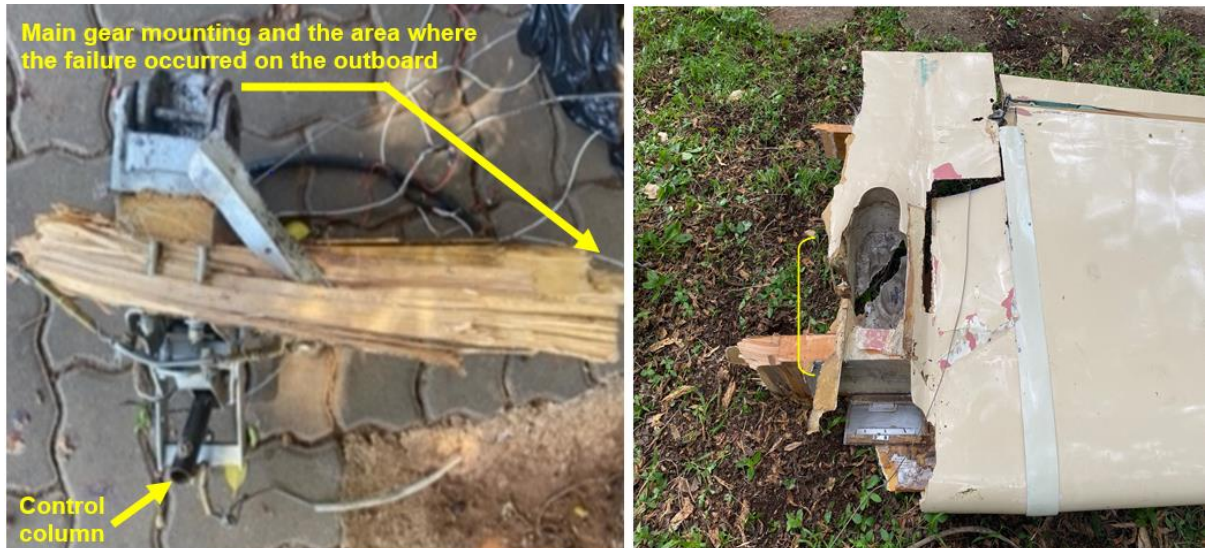
Figures 9/10: The outboard gear mount area showing where the failure occurred (left picture). The right wing and the right gear wheel well/fairing after they were reconstructed post-accident (right picture).

2.2.4 The on-site investigation confirmed that the aircraft had experienced an in-flight break-up. Evidence to support this conclusion includes the area where the right-wing failure occurred underneath the pilot's seat outboard right main landing gear mount. The failed right wing was recovered for engineering examination. Visual examination of the wood used to build the aircraft's wings showed no inherent defects. The investigation revealed that the right-wing aileron was not balanced in accordance with the Build Manual. The aileron was under balanced to the extent of 60kg/mm residual moment. This could have led to the aerodynamic flutter, resulting in structural overload of the right-wing spar.

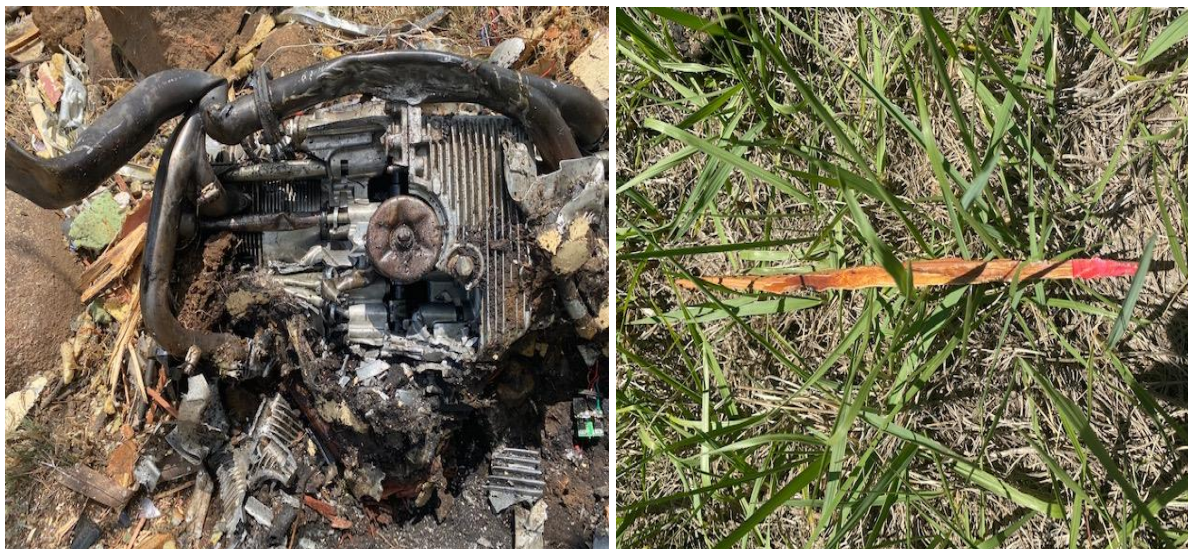
- 1.12.5 The VW 2180 CC 4-cylinder engine had broken into fragments due to high-impact force. The two-blade fixed pitch wooden propeller had remained attached to the hub and the hub had remained attached to the crankshaft. One propeller blade was severely splintered, which was consistent with the engine producing a substantial amount of power on impact.

Figures 11/12: The fragmented VW 2180 CC engine (left picture). Wooden blade remnant indicates an engine that was operating prior to impact (right picture).

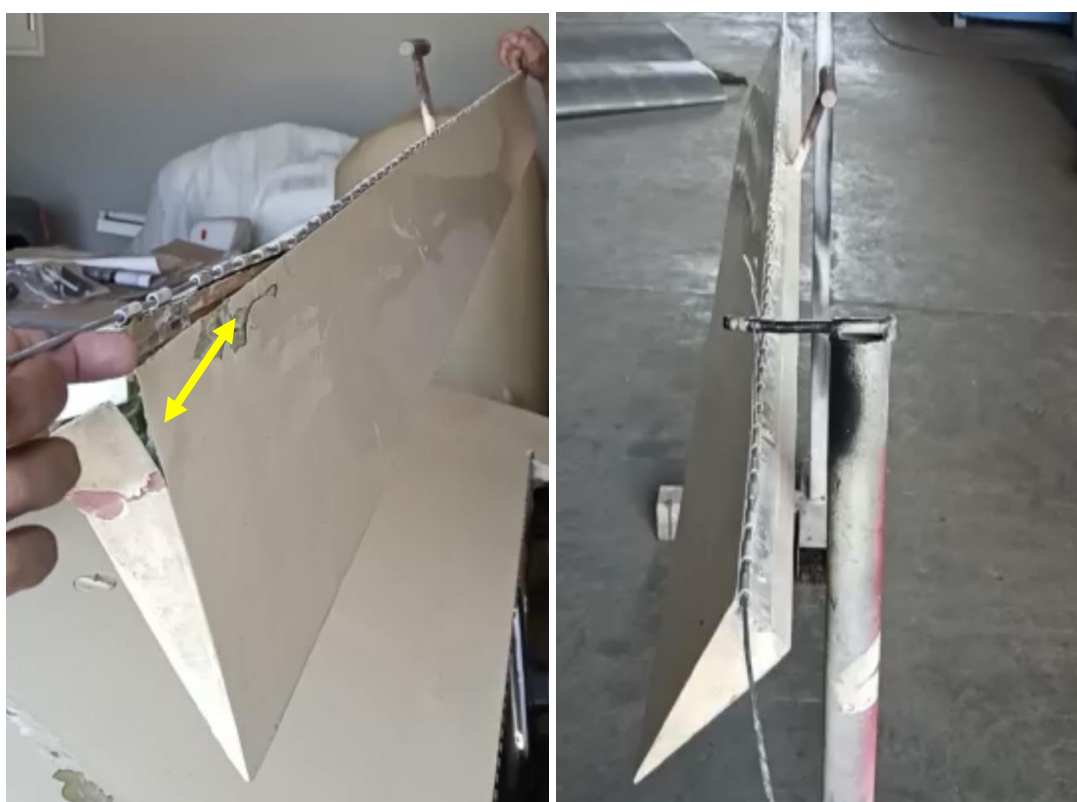
1.16.3 The right wing was recovered from FAKT to Wonderboom Aerodrome (FAWB) for a detailed engineering examination. The aileron operation was restricted by the distortion which resulted from ground impact. The aileron was removed from the wing and glued together on the bell crank attachment side where it had separated. After it had dried up, it was hung using a fine wire in a flying position and checked for mass balancing.

Figures 13/14: The aileron after it was removed from the failed right-wing (left picture). The aileron after it was glued together (right picture).

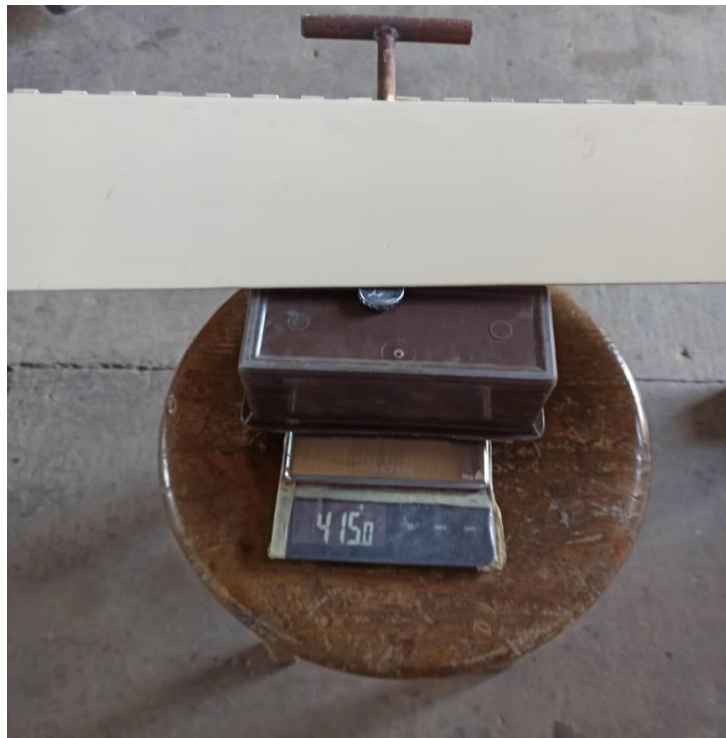
1.16.4 The residual moment was obtained by multiplying the scale reading of 0.415 kilograms (kg) with the moment arm of 145 millimetres (mm). The cord line was placed horizontally level and the hinge line was properly supported when the static line was measured. It was then discovered that the aileron was not balanced IAW the Build Manual (see attached Appendices). The aileron was under balanced to the extent of 60kg/mm residual moment. This contributed to the aileron flutter (explained in paragraph 1.18.1) which further caused the separation of the aileron and its bell crank. The aircraft was manufactured in 1980 and

Figure 15: View of the aileron on a calibrated scale.

- 3.2.12 The investigation showed that the aileron was not balanced IAW the Build Manual. The aileron was under balanced to the extent of 60kg/mm residual moment. This could have led to aerodynamic flutter, resulting in structural overload on the right-wing spar.

- 1) During every annual inspection, the mass balancing of all control surfaces must be checked against the limits set by the manufacturer/designer.
- 2) If maintenance is performed on any control surface that may add weight to that control surface/s, then mass balancing must also be checked at that time and before further flights; this includes paint jobs.

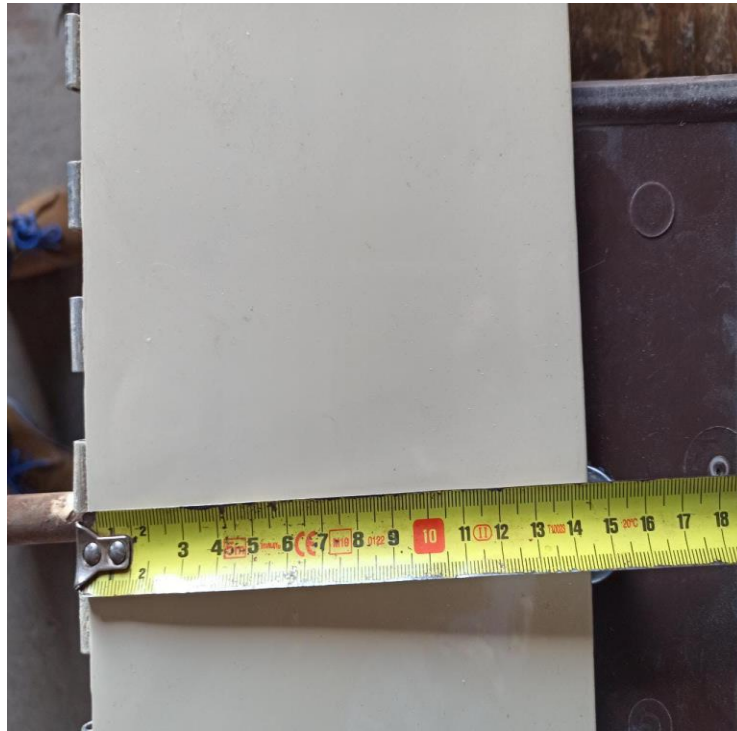
Figure 16: View of the aileron with the moment measured using a tape.

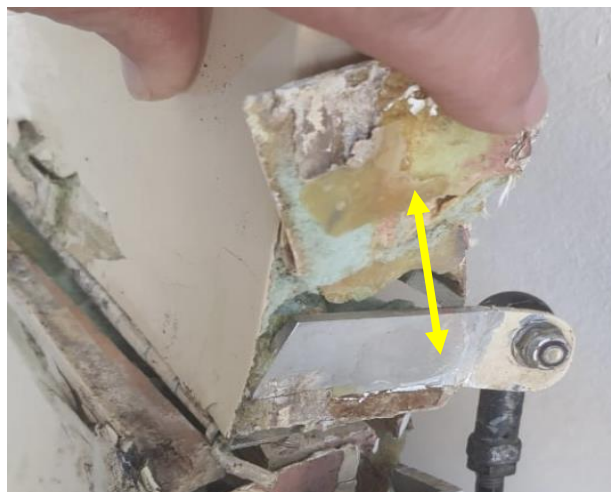
- 1.16.5 Available records showed no evidence of alterations made on the ailerons; however, this cannot be verified with certainty as some records of prior years could not be traced. Post-accident visual examination of the right-wing spars was an indication of structural overload in both a positive and negative direction.

Figure 17: The aileron and bell crank separation caused by flutter.

- 3.3.1 The pilot lost control of the aircraft after the right wing broke off in-flight due to aileron aerodynamic flutter.
