LIMITED ACCIDENT INVESTIGATION REPORT

Reference Number	CA18/2/3/10063						
Classification	Accident	Date	1 November 2021	Time	1030Z		
Type of Operation	Private (Part 91)						
Location							
Place of Departure	Krugersdorp (FAKR) Gauteng		Place of Intended Landing	Krugersdorp (FAKR) Gauteng			
Place of Accident	Runway 26 FAKR						
GPS Co-ordinates	Latitude	S 26°04'50.71"	Longitude	E 27°43'33.8"	Elevation	5501ft	
Aircraft Information							
Registration	ZS-LMO						
Model/Make	Cessna 210 N (Serial Number: 210-64230)						
Damage to Aircraft	Substantial		Total Aircraft Hours	3934.4			
Pilot-in-command							
Licence Valid	Yes	Gender	Male		Age	66	
Licence Type	Private Pilot Licence (Aeroplane)						
Total Hours on Type	429.98		Total Flying Hours	604.3			
People On-board	1+0	Injuries	0	Fatalities	0	Other (On ground)	0
What Happened							
<p>On 1 November 2021, a pilot on-board a Cessna 210 aircraft with registration ZS-LMO took off from Krugersdorp Airfield (FAKR) Runway 08 at 1000Z to the general flying area (GFA) with the intention to land back at FAKR. On his return to the airfield, the prevailing wind was favouring Runway 26. During the landing phase, there was a crosswind from

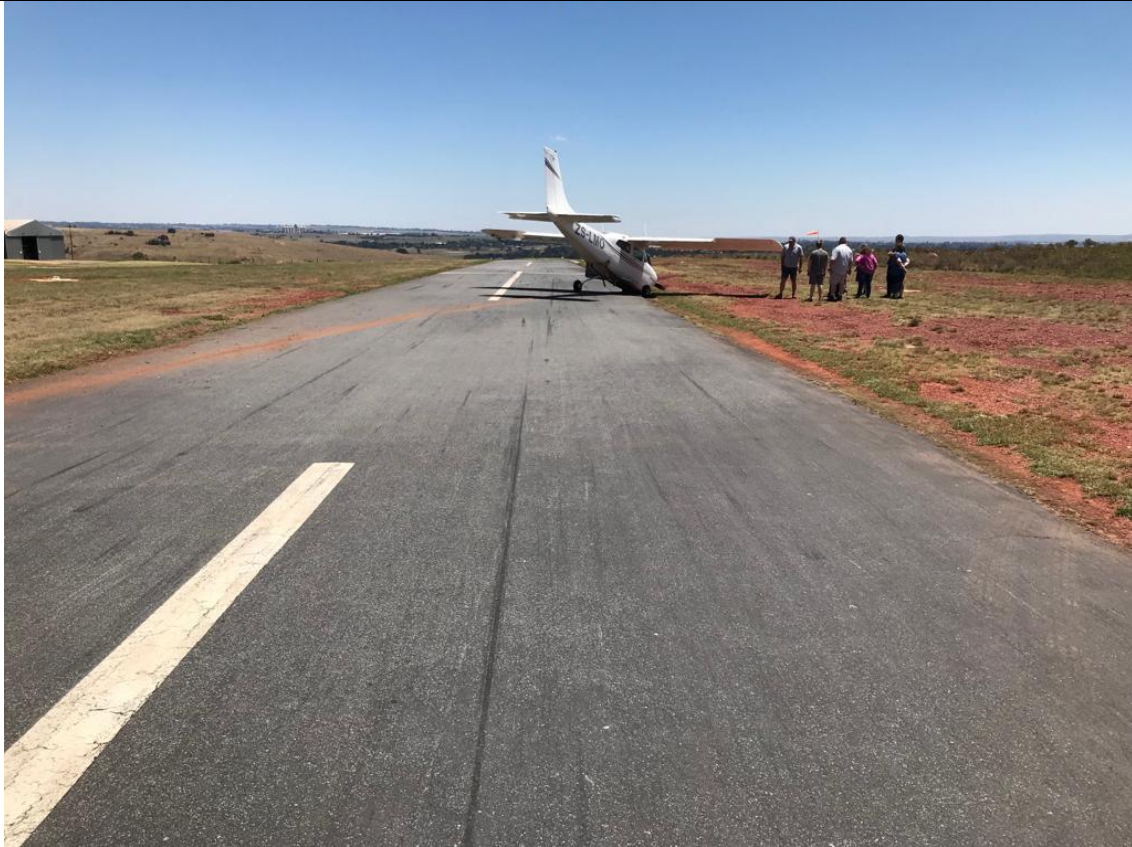
Figure 2: Picture showing the aircraft as it came to rest. (Source: Pilot)

Probable cause:	
The aircraft encountered a crosswind from the right, causing an unstable approach; thus, the pilot lost directional control of the aircraft during the landing roll.	
Safety Action/s	
None.	
Safety Message and/or Safety Recommendation/s	
None.	
Purpose of the Investigation	
<i>In terms of Regulation 12.03.1 of the Civil Aviation Regulations (CAR) 2011, this report was compiled in the interest of the promotion of aviation safety and the reduction of the risk of aviation accidents or incidents and not to apportion blame or liability.</i>	
About this Report	
<i>Decisions regarding whether to investigate, and the scope of an investigation are based on many factors, including the level of safety benefit likely to be obtained from an investigation. For this occurrence, no investigation has been conducted, and the Accident and Incident Investigations Division (AIID) has relied on the information submitted by the affected person/s and organisation/s to compile this brief report. The report has been compiled using information supplied in the initial notification, as well as follow-up information to bring awareness of potential safety issues to the industry in respect of this occurrence, as well as possible safety action/s that the industry might want to consider in preventing a recurrence of a similar accident.</i>

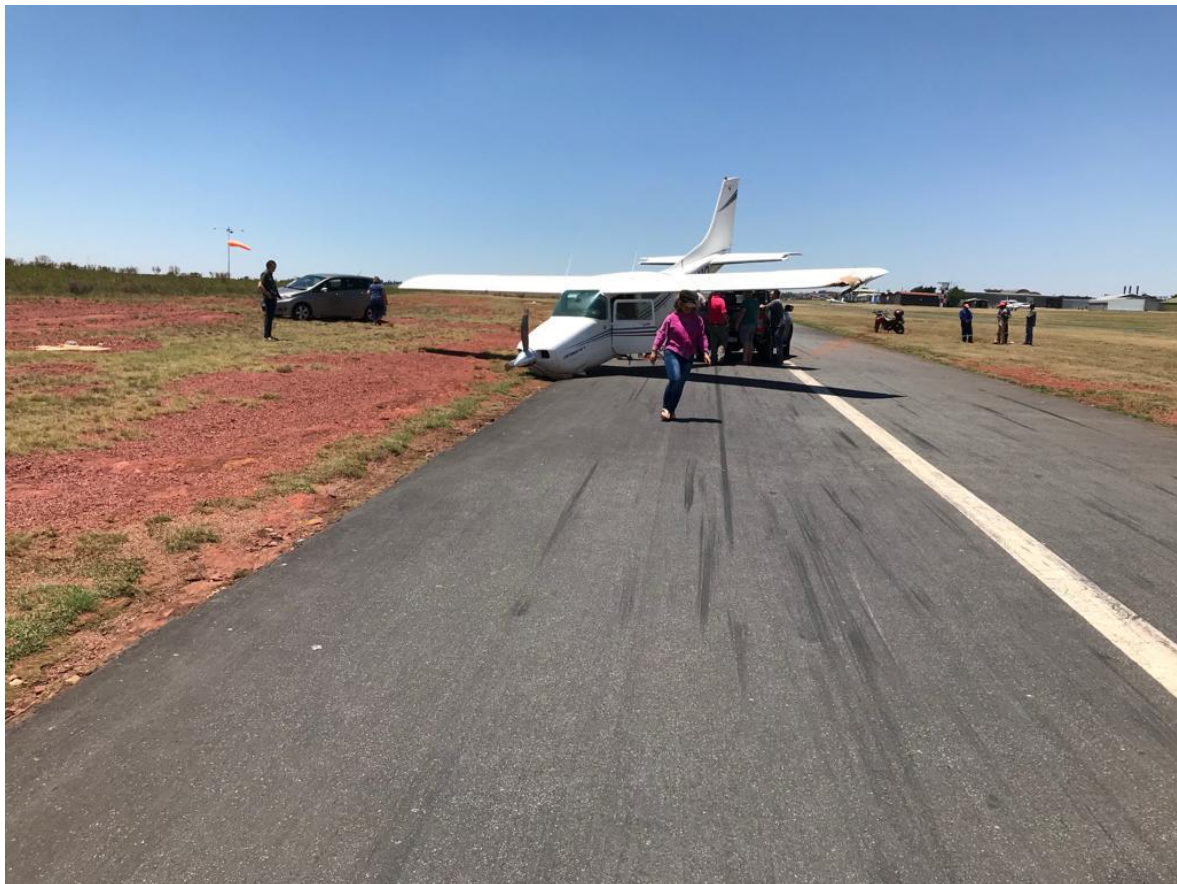
Figure 3: Picture showing damage to propeller and left-wing tip. (Source: Pilot)
