LIMITED ACCIDENT INVESTIGATION REPORT
--

Reference Number		CA18/2/3/10065								
Classification		Accident		Date		2 November 2021	Time		1112Z	
Type of Operation		Private (Part 91)								
Location										
Place of Departure		Nelspruit Aerodrome (FANS), Mpumalanga Province		Place of Intended Landing		Douglas Backhouse Aerodrome, Northern Cape Province				
Place of Occurrence		Runway 34, Douglas Backhouse Aerodrome, Northern Cape Province								
GPS Co-ordinates		Latitude		29° 04' 39.00" S		Longitude		023° 48' 01.40" E	Elevation	3 382 ft
Aircraft Information										
Registration		ZS-FRO								
Model/Make		Mooney M20G								
Damage to Aircraft		Substantial			Total Aircraft Hours		4 858.0			
Pilot-in-command										
Licence Valid		Yes			Gender		Male	Age	51	
Licence Type		Private Pilot Licence (PPL)								
Total Hours on Type		63.0			Total Flying Hours		136.8			
People On-board		1 + 0	Injuries		0	Fatalities		0	Other (on ground)	0
What Happened

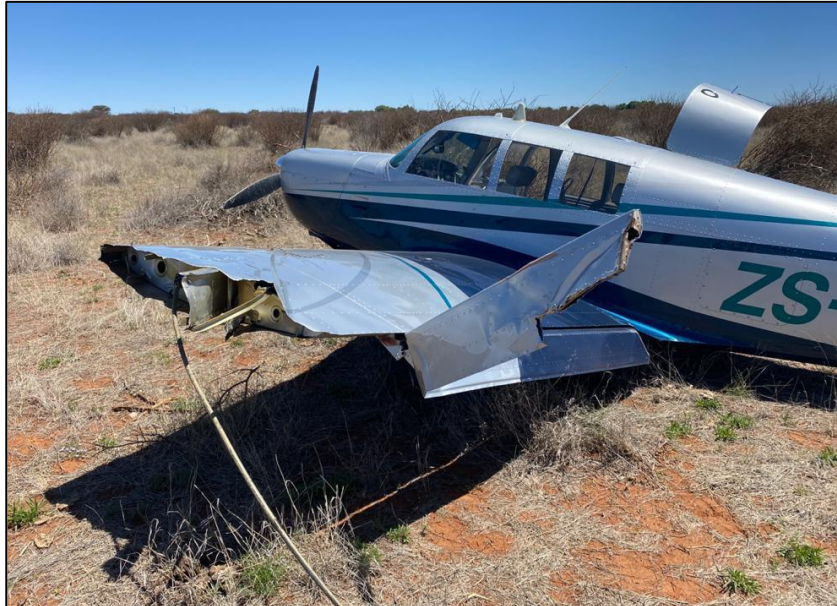
Figure 1: ZS-FRO's damaged left wing. (Source: Pilot)

<p>Probable cause:</p> <p>The aircraft was flared too high, causing it (aircraft) to land hard and balloon. This led to the pilot losing control of the aircraft, which resulted in the aircraft veering off to the left of the runway before colliding with the parameter fence pole.</p>
<p>Safety Action</p> <p>None.</p>
<p>Safety Message</p> <p>Pilots should execute a go-around immediately if they recognise that their approach is unstable. This is a proven risk mitigation when it comes to avoiding a hard touchdown which may result in damage to the aircraft and/or injury to persons.</p>
<p>Purpose of the Investigation</p> <p><i>In terms of Regulation 12.03.1 of the Civil Aviation Regulations (CAR) 2011, this report was compiled in the interest of the promotion of aviation safety and the reduction of the risk of aviation accidents or incidents and not to apportion blame or liability.</i></p>
<p>About this Report</p> <p><i>Decisions regarding whether to investigate, and the scope of an investigation are based on many factors, including the level of safety benefit likely to be obtained from an investigation. For this occurrence, no investigation has been conducted, and the Accident and Incident Investigations Division (AIID) has relied on the information submitted by the affected person/s and organisation/s to compile this brief report. The report has been compiled using information supplied in the initial notification, as well as follow-up information to bring awareness of potential safety issues to the industry in respect of this occurrence, as well as possible safety action/s that the industry might want to consider in preventing a recurrence of a similar accident.</i></p> <p><i>This report provides an opportunity to share safety message/s in the absence of an investigation.</i></p> <p><i>All times given in this report are Co-ordinated Universal Time (UTC) and will be denoted by (Z). South African Standard Time is UTC plus 2 hours.</i></p>
