LIMITED ACCIDENT INVESTIGATION REPORT

Reference Number	CA18/2/3/10066						
Classification	Accident	Date	3 November 2021	Time	1150Z		
Type of Operation	Aerial Work / Crop-spraying (Part 138)						
Location							
Place of Departure	Farm Mooipan, Theunnisen District, Free State Province		Place of Intended Landing	Farm Mooipan, Theunnisen District, Free State Province			
Place of Accident	Runway 35 overrun area on farm Mooipan, Theunnisen District						
GPS Co-ordinates	Latitude	28°17'01.74" S	Longitude	026°37'53.28" E	Elevation	4 526 ft	
Aircraft Information							
Registration	ZS-DZM						
Make/Model	Air Tractor AT402B (Serial Number: 402B-1397)						
Damage to Aircraft	Substantial		Total Aircraft Hours	1 459.6			
Pilot-in-command							
Licence Valid	Yes		Gender	Male		Age: 38	
Licence Type	Commercial Pilot Licence						
Total Hours on Type	5.4		Total Flying Hours	1 553.9			
People On-board	1 + 0	Injuries	0	Fatalities	0	Other (On Ground)	0
What Happened

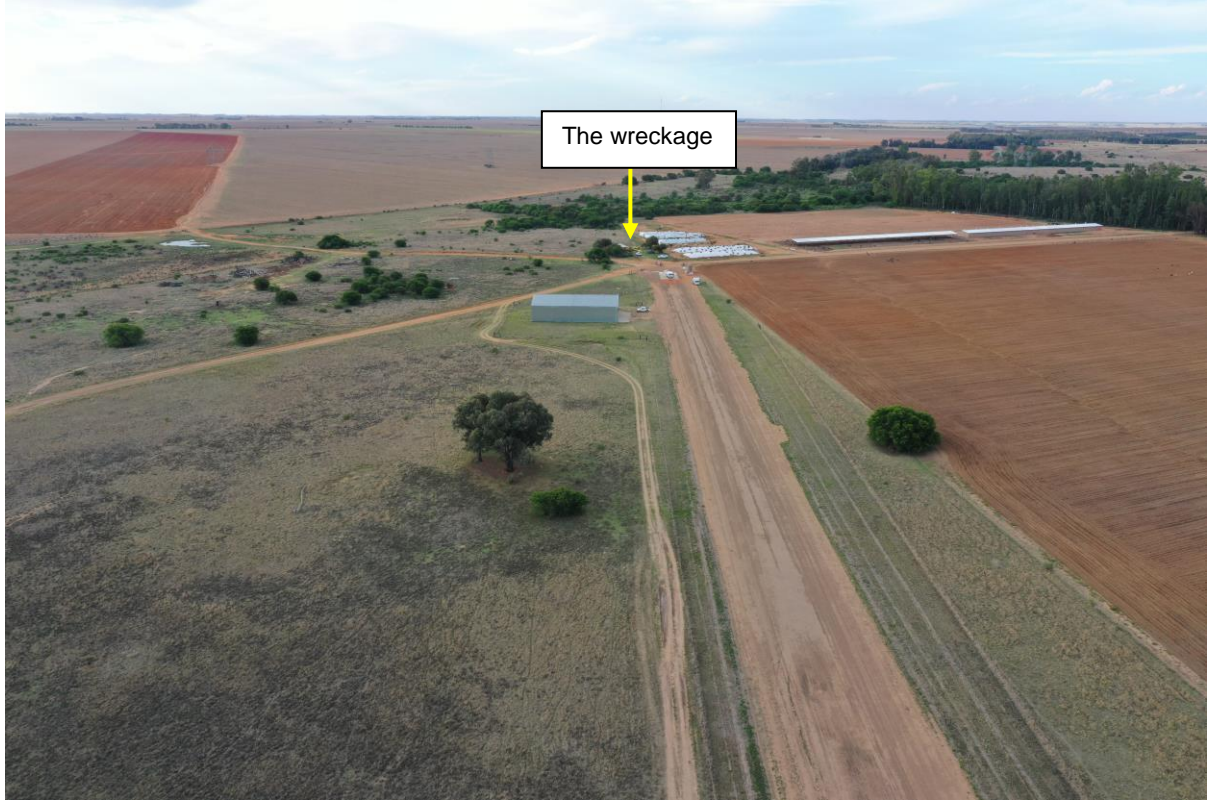
The pilot overran the runway as he was unable to bring the aircraft to a stop before the end of the runway surface. The left wing impacted a tree and uprooted it. Further along, the same wing impacted a brick building (store room), which caused the aircraft to ground loop to the right before coming to rest facing the building. The pilot was not injured in the accident. As he disembarked the aircraft, he noticed smoke coming from the front section of the engine. He then took portable fire extinguisher that was in the cockpit and dosed the fire. The source of smoke was found to be from an engine oil line that ruptured, and the leaking oil coming into contact with the hot engine.

Figure 1: An aerial view of part of the runway and the final position of the wreckage. (Source: AAS)

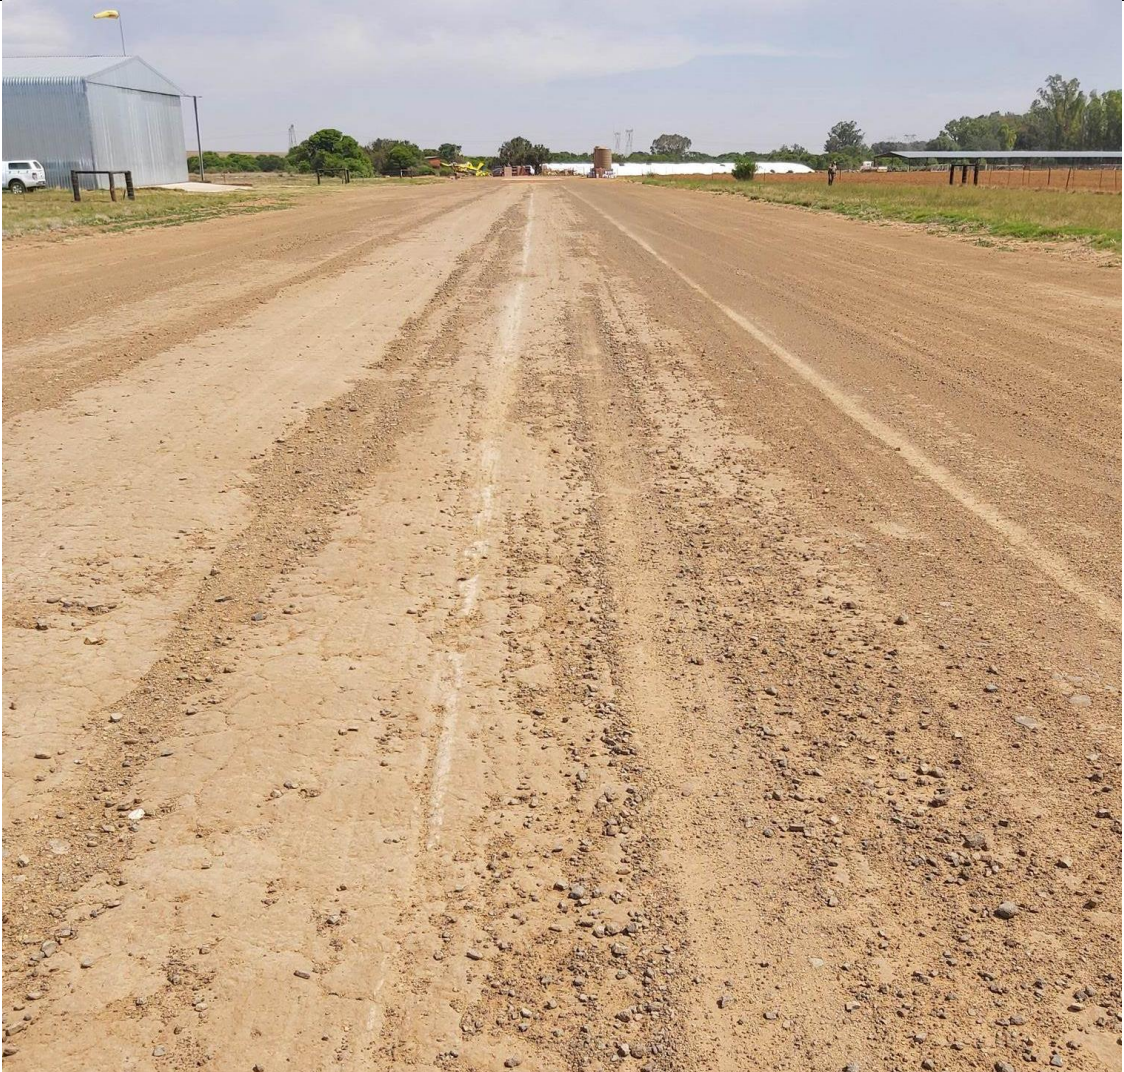
Figure 2: Tyre brake markings visible on the gravel runway.

- (viii) The runway surface had stones/rocks (see Figure 2) which not only posed a risk of foreign object damage to the aircraft making use of the runway, but also could affect the effectiveness of the brakes, especially during an aborted take-off.

1. It is recommended to the farm owner (Mooipan) that all obstructions on the overrun area of Runway 35 be removed to ensure there is a proper runway end safety area (RESA). This recommendation was issued in the interest of aviation safety.
2. It is also recommended to the farm owner (Mooipan) that the runway surface be cleared of all stones/rocks on the runway surface. These stones/rocks have the potential not only to cause foreign object damage (FOD) to the aircraft, but could also contribute to inadequate braking and controllability related issues during crosswind conditions.

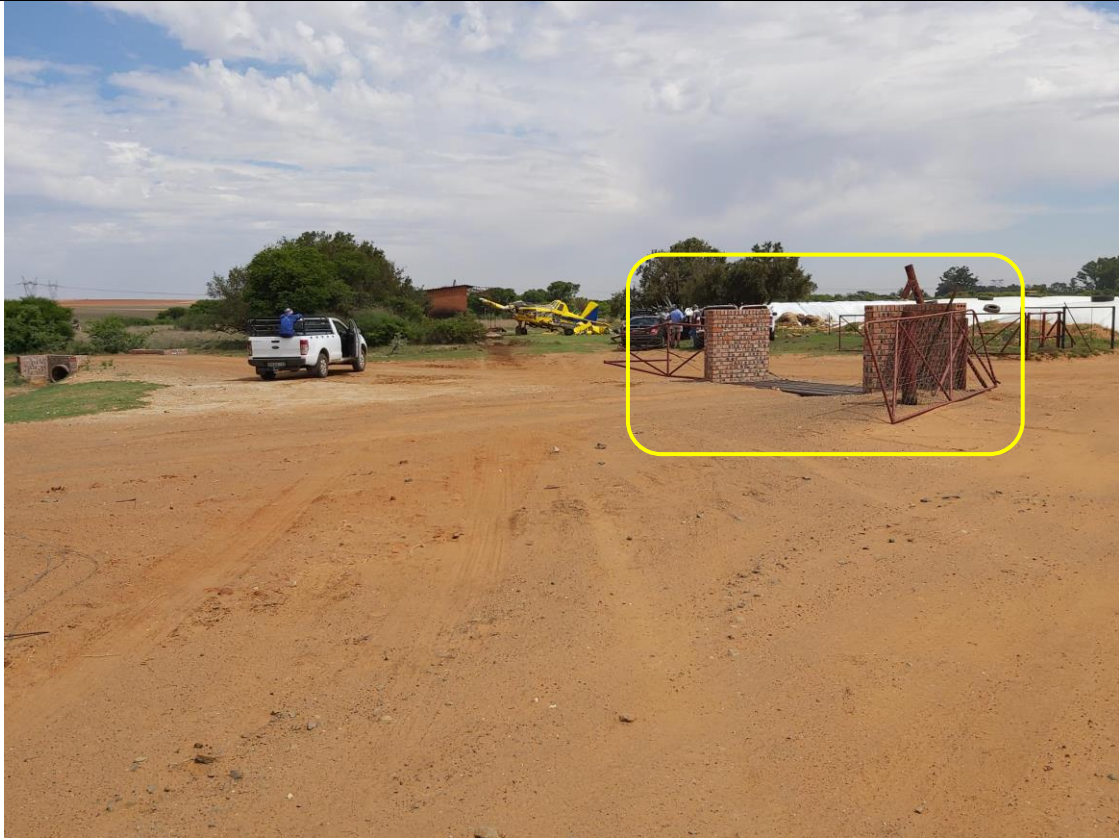
Figure 3: Man-made obstacles on the runway overrun area.

- (v) The pilot did not make use of reverse thrust to decelerate the aircraft following the aborted take-off.
- (vii) This was an unlicensed aerodrome with several man-made obstructions on the overrun area of Runway 35, which the pilot could not avoid when the aircraft overran the runway.

1. There were several man-made obstructions on the overrun area of Runway 35, which the pilot was unable to avoid.
2. The pilot had limited flying experience on the aircraft type.
3. This was the first time the pilot flew a turbine-driven engine aircraft.
4. The pilot did not take into consideration the effect of density altitude as the day progressed.
5. The pilot did not comply with the recommendation as per the flight instructor's advice following his conversion the previous day of flying with an empty hopper tank for 5 to 10 hours and, thereafter, flying with half-load for the next 20 hours.
6. Operational pressure was found to be a significant contributory factor in this accident, which is why the flight instructor's recommendation was ignored by the employer and the pilot immediately started flying with full hopper loads the next day.

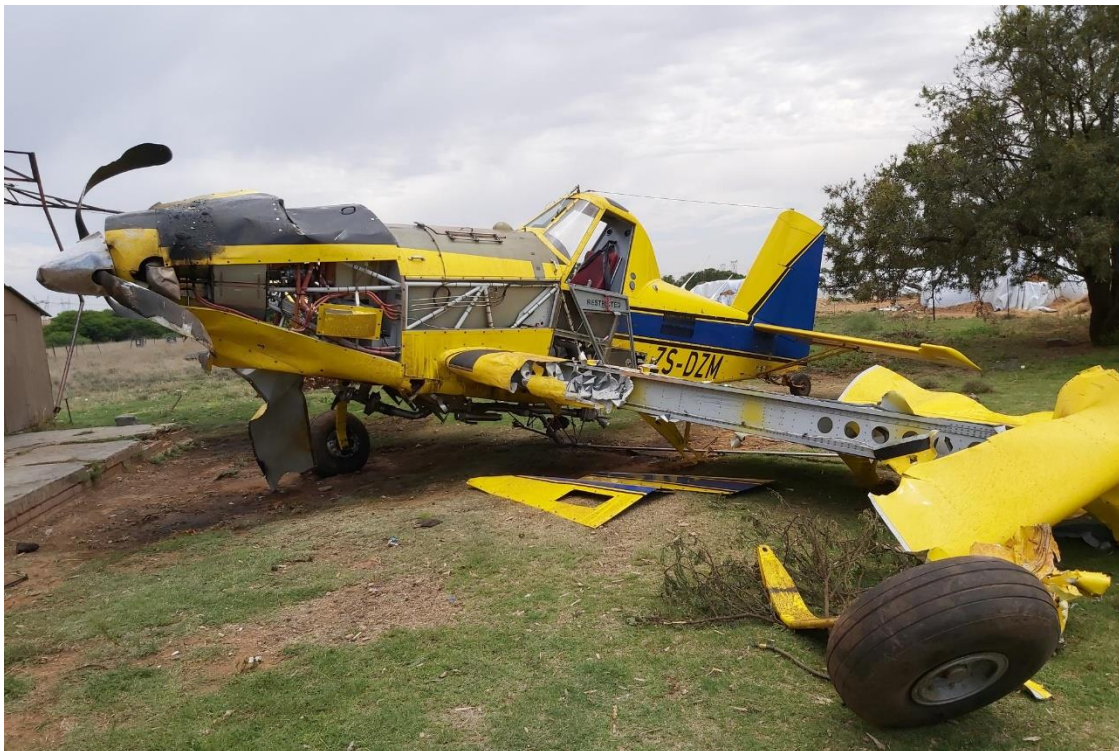
Figure 4: The aircraft as it came to rest.

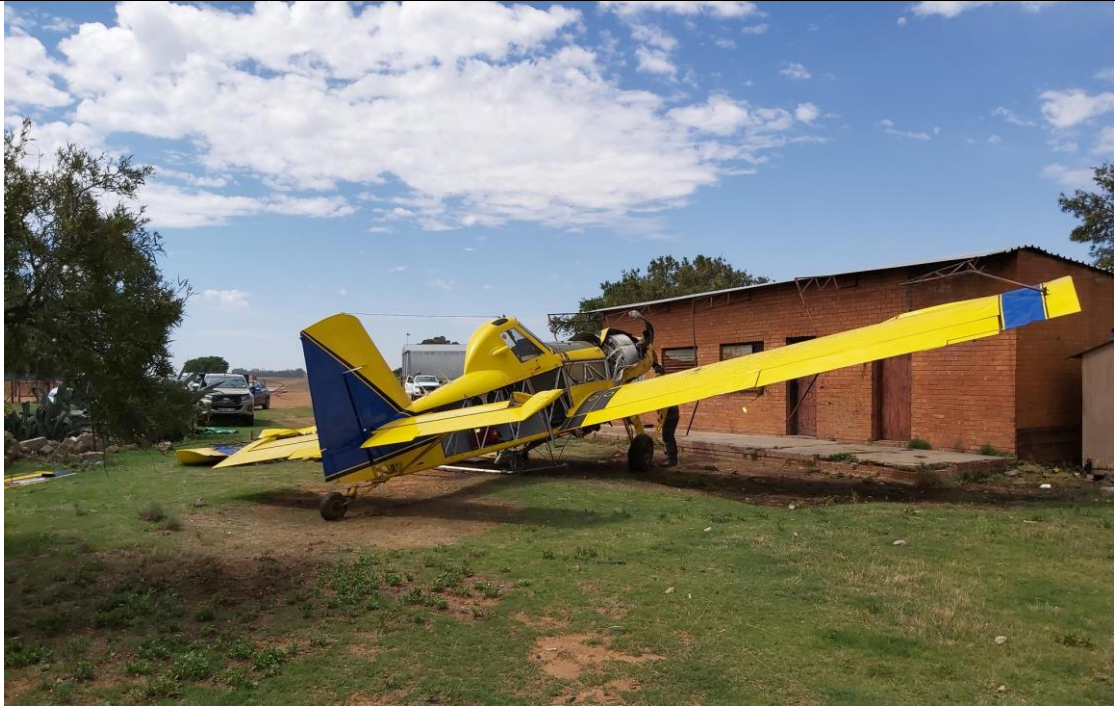
Figure 5: The accident aircraft with the store room in front of it.

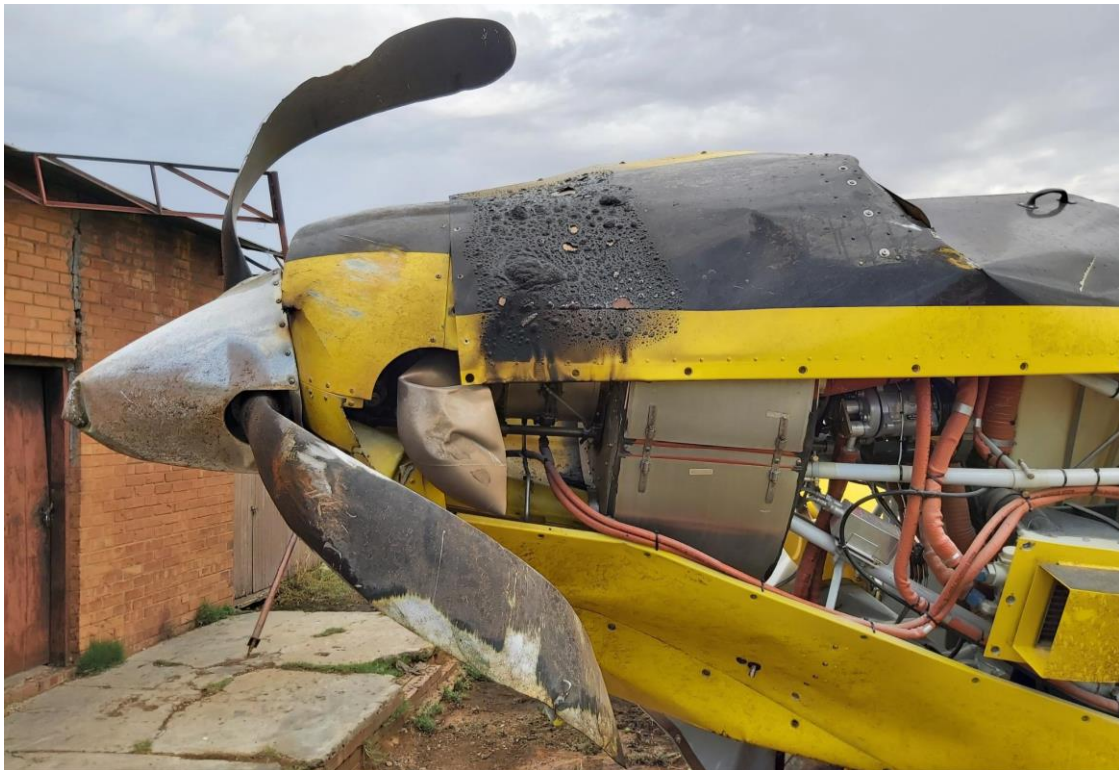
Figure 6: A closer view of the engine and propeller.

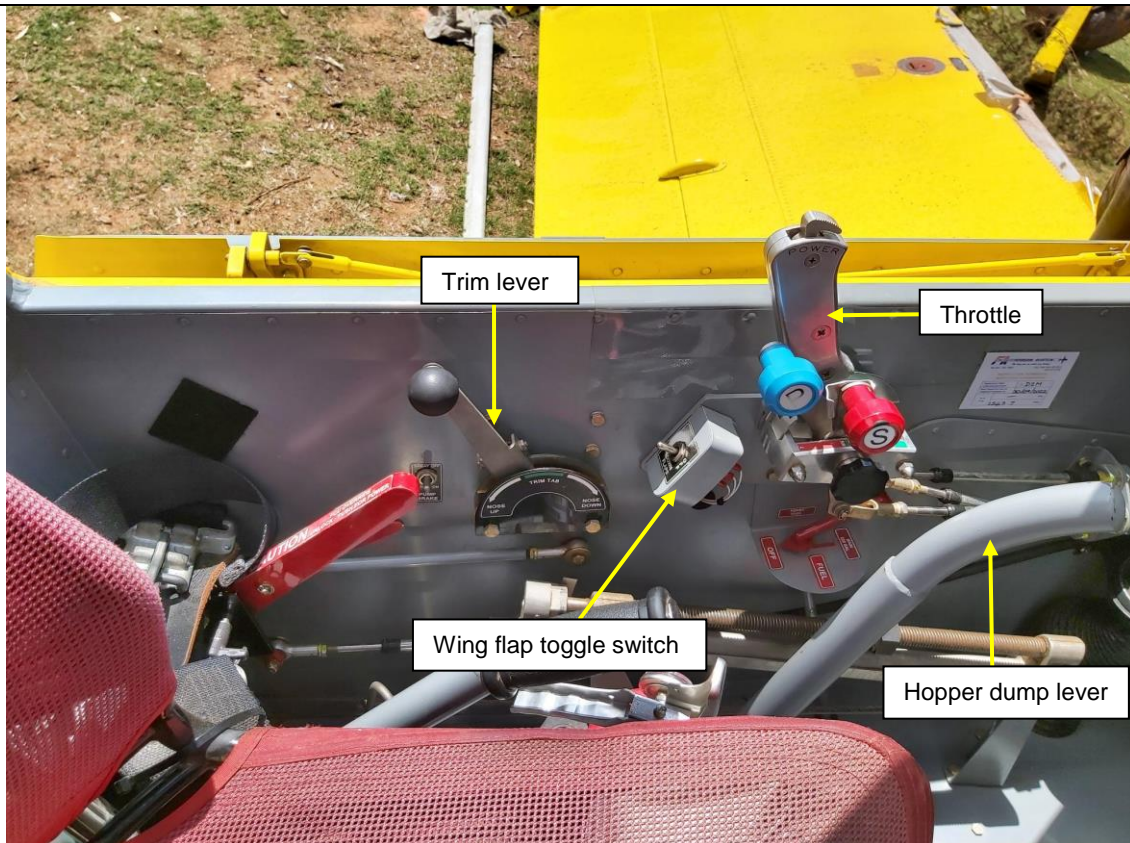
The hopper tank was filled by ground personnel near the threshold of Runway 17. Once filled, the pilot taxied to the threshold of Runway 35, which was the active runway at the time with the prevailing wind from north-west. The pilot stated that he selected a slight nose up trim and lowered the wing flaps as required for take-off. It should be noted that the pilot determines the flap setting as there is no pre-selected flap settings as those found on most other aircraft types. The aircraft is fitted with a wing flap toggle switch (see Figure 7).

Figure 7: A cockpit view illustrating some primary controls.
