LIMITED ACCIDENT INVESTIGATION REPORT

Reference Number		CA18/2/3/10067					
Classification	Accident	Date	4 November 2021	Time	0700Z		
Type of Operation	Private (Part 94)						
Location							
Place of Departure	Farm Klipdrift, Parys, Free State Province		Place of Intended Landing	Farm Klipdrift, Parys, Free State Province			
Place of Accident	Runway (RWY 06), Farm Klipdrift						
GPS Co-ordinates	Latitude	26°53'36" S	Longitude	027°4'48.54" E	Elevation	4749 feet	
Aircraft Information							
Registration	ZU-BZE						
Model/Make	Chayair Sycamore Mk.1 (Serial number:0006)						
Damage to Aircraft	Substantial		Total Aircraft Hours	532.3			
Pilot-in-command							
Licence Type	National Pilot License (NPL)	Gender	Male	Age	48		
Licence Valid	Yes						
Total Hours on Type	±62.1		Total Flying Hours	457.3			
People On-board	1 + 0	Injuries	0	Fatalities	0	Other (on ground) 0	
What Happened							
<p>On 4 November 2021 at approximately 0700Z, a pilot on-board a Chayair Sycamore Mk.1 Gyrocopter with registration ZU-BZE was about to take-off from Farm Klipdrift Runway 06 with the intention to perform circuits on the same farm. The pilot stated that he taxied to Runway 06 threshold and did the pre

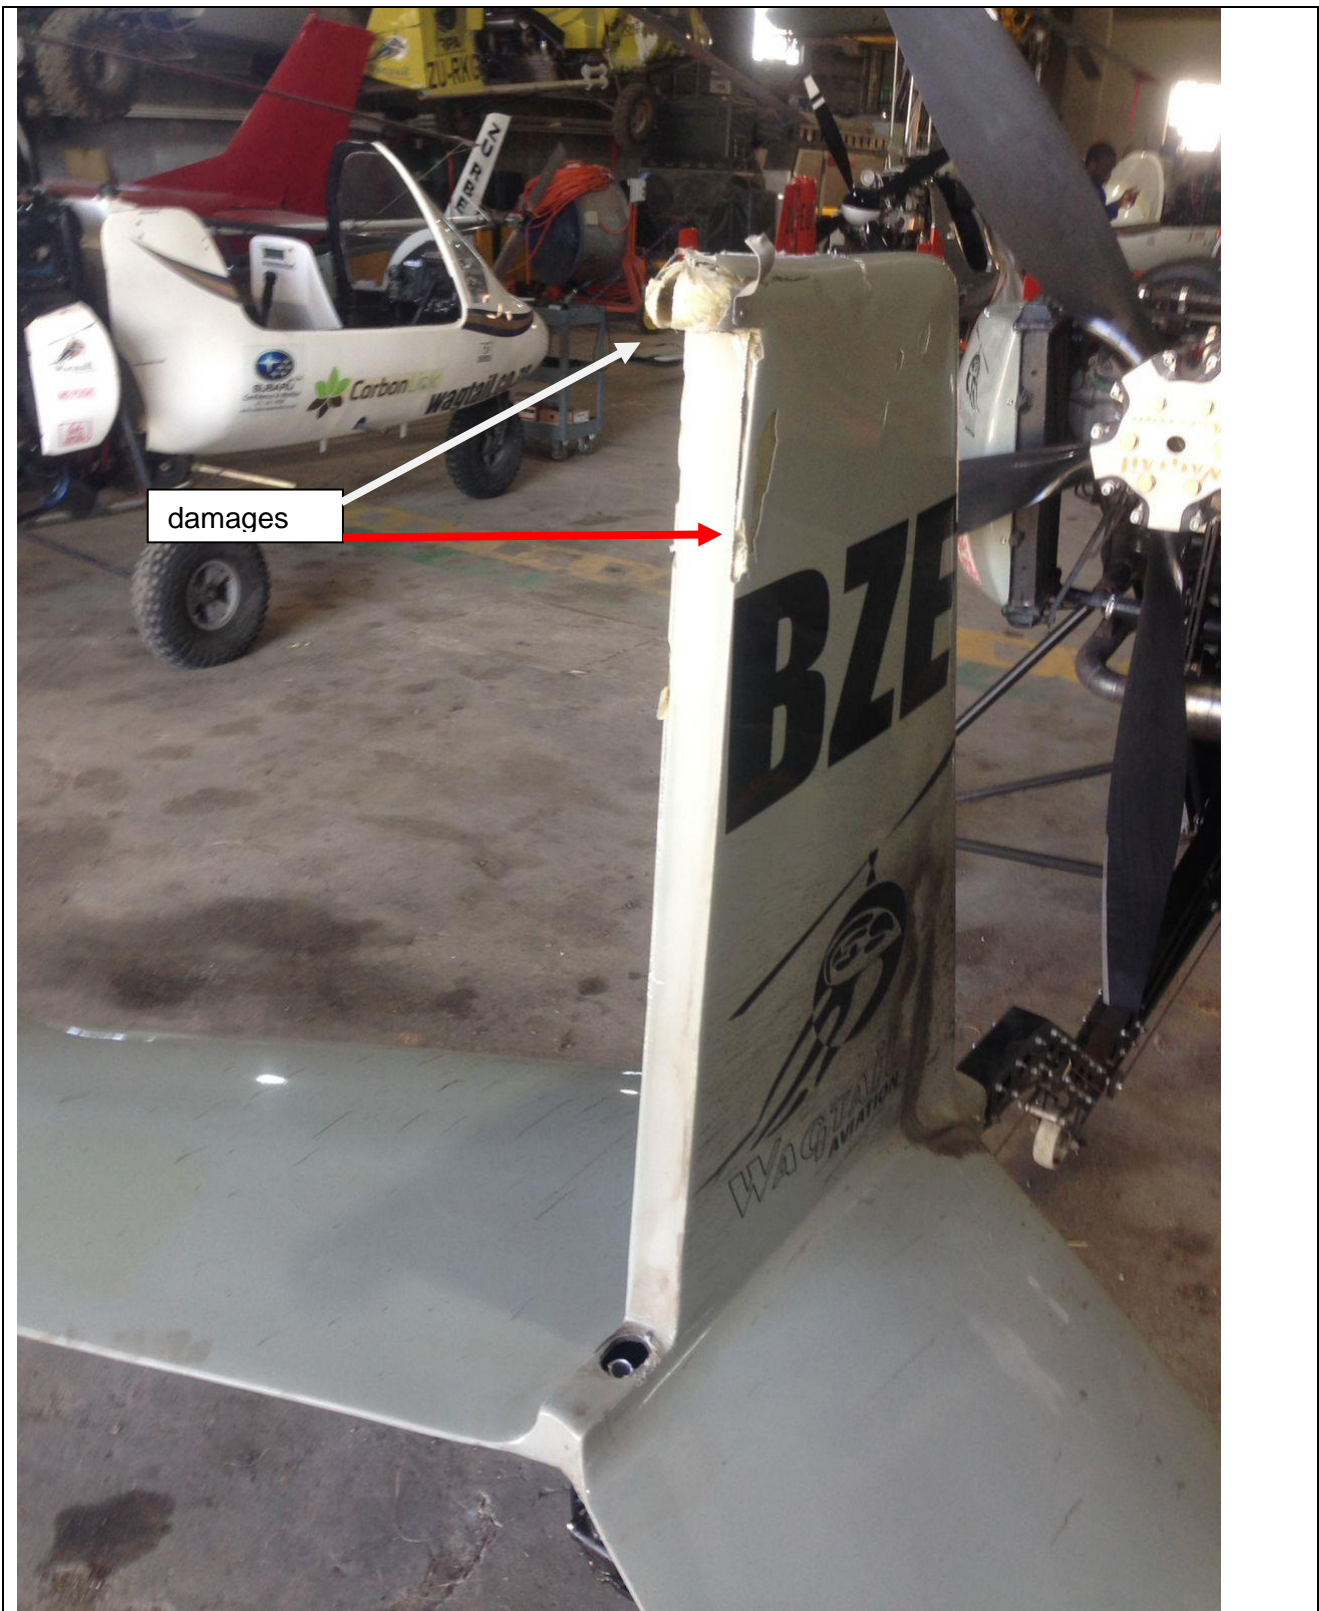
Figure 1: Damage on the rudder. (Source: Pilot)

The gyrocopter hit a bump on the grass runway and bounced before the main rotor blades struck the rudder and the tail, causing damage to both components. This resulted in the pilot aborting take-off.

Safety recommendation: The Director of Civil Aviation (DCA) to consider including in Part 94 of the CAR 2011 the requirements of gyrocopters to ensure runway safety prior to take-off.

<p>Safety Message: Pilots who operate gyrocopters should do a runway inspection prior to take-off to identify possible hazards.</p>	
<p>Purpose of the Investigation</p>	
<p><i>In terms of Regulation 12.03.1 of the Civil Aviation Regulations (CAR) 2011, this report was compiled in the interest of the promotion of aviation safety and the reduction of the risk of aviation accidents or incidents and not to apportion blame or liability.</i></p>	
<p>About this Report</p>	
<p><i>Decisions regarding whether to investigate, and the scope of an investigation are based on many factors, including the level of safety benefit likely to be obtained from an investigation. For this occurrence, no investigation has been conducted, and the Accident and Incident Investigations Division (AIID) has relied on the information submitted by the affected person/s and organisation/s to compile this brief report. The report has been compiled using information supplied in the initial notification, as well as follow-up information to bring awareness of potential safety issues to the industry in respect of this occurrence, as well as possible safety action/s that the industry might want to consider in preventing a recurrence of a similar accident.</i></p> <p><i>This report provides an opportunity to share safety message/s in the absence of an investigation.</i></p> <p><i>All times given in this report are Co-ordinated Universal Time (UTC) and will be denoted by (Z). South African Standard Time is UTC plus 2 hours.</i></p>

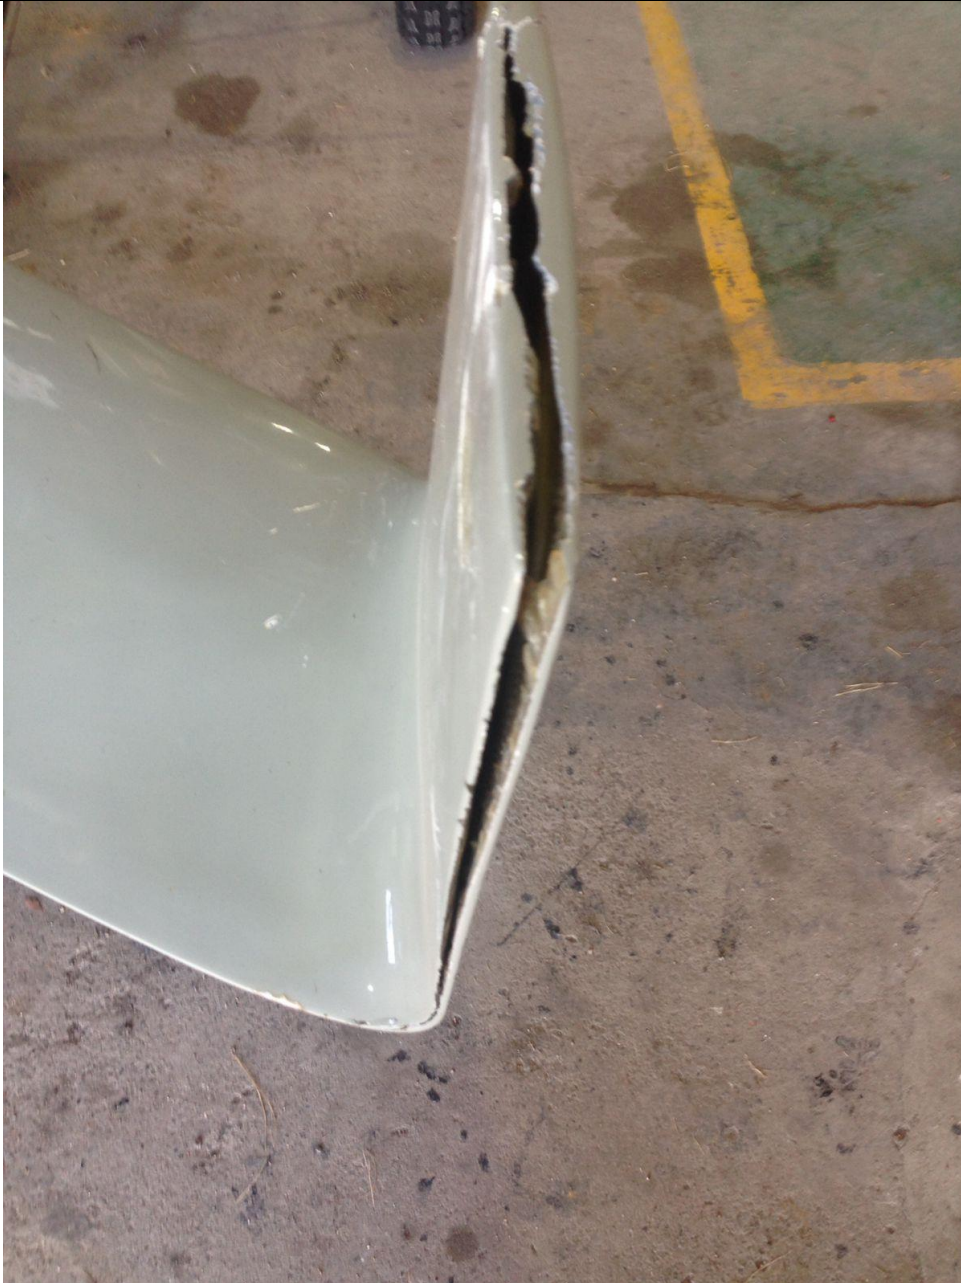
Figure 2: Damaged winglet. (Source: Pilot)

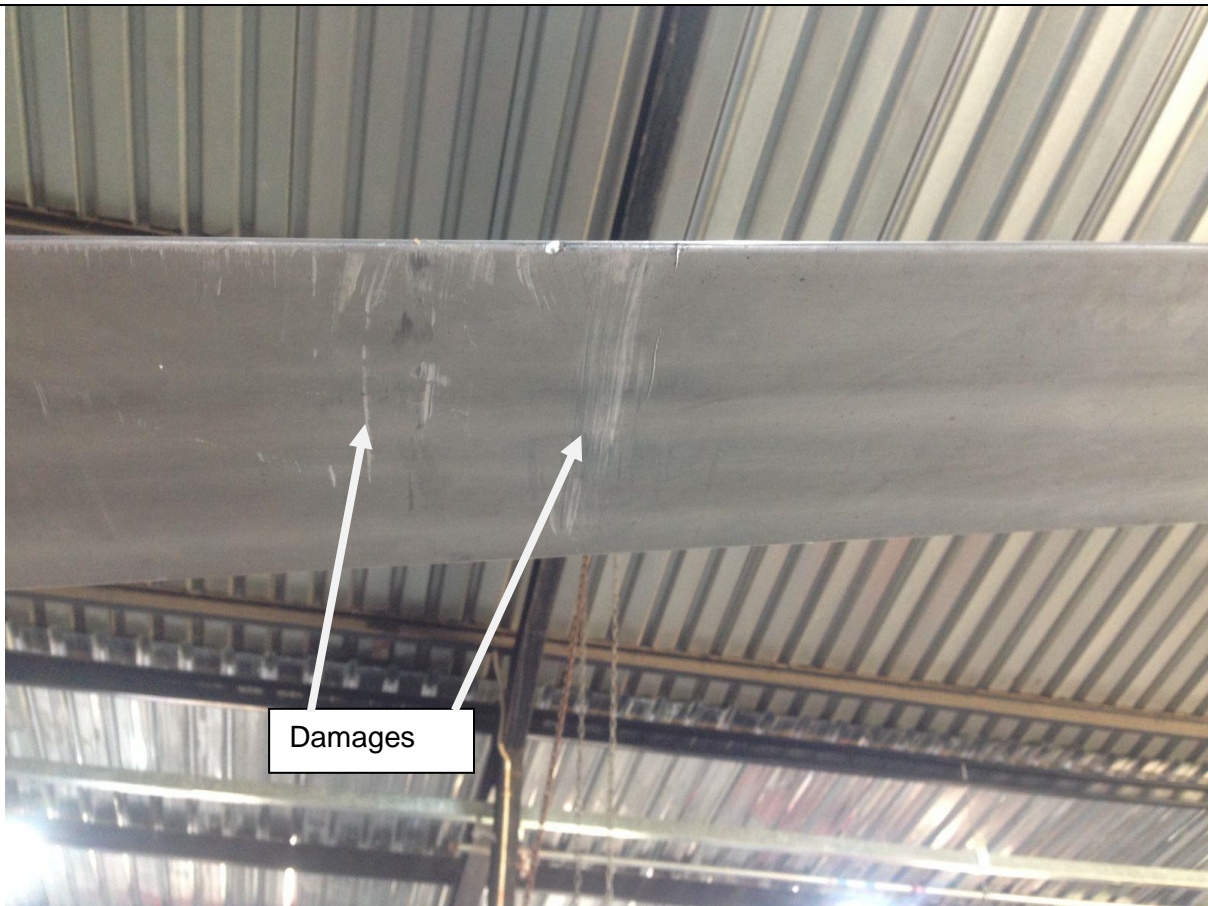
Figure 3: Damage on the main rotor blade.
