LIMITED ACCIDENT INVESTIGATION REPORT
--

Reference Number		CA18/2/3/10068					
Classification	Accident	Date	4 November 2021	Time	0900Z		
Type of Operation	Private (Part 94)						
Location							
Place of Departure		Parys Airfield (FAPY), Free State Province		Place of Intended Landing		Klipdrift Farm, Parys, Free State Province	
Place of Accident		Runway (RWY 24), Parys Airfield (FAPY)					
GPS Co-ordinates	Latitude	26°53'04" S	Longitude	027°30'22" E	Elevation	4705 feet	
Aircraft Information							
Registration		ZU-RKM					
Model/Make		Trojan Gyro (Serial Number: 1301)					
Damage to Aircraft		Substantial		Total Aircraft Hours		845.2	
Pilot-in-command							
Licence Type		National Pilot Licence	Gender		Male	Age 48	
Licence Valid		Yes					
Total Hours on Type		±62.1		Total Flying Hours		457.3	
People On-board	1 + 0	Injuries	0	Fatalities	0	Other (on ground) 0	
What Happened							
<p>On Thursday, 4 November 2021 at approximately 0900Z, a pilot on-board a Trojan Gyrocopter with registration ZU-RKM took off from Farm Klipdrift to Parys Airfield (FAPY), which is 23 nautical miles (nm) away, to have lunch. After landing on Runway (RWY) 24 at FAPY, he discovered that the restaurant in whi

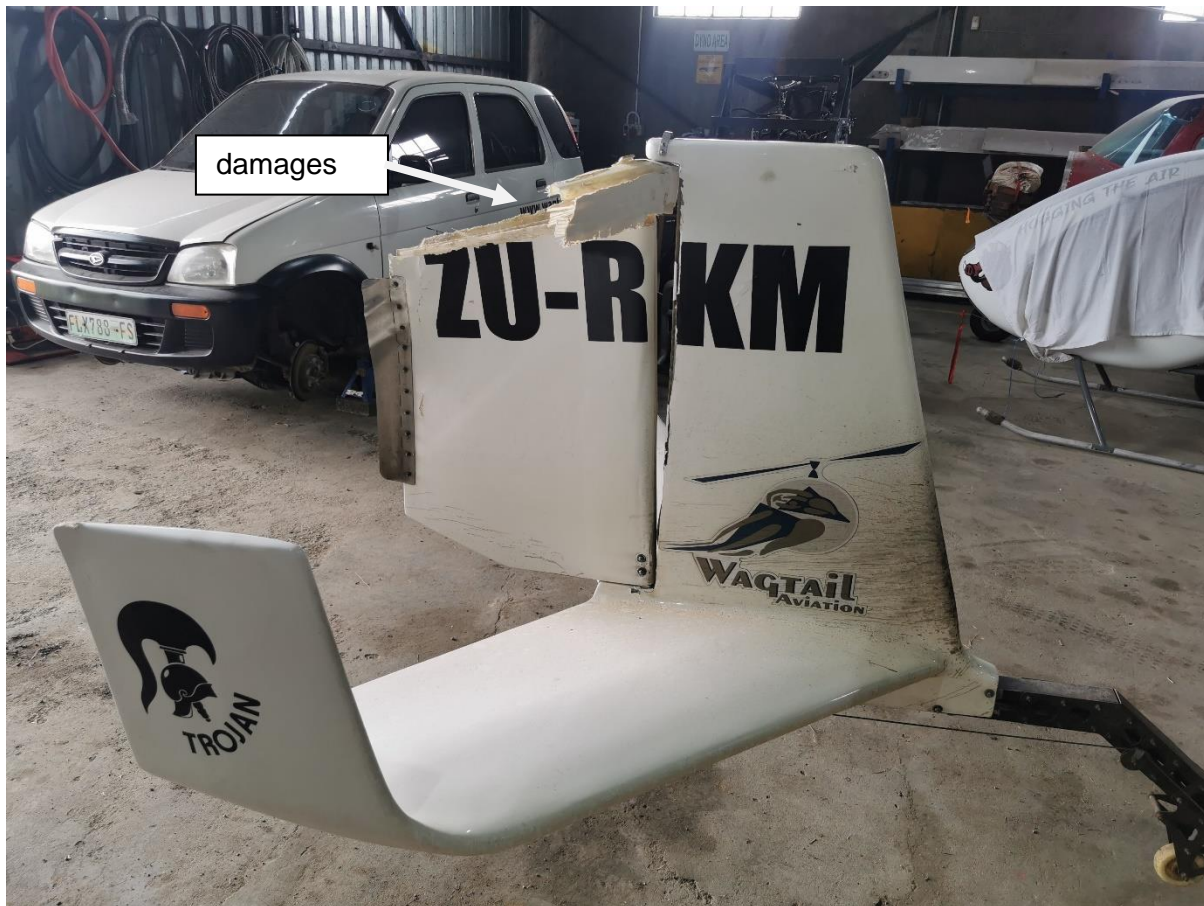
94 of the Civil Aviation Regulations (CAR) 2011 as amended. The pilot was not injured during the accident; the gyrocopter sustained damage to the main rotor and the rudder.

Figure 1: Damage on the rudder. (Source: Pilot)

The pilot aborted take-off after the main rotor blades flapped during take-off run, whereafter they came into contact with the rudder.
