LIMITED ACCIDENT INVESTIGATION REPORT

Reference Number	CA18/2/3/10069						
Classification	Accident	Date	6 November 2021	Time	0511Z		
Type of Operation	Private (Part 94)						
Location							
Place of Departure	Middelburg Aerodrome (FAMB), Mpumalanga Province		Place of Intended Landing	Middelburg Aerodrome (FAMB), Mpumalanga Province			
Place of Accident	During the climb phase from FAMB Runway 14, approximately 350 feet (ft) above ground level (AGL)						
GPS Co-ordinates	Latitude	S 25°40'53.11"	Longitude	E029°26'30.38"	Elevation	4 885 feet	
Aircraft Information							
Registration	ZU-CXY						
Model/Make	Cheetah 912 ULS (Serial number: CH-016)						
Damage to Aircraft	Destroyed		Total Aircraft Hours	846.7			
Pilot-in-command							
Licence Type	Private Pilot Licence	Gender	Male		Age: 50		
Licence Valid	Yes						
Total Hours on Type	182.4		Total Flying Hours	347.8			
People On-board	1 + 1	Injuries	0	Fatalities	0	Other (on ground)	0
What Happened

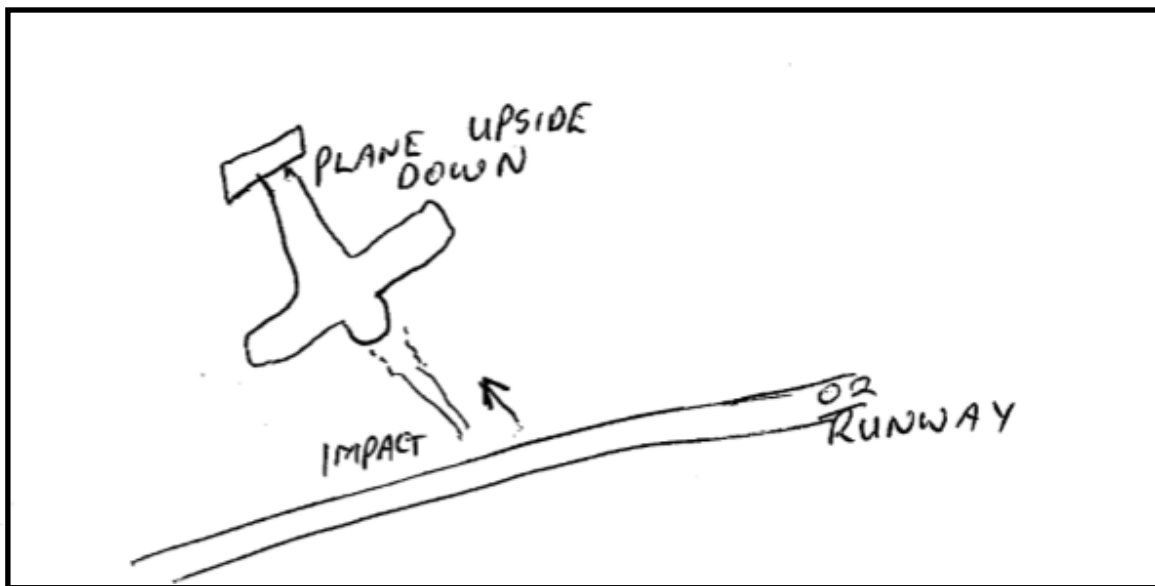
<p>On 6 November 2021 at approximately 0510Z, a pilot and a passenger on-board a Cheetah 912 ULS aircraft with registration ZU-CXY took off from Runway 14 at Middelburg Aerodrome (FAMB) in Mpumalanga province with the intention to fly around Loskop Dam area near Groblersdal and return to FAMB. The private flight was conducted under visual flight rules (VFR) by day and under the provisions of Part 94 of the Civil Aviation Regulations (CAR) 2011 as amended.</p> <p>The pilot stated that after the pre-flight checks, he taxied the aircraft to the holding point of Runway 14 where he did his pre-take-off run-up checks. The pilot ran the engine at different power settings including at 3 000 revolutions per minute (rpm) for quite a while until the oil pressure and temperature were within the green arch. Once satisfied, he took off from Runway 14; however, during the climb phase at approximately 350 feet (ft) above ground level (AGL), he made a left turn towards Loskop Dam. He stated that moments later, the engine started to lose power and the aircraft lost height very quickly. At the time, the aircraft was approximately 3 nautical miles (nm) from the aerodrome. The pilot verified the position of the throttle, which was in the fully open position, he then turned left in an attempt to return to FAMB with the intention to land on Runway 20. However, during the turn back, the aircraft entered into a spin.</p>

Figure 2: Schematic representation of the accident site. (Source: Pilot)

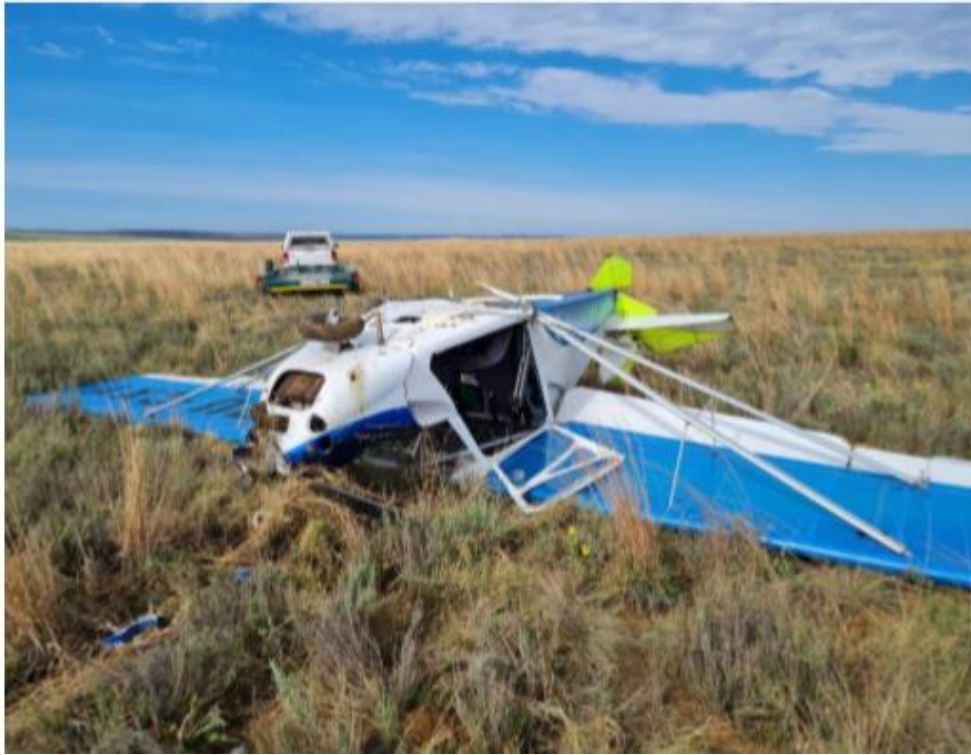
The pilot stated that he attempted to stop the spin by applying the right rudder pedal and by pushing the control stick to the right-side to level the wings before executing a forced landing on Runway 20, but the aircraft lost forward speed and crash-landed on the grass approximately 10 metres (m) from the runway edge. During the landing roll, the nose gear strut broke off and the aircraft nosed over. The aircraft sustained substantial damage. The occupants were not injured during the accident sequence.

Figure 3: The aircraft as it came to rest in an inverted position. (Source: Operator)

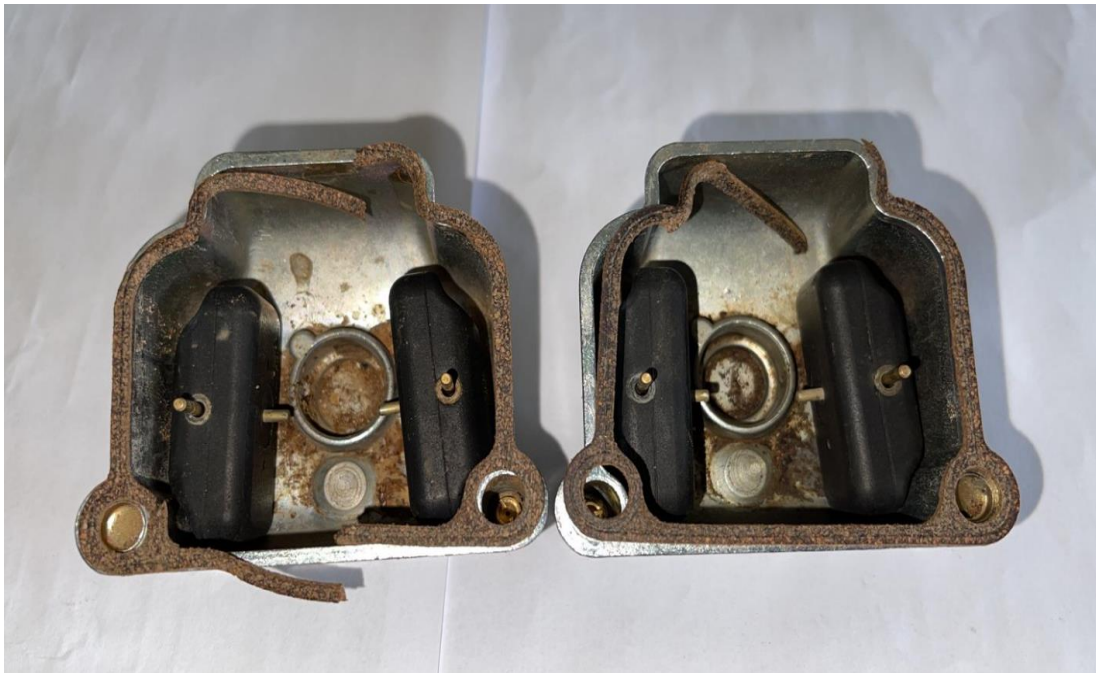
- The aircraft maintenance organisation (AMO) that bought the engine stated that the only components that were inspected in the engine were the carburettors. The carburettors were found dirty and the gaskets were broken.

Figure 4: Carburettors with dirt and broken gaskets.

The engine stopped in-flight because of fuel starvation, this was followed by an unsuccessful forced landing.
