LIMITED ACCIDENT INVESTIGATION REPORT

| Reference Number | CA18/2/3/10071 | | | | | | |
| Registration | ZS-IJL | | | | | | |
| Model/Make | Bonanza K35 | | | | | | |

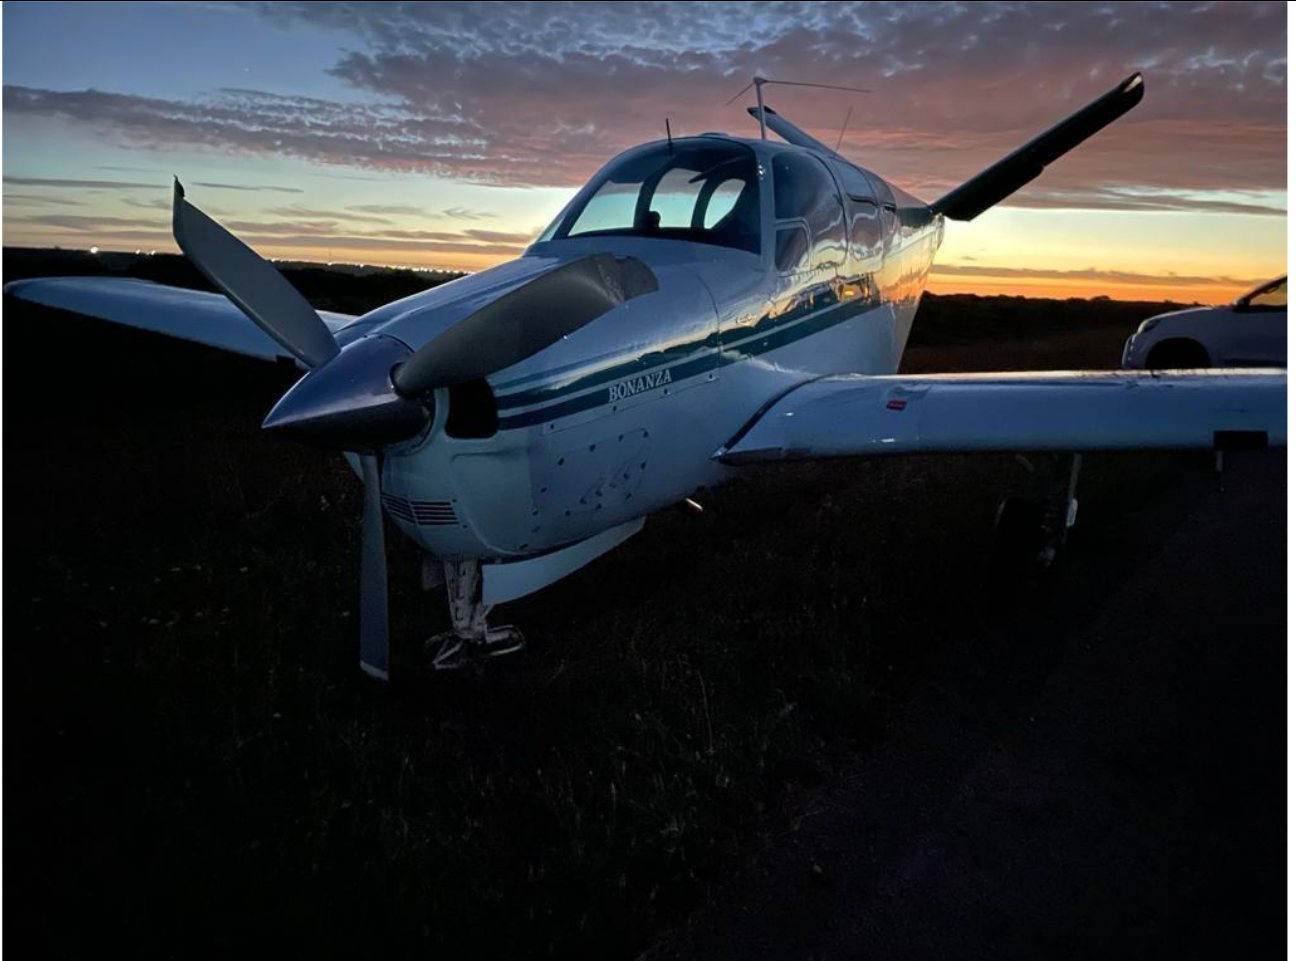
Figure 2: The aircraft post-accident. (Source: Pilot)

The aircraft bounced during the landing phase and the pilot was unable to recover timeously; as a result, the aircraft veered off the runway.
