<b>LIMITED ACCIDENT INVESTIGATION REPORT</b>
--

<b>Reference Number</b>		CA18/2/3/10073					
<b>Classification</b>	Accident	<b>Date</b>	11 November 2021	<b>Time</b>	1250Z		
<b>Type of Operation</b>	Training (Part 141)						
<b>Location</b>							
Place of Departure	Wonderboom Aerodrome (FAWB), Gauteng Province		Place of Intended Landing	Wonderboom Aerodrome (FAWB), Gauteng Province			
Place of Occurrence	Runway 29, Wonderboom Aerodrome (FAWB), Gauteng Province						
GPS Co-ordinates	Latitude	25° 39' 15.37" S	Longitude	028° 13' 36.85" E	Elevation	4 078ft	
<b>Aircraft Information</b>							
Registration	ZS-CZU						
Model/Make	Piper PA-28-180 Cherokee (Serial Number: 28-971)						
Damage to Aircraft	Substantial		Total Aircraft Hours	3 693.9			
<b>Pilot-in-command</b>							
Licence Valid	Yes		Gender	Male	Age	19	
Licence Type	Student Pilot Licence (SPL) Aeroplane						
Total Hours on Type	23.5		Total Flying Hours	23.5			
People On-board	1 + 0	Injuries	0	Fatalities	0	Other (on ground)	0

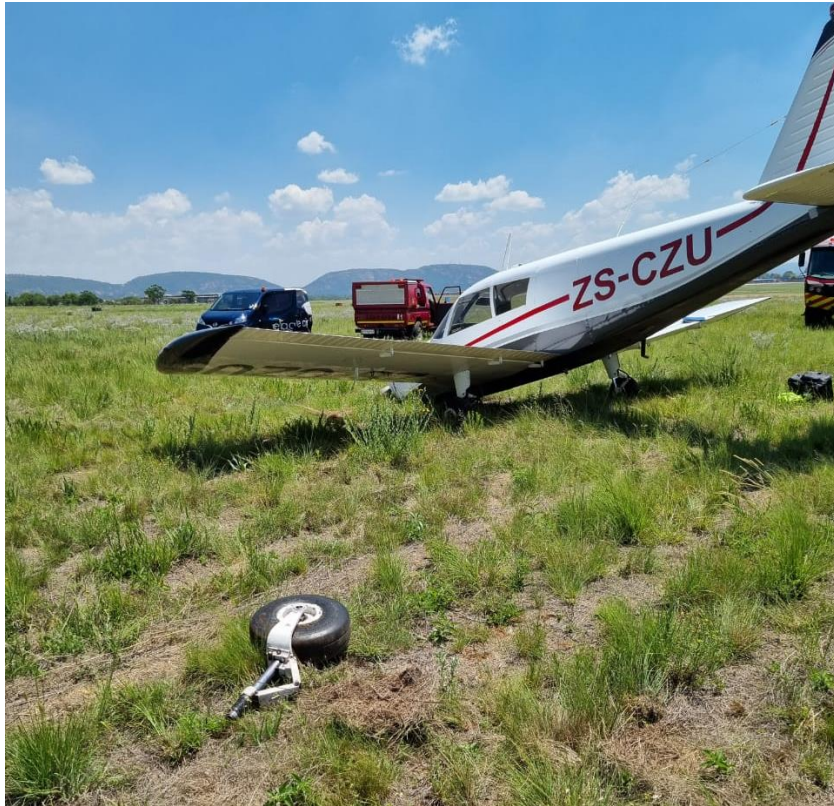
the propeller struck the ground before the aircraft stopped approximately 15 metres (m) from the runway edge. The aircraft was substantially damaged, and the SP did not report any injuries.

**Figure 1:** The aircraft as it came to rest with the propellers bent due to ground impact. (Source: Operator)

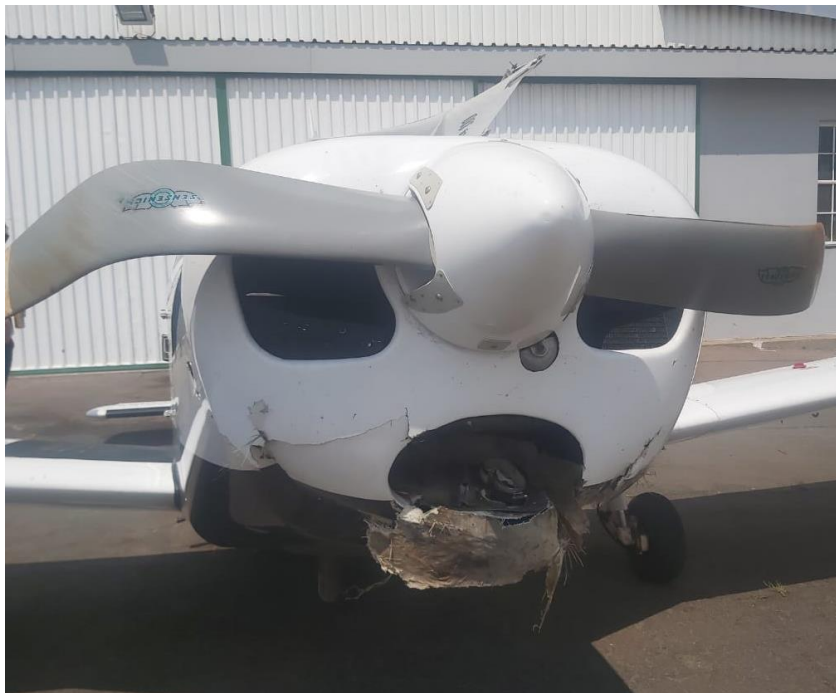
**Figure 2:** Close-up view of damages on the lower cowling and propellers.

- Propeller was completely damaged and needed replacement.
  - Engine was due for shock load inspection.
  - Engine cradle was bent and cracked, and the lower part of oleo collar had completely broken off.

- Damage to carburettor heat box and air intake box.
  - Damage to lower cowling and nose cone.
- It is likely that the violent nose wheel shimmy felt by the SP during the landing roll was due to the torn nose gear oleo outer steering tube, which broke off after exiting the asphalt runway edge.

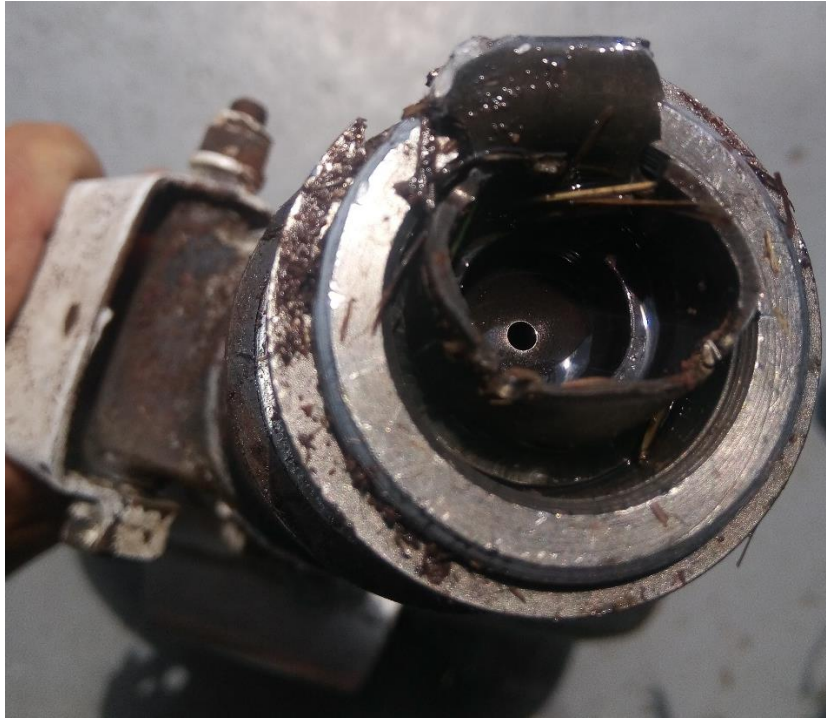
**Figure 3:** Close-up view of the damaged nose gear steering tube assembly.

- Nose gear oleo outer steering tube was completely torn out of the engine cradle's lower section, no damage to nose gear fork.
  - Damage to firewall.

It is likely that the aircraft was unstable on approach, resulting in the aircraft landing on its nose wheel first, which broke off; the aircraft lost directional control and veered off to the left of the runway.

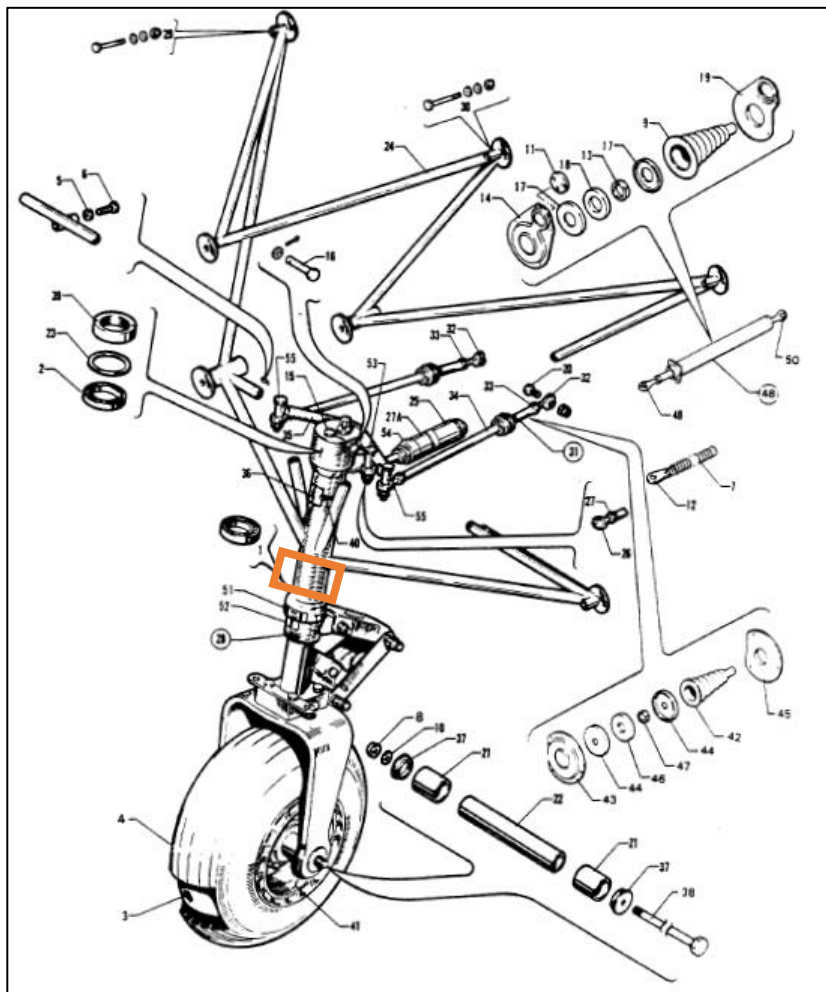
**Diagram 1:** Schematic of the nose gear. The orange window shows the area or separation/failure at the upper nose steering tube assembly due to impact. (Source: Piper PA-28-180 Parts Catalogue)
