LIMITED ACCIDENT INVESTIGATION REPORT
--

Reference Number		CA18/2/3/10074					
Classification	Accident	Date	13 November 2021	Time	1035Z		
Type of Operation	General Aviation (Part 91)						
Location							
Place of Departure	Pietermaritzburg Aerodrome (FAPM), KwaZulu-Natal		Place of Intended Landing	Magwa Tea Estate, near Lusikisiki, Eastern Cape			
Place of Accident	Magwa Tea Estate, 6nm east of Lusikisiki, Eastern Cape						
GPS Co-ordinates	Latitude	S 31°23'33.00"	Longitude	E 029°41'40.71"	Elevation	1722 ft	
Aircraft Information							
Registration	ZS-JZP						
Model/Make	Piper 28R-201T Cherokee Arrow III (Serial Number: 28R-7703039)						
Damage to Aircraft	Substantial	Total Aircraft Hours		4852.32			
Pilot-in-command							
Licence Type	Private Pilot Licence (PPL)	Gender	Male	Age	58		
Licence Valid	Yes						
Total Hours on Type	1510.62		Total Flying Hours	1743.92			
People On-board	1 + 1	Injuries	0	Fatalities	0	Other (on ground)	0
What Happened

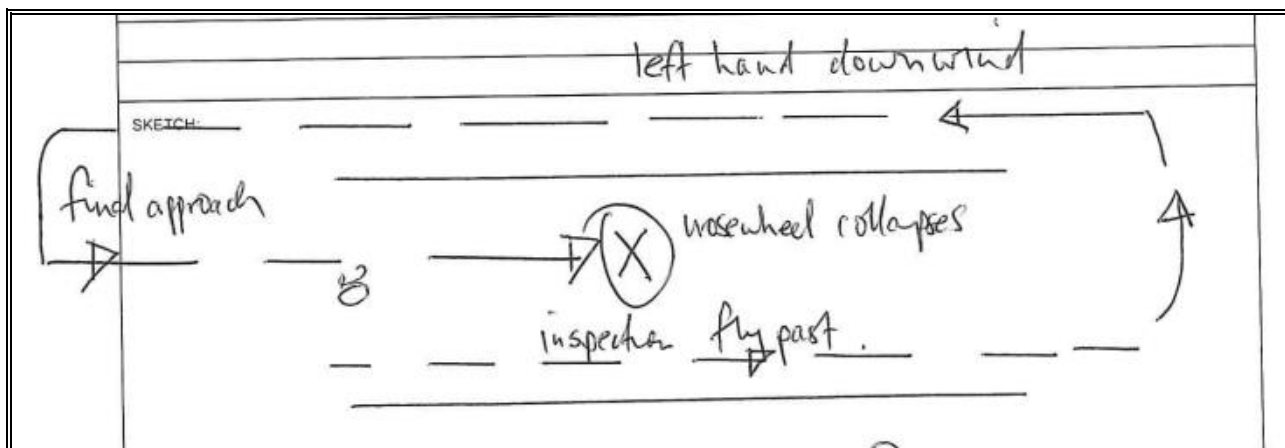
Figure 1: Pilot's illustration of final events. (Source: Pilot)

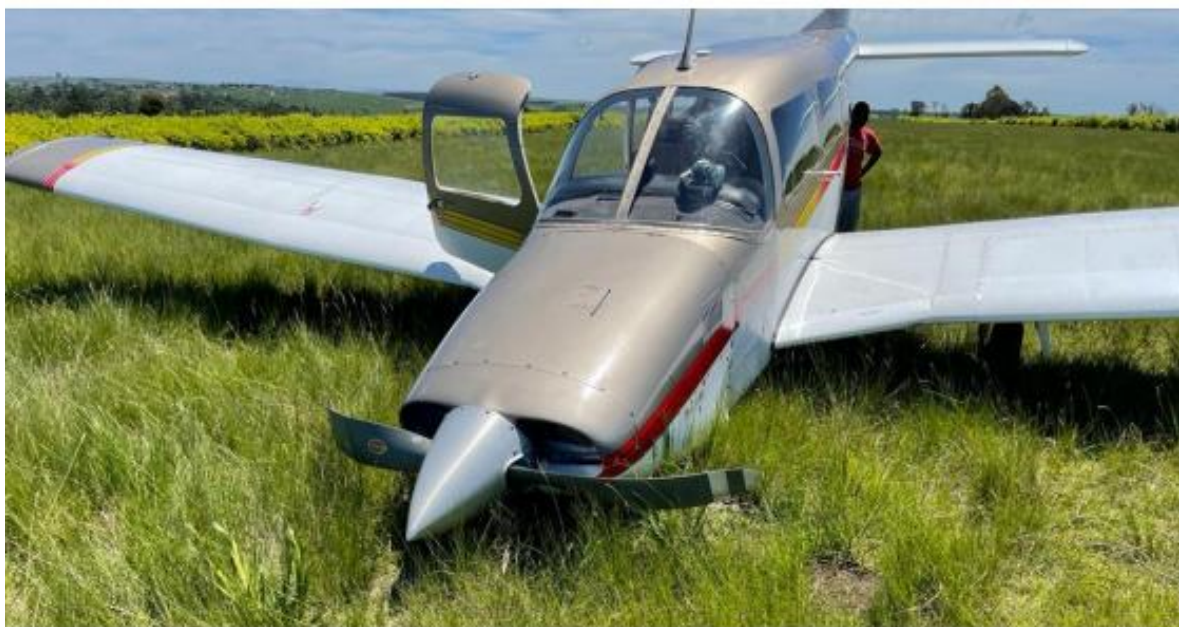
<p>On 13 November 2021 at approximately 0930Z, a Piper 28R-201T Cherokee Arrow III single engine aircraft with registration ZS-JZP took off on a private flight with a pilot and a passenger on-board from Pietermaritzburg Aerodrome (FAPM) to Magwa Tea Estate private strip, near Lusikisiki in the Eastern Cape. The flight was conducted during day light in visual meteorological conditions (VMC) and under the provisions of Part 91 of the Civil Aviation Regulations 2011 as amended.</p> <p>According to the pilot, they had 4.5 hours fuel endurance and the distance to their destination was 113 nautical miles (nm), which would take approximately 1 hour to complete. The aircraft's weight and balance were within limits and the weather was fine with clear skies and good visibility. The pilot stated that the cruise was uneventful. On arrival at Magwa Tea Estate, the pilot followed the unmanned airfield joining procedure and proceeded to join left downwind for Runway (RWY) 02. He stated that he performed all the downwind checks, thus, making sure that the flaps were lowered to 30° setting, fuel flow was normal, and the landing gear was extended with the three green lights illuminated. The pilot touched down at 75 knots (kts) on the main landing gears and held the nose gear up for a moment. He then allowed the nose gear to drop, however, the nose gear collapsed, and the propeller struck the ground. The aircraft skidded on its lower engine cowling before coming to a stop on the grass runway. The aircraft sustained damages to the propeller (struck the ground), lower engine cowling and the collapsed nose-gear strut.</p>

Figure 2: The last position of the aircraft. (Source: Pilot)

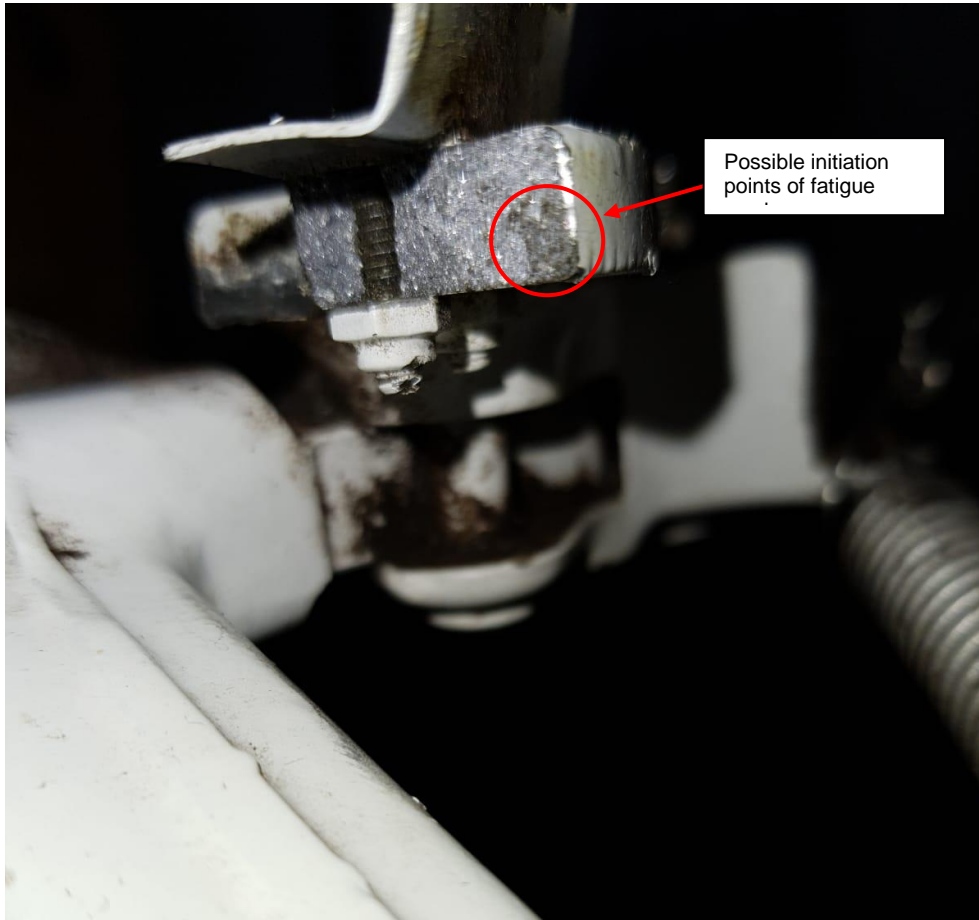
- The down lock assembly hook had fractured/broken off, leaving the springs only to keep the nose gear in the locked position. Furthermore, the hydraulic actuator shaft was bent, another indication of the failure of the down lock assembly hook.

- The failed section, which was remaining on the aircraft after the accident, had possible signs of fatigue as indicated by the lower left part of the component in Figure 3, which seems as if (the crack) had occurred earlier when compared to the rest of the damage (or failed components).

Figure 3: The broken nose gear lock assembly hook. (Source: AMO)

The aircraft's nose gear strut collapsed due to the break off of the nose gear lock assembly hook, probably as a result of fatigue. This resulted in the propeller striking the ground.

Since the component is an on-condition unit and the aircraft had over 4800 hours in service, it is recommended that the manufacturer issues an Airworthiness Directive which mandates owners/operators to perform an appropriate non-destructive testing (NDT) on all undercarriage locking components every 2000 hours.

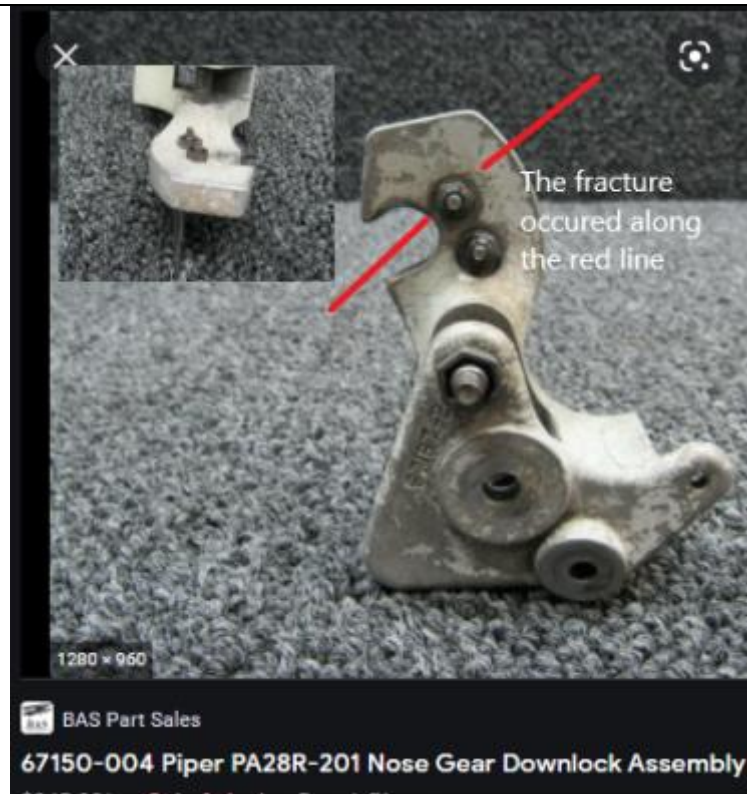
Figure 4: The downlock assembly. Inset shows thickness. (Source: <https://cdn11.bigcommerce.com/s-lh7wonygtd/images/>)
