LIMITED ACCIDENT INVESTIGATION REPORT

Reference Number	CA18/2/3/10076						
Classification	Accident	Date	16 November 2021	Time	0750Z		
Type of Operation	Training (Part 141)						
Location							
Place of Departure	Wonderboom Aerodrome (FAWB)		Place of Intended Landing		Wonderboom Aerodrome (FAWB)		
Place of Accident	Runway 29, FAWB						
GPS Co-ordinates	Latitude	25°39'19.11" S	Longitude	028°13'16.81" E	Elevation	4 095 ft	
Aircraft Information							
Registration	ZS-PMK						
Make / Model	Cessna 172M						
Damage to Aircraft	Substantial		Total Aircraft Hours		17 352.1		
Pilot-in-command							
Licence Valid	Yes		Gender	Male		Age: 22	
Licence Type	Private Pilot Licence (PPL)						
Total Hours on Type	10.7		Total Flying Hours		93.2		
People On-board	1 + 0	Injuries	0	Fatalities	0	Other (On Ground)	0
What Happened							
<p>On Tuesday 16 November 2021, a pilot being the sole occupant on-board a Cessna 172M with registration ZS-PMK took off from Wonderboom Aerodrome (FAWB) on a training flight under the provisions of Part 141 of the Civil Aviation Regulations, 2011.</p> <p>Upon his return flight to FAWB, he was cleared for landing Runway 29 by air traffic control (ATC). The aircraft to

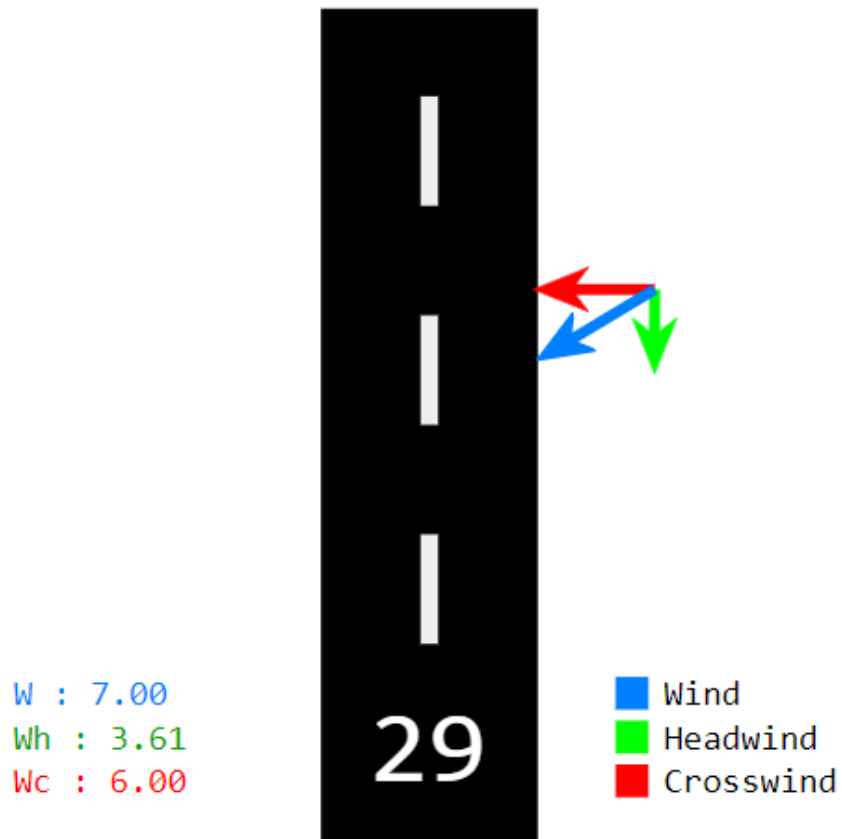
The prevailing wind conditions at the time of the accident. (Source: <https://e6bx.com>)

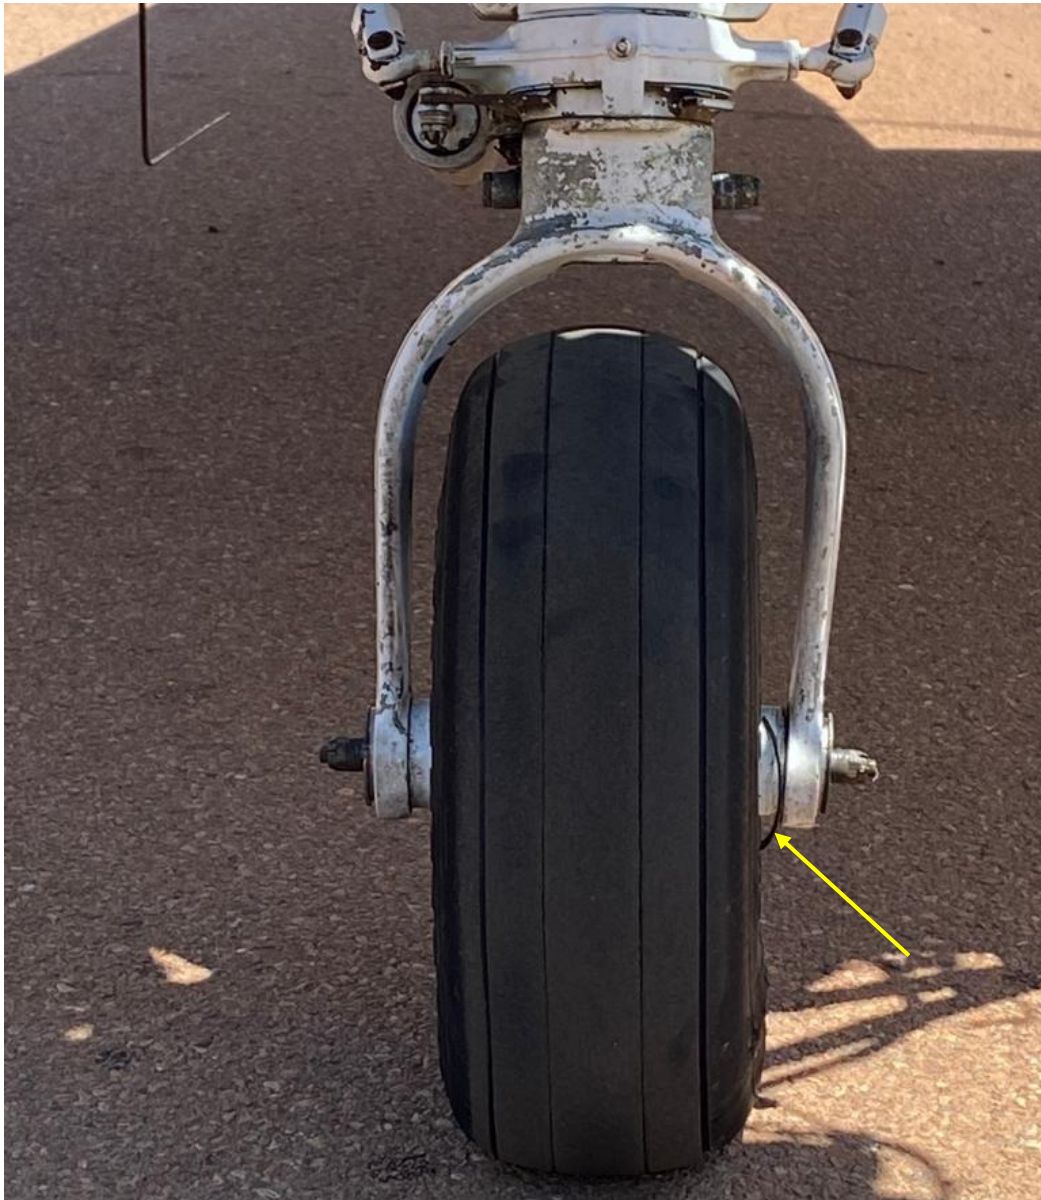
Figure 1: The nose gear fork displays slight bending deformation and damage at the axle.

The pilot used incorrect landing technique, which resulted in a hard landing.

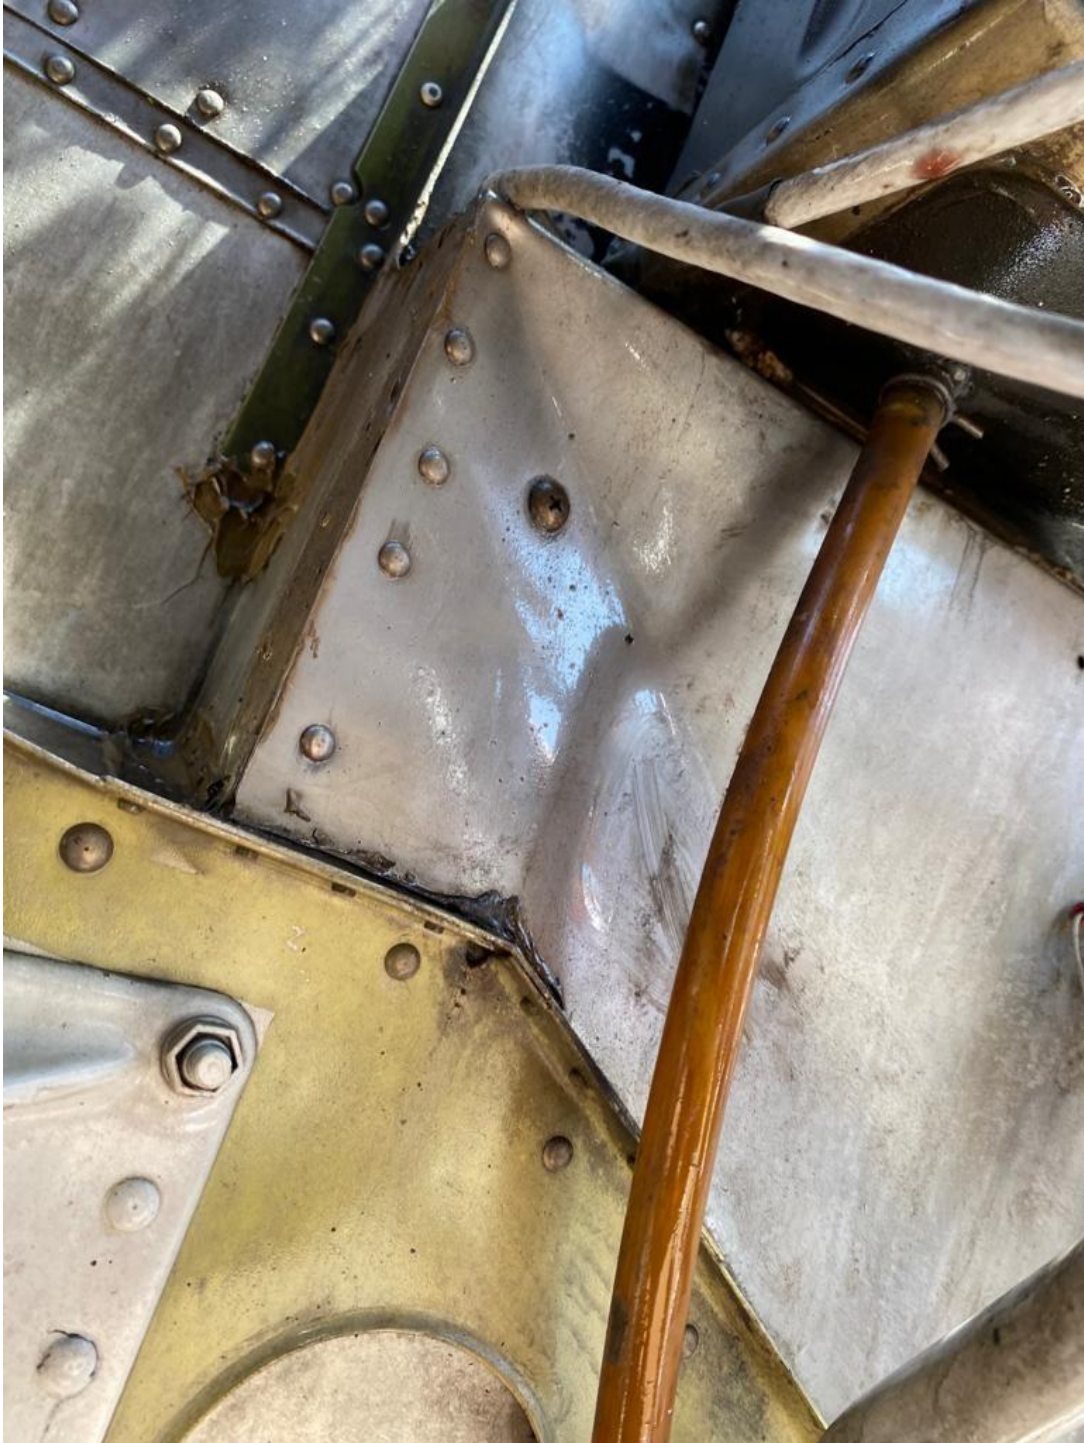
Figure 2: Deformation on the firewall.
