LIMITED ACCIDENT INVESTIGATION REPORT
--

Reference Number	CA18/2/3/10077						
Classification	Accident	Date	16 November 2021	Time	1330Z		
Type of Operation	Training (Part 141)						
Location							
Place of Departure	Wonderboom Aerodrome (FAWB)		Place of Intended Landing	Wonderboom Aerodrome (FAWB)			
Place of Accident	Runway 29, FAWB						
GPS Co-ordinates	Latitude	25°39'19.11" S	Longitude	028°13'16.81" E	Elevation	4 095 ft	
Aircraft Information							
Registration	ZS-JBO						
Make/Model	Cessna 172M						
Damage to Aircraft	Substantial		Total Aircraft Hours	20 332.3			
Pilot-in-command							
Licence Valid	Yes		Gender	Male		Age: 20	
Licence Type	Student Pilot Licence (SPL)						
Total Hours on Type	Not available		Total Flying Hours	80.4			
People On-board	1 + 0	Injuries	0	Fatalities	0	Other (On Ground)	0
What Happened							
<p>The student pilot, who was the sole occupant on-board the aircraft took off from Wonderboom Aerodrome (FAWB) at 1248Z on a solo navigational flight. Due to extremely turbulent conditions, the pilot decided to return to FAWB. He stated that he was cleared for landing Runway 29 at FAWB by air traffic control (ATC). He selected 20° of wing flaps for landing.

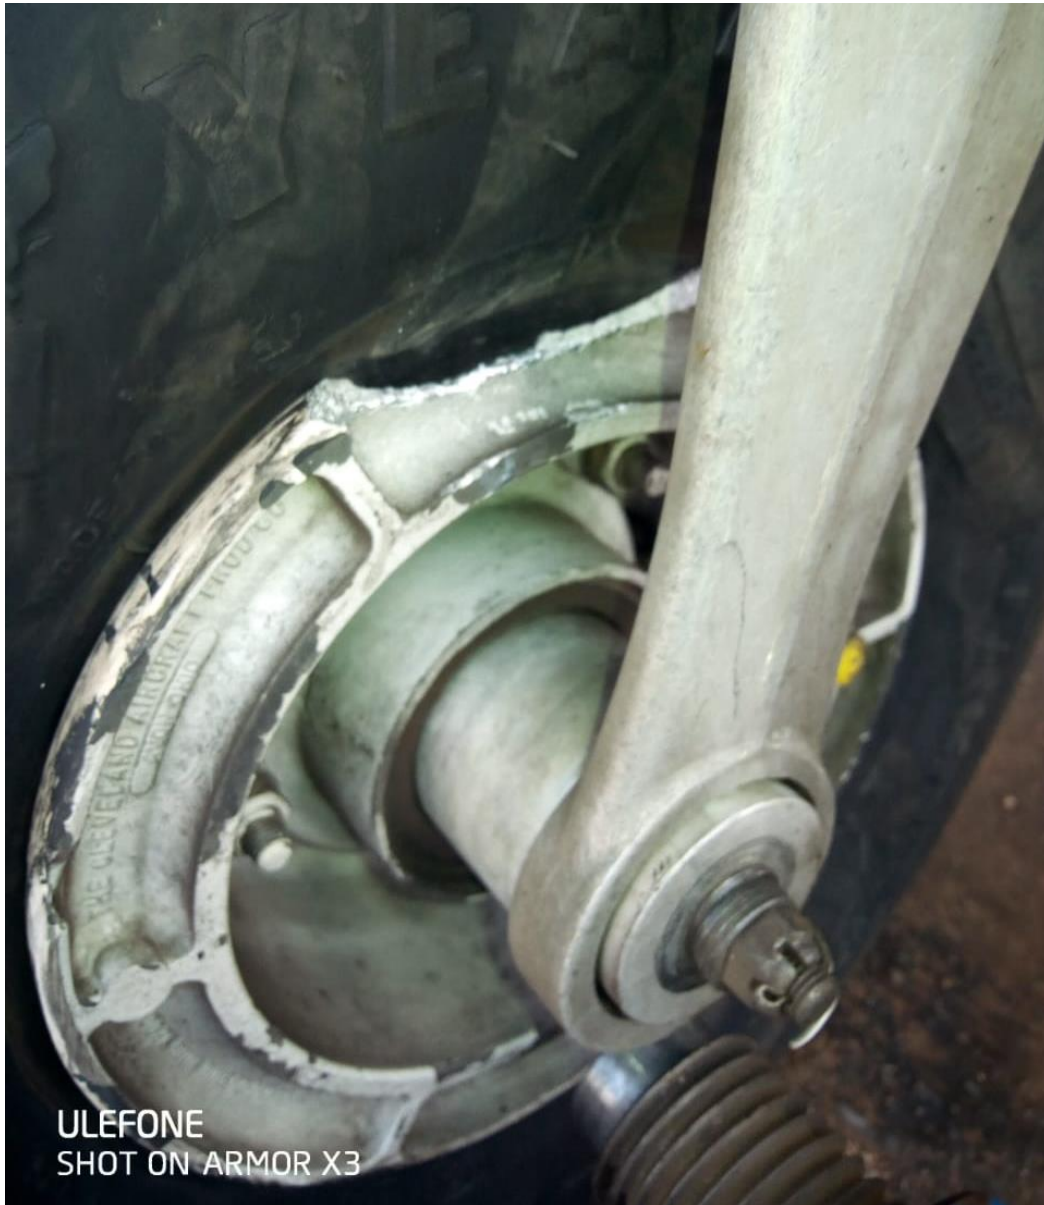
Figure 1: The nose wheel rim sustained damage during hard landing.

The student pilot used incorrect landing technique, which resulted in a hard landing.

Following two hard landing accidents on the same day from the same ATO, the institution issued a safety notice on 16 November 2021 which calls for all student pilots, pilots under training as well as all pilots who want to hire and fly an aircraft (from the ATO) to be subjected to a dual check (of at least three circuits) by a flight instructor before their next flight.

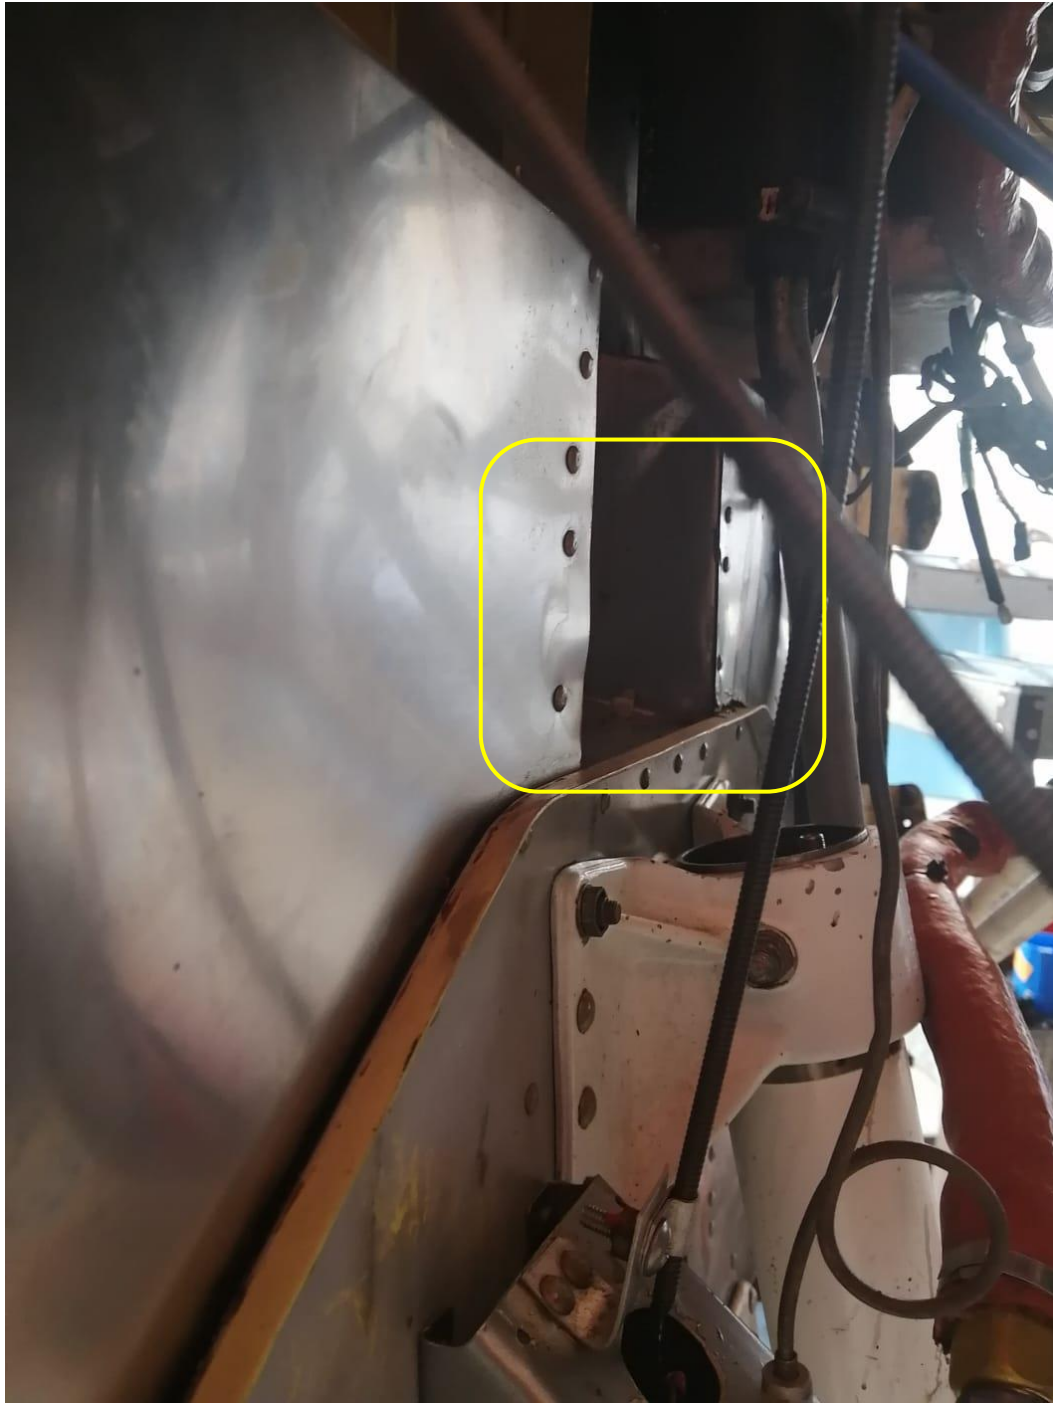
Figure 2: Deformation visible on the firewall.
