LIMITED INVESTIGATION ACCIDENT REPORT

Reference Number		CA18/2/3/10078					
Classification	Accident	Date	16 November 2021	Time	1915Z		
Type of Operation		Training (Part 141)					
Location							
Place of Departure	Cape Town International Airport (FACT), Western Cape Province		Place of Intended Landing	Cape Town International Airport (FACT), Western Cape Province			
Place of Occurrence	Apron area at Cape Town Flying Club						
GPS Co-ordinates	Latitude	S33° 58'.16. 93"	Longitude	E018°36'.15.55"	Elevation	151 feet	
Aircraft Information							
Registration	ZS-KBK						
Model/Make	Piper PA-28-161 Warrior II (Serial Number: 28-7716255)						
Damage to Aircraft	Substantial		Total Aircraft Hours	5370.6			
Pilot-in-command							
Licence Valid	Yes	Gender	Male	Age	31		
Licence Type	Airline Transport Pilot Licence (ATPL)						
Total Hours on Type	382.9		Total Flying Hours	4900.4			
People On-board	2 + 0	Injuries	0	Fatalities	0	Other (On Ground)	0
What Happened

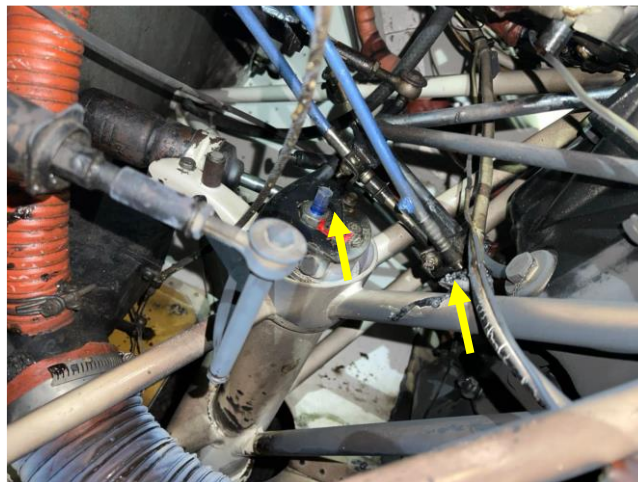
Figure 1: Some melted wiring post-accident. (Source: Operator).

The aircraft maintenance organisation (AMO) examined the aircraft after the accident and the technical report indicated that the fuel system was tested, and no leaks or incorrect operations were found or noted. The fire burnt mainly the hoses and electrical wiring situated along the right-side of the engine, as well as the engine mount. Fire damage was also noted at the base of the bottom and top cowlings.

<p>Probable cause:</p> <p>It is likely that during engine start, the pilot most probably over-primed the engine, causing excess fuel to drip down and collect in the heat box. As the engine was still hot, it resulted in fuel vapour catching fire.</p> <p>Contributory factor:</p> <p>Incorrect engine start technique.</p>
<p>Safety Action/s</p> <p>None.</p>
<p>Safety Message and/or Safety Recommendation/s</p> <p>None.</p>
<p>Purpose of the Investigation</p> <p><i>In terms of Regulation 12.03.1 of the Civil Aviation Regulations (CAR) 2011, this report was compiled in the interest of the promotion of aviation safety and the reduction of the risk of aviation accidents or incidents and not to apportion blame or liability.</i></p>
<p>About this Report</p> <p><i>Decisions regarding whether to investigate, and the scope of an investigation are based on many factors, including the level of safety benefit likely to be obtained from an investigation. For this occurrence, no investigation has been conducted, and the Accident and Incident Investigations Division (AIID) has relied on the information submitted by the affected person/s and organisation/s to compile this brief report. The report has been compiled using information supplied in the initial notification, as well as follow-up information to bring awareness of potential safety issues to the industry in respect of this occurrence, as well as possible safety action/s that the industry might want to consider in preventing a recurrence of a similar accident.</i></p> <p><i>This report provides an opportunity to share safety message/s in the absence of an investigation.</i></p> <p><i>All times given in this report are Co-ordinated Universal Time (UTC) and will be denoted by (Z). South African Standard Time is UTC plus 2 hours.</i></p>

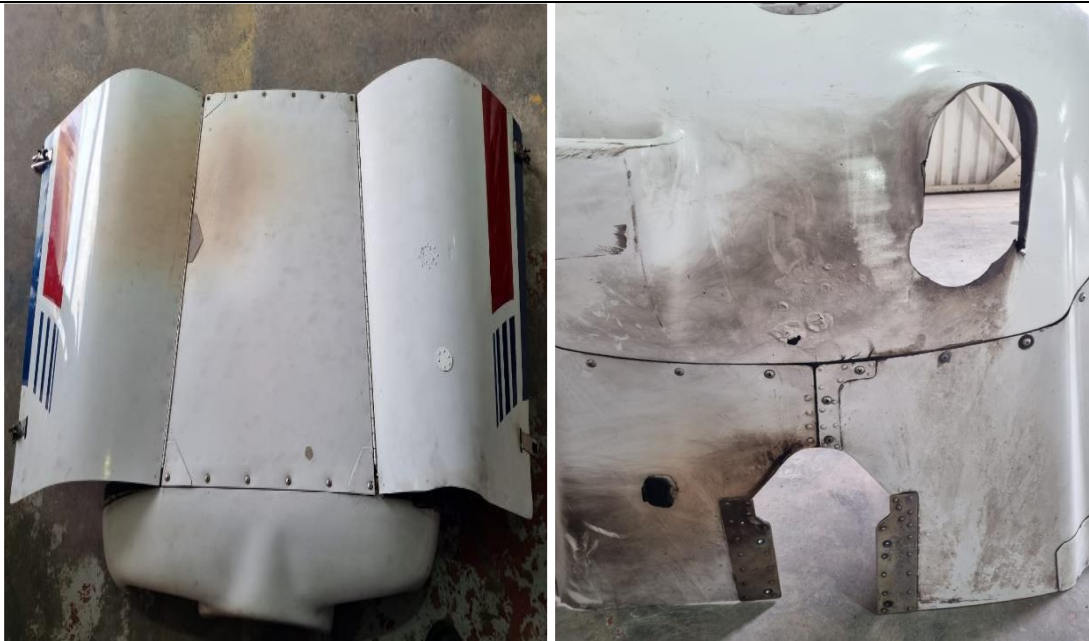
Figures 2/3: Fire damage at the top and bottom cowlings. (Source: Operator).

The source of fire in the engine compartment was likely to have been caused by excessive fuel pumped into the carburettor venturi by the carburettor accelerator pump, which operates when the throttle lever is advanced forward. The induction of fuel into the engine relies on airflow to move fuel upwards into the engine inlet manifold. However, if the engine is stopped when the throttle lever is advanced, excess fuel will drip downwards from the carburettor and pool in the carburettor heat box. The heat radiated by the hot exhaust system could then cause the pooled fuel to vaporise and could also act as an ignition source for the fuel vapour.
