**LIMITED ACCIDENT INVESTIGATION REPORT**

<b>Reference Number</b>		CA18/2/3/10042					
<b>Classification</b>	Accident	<b>Date</b>	15 December 2021	<b>Time</b>	1520Z		
<b>Type of Operation</b>	Training (Part 141)						
<b>Location</b>							
<b>Place of Departure</b>		Wonderboom Aerodrome (FAWB)		<b>Place of Intended Landing</b>		Wonderboom Aerodrome (FAWB)	
<b>Place of Accident</b>		Approximately 2.2nm North-east of FAWB, Gauteng Province					
<b>GPS Co-ordinates</b>	<b>Latitude</b>	25°38'29" S	<b>Longitude</b>	028°15'43.6" E	<b>Elevation</b>	4110ft	
<b>Aircraft Information</b>							
<b>Registration</b>		ZU-WMM					
<b>Model/Make</b>		Sling 2 (Serial Number: 144)					
<b>Damage to Aircraft</b>		Substantial		<b>Total Aircraft Hours</b>		2477.9	
<b>Pilot-in-command</b>							
<b>Licence Valid</b>		Yes	<b>Gender</b>	Male	<b>Age</b>	37	
<b>Licence Type</b>		Airline Transport Pilot Licence (ATPL) Aeroplane					
<b>Total Hours on Type</b>		±26.5		<b>Total Flying Hours</b>		10 209.5

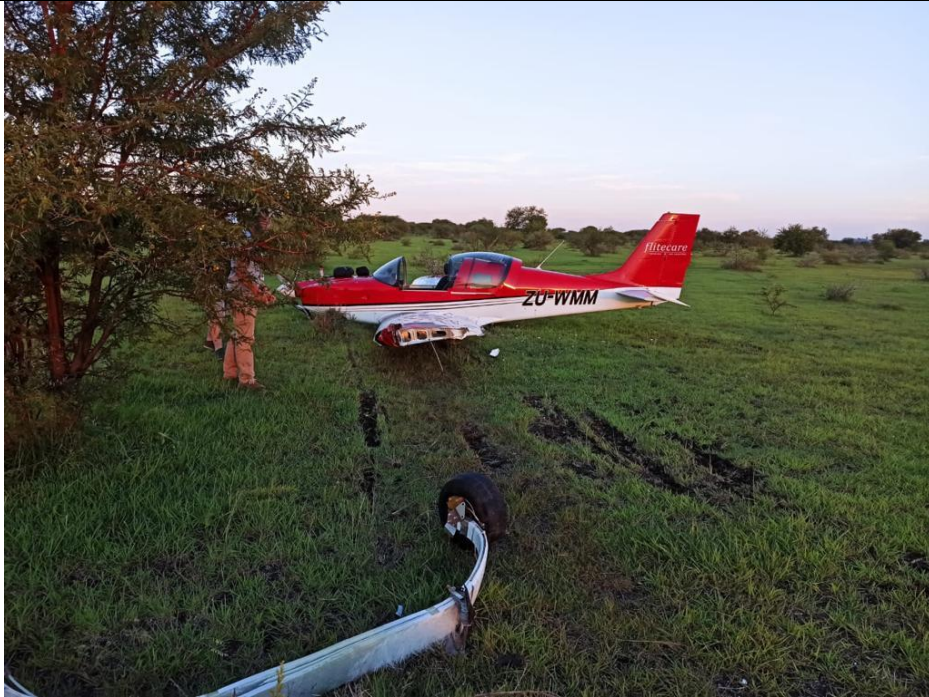
**Figure 1:** The aircraft at the accident site and the main landing gear strut in the foreground. (Source: Pilot)

Loss of engine power due to the air-filter housing limiting the movement of the throttle lever cable into full forward position and causing the engine rpm not to reach the desired power. During a forced landing on a wetland, the spring-loaded main landing gear got stuck and detached from the underbelly attachment point; and the aircraft collided with a parameter fence.

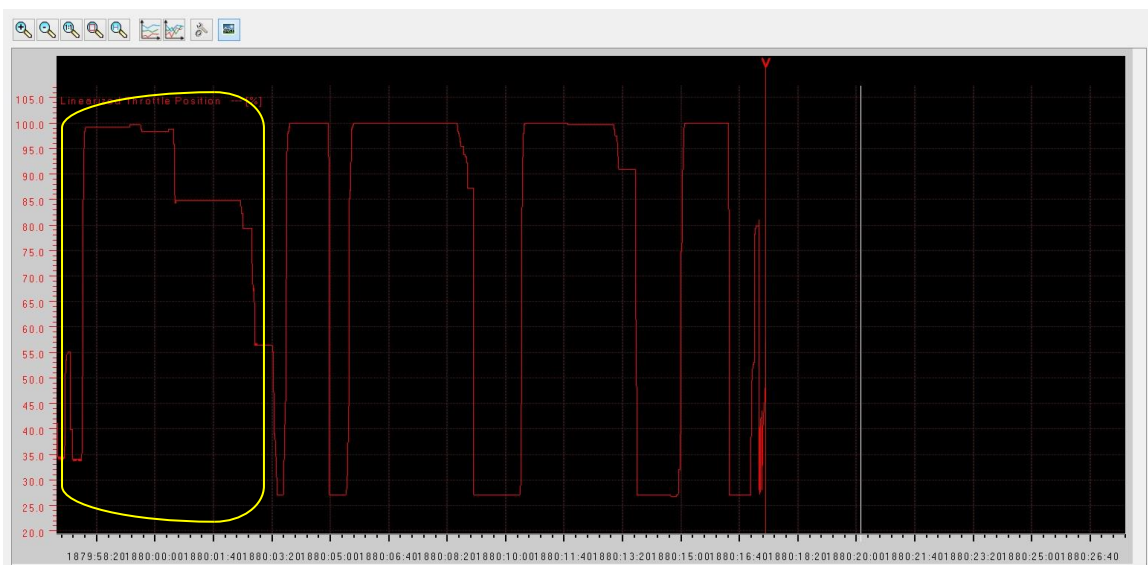
- The engine was running as per normal throughout the flight with no abnormal indication parameters being recorded, with the exception of the indications of the throttle position sensor. This contradicts the throttle position statements by the student pilot and the instructor pilot.

**Figure 2:** The throttle position sensor recordings.

- The throttle sensor position varied between 28% and a maximum of 50%. Up until the time the aircraft landed, the above recordings depict a clear indication of loss of engine power control attributed to an unresponsive throttle movement which was limited by the air filter housing.

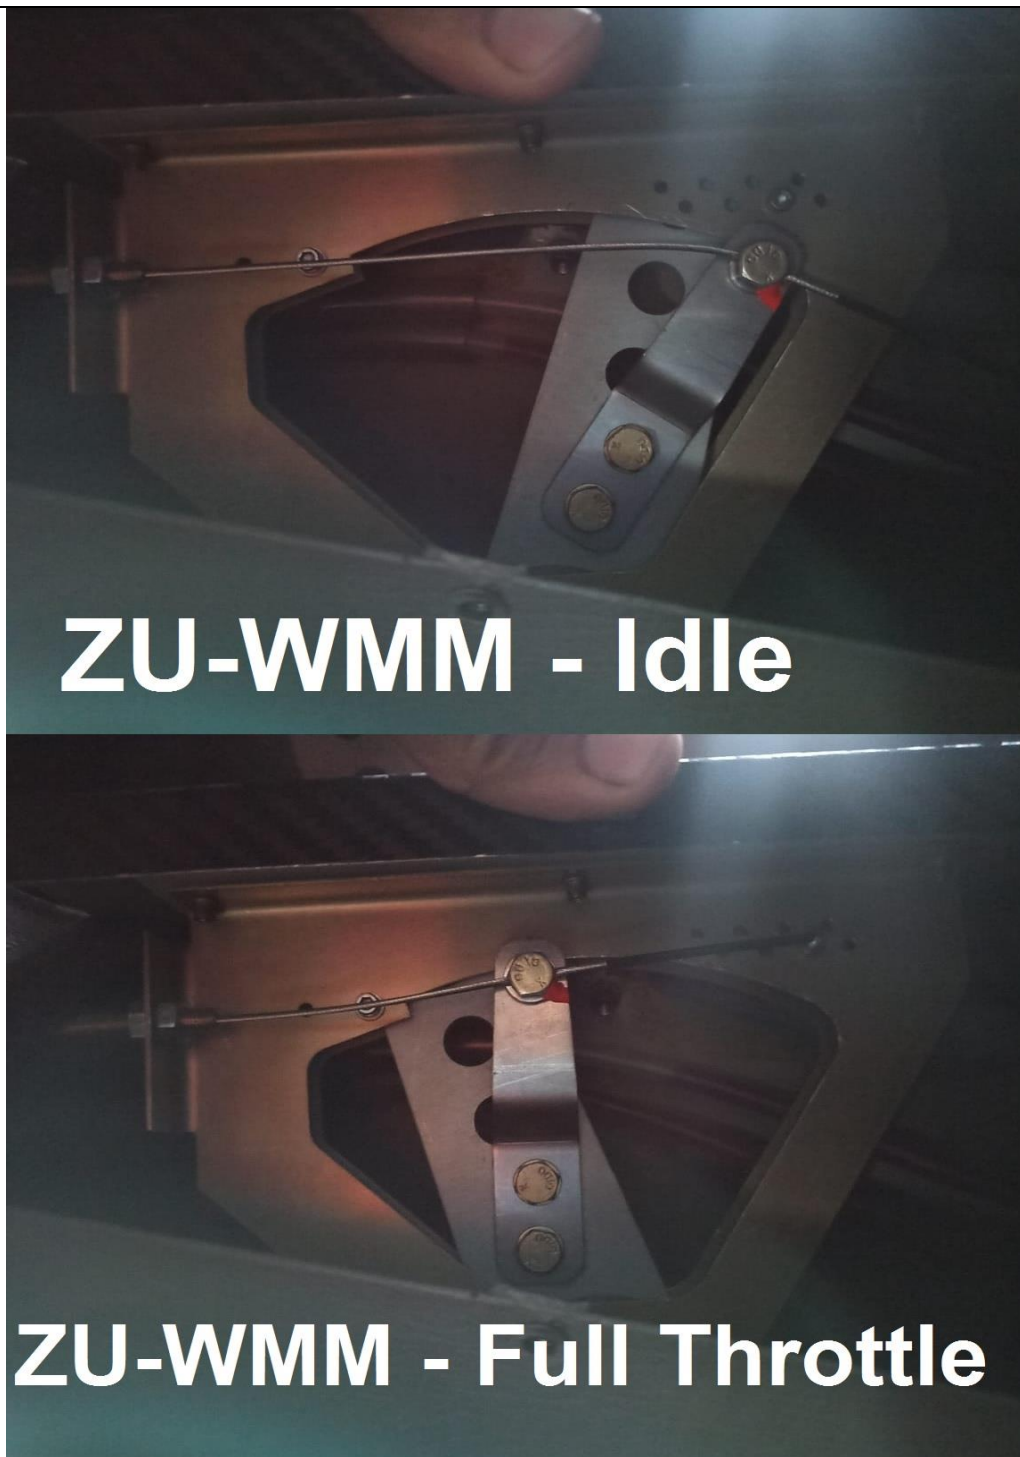
**Figure 3:** The throttle quadrant at idle and full power settings. (Source: AMO)

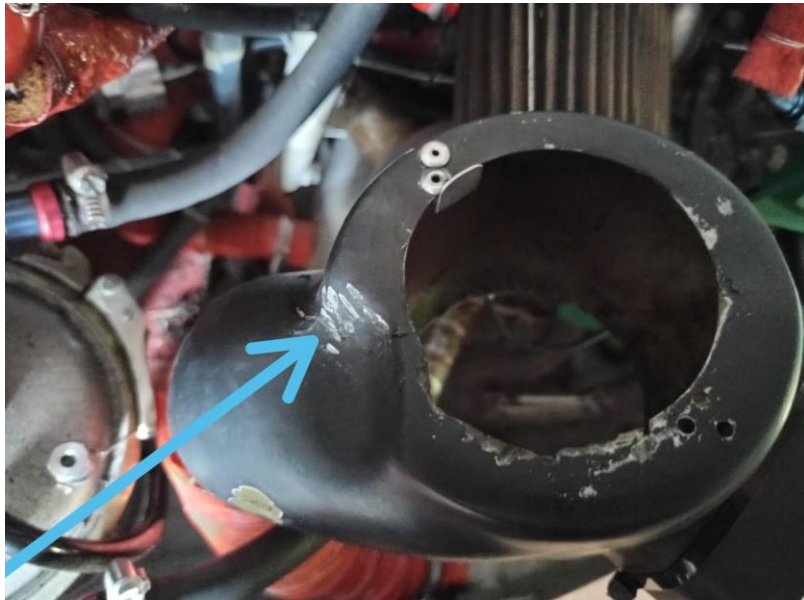
- Further investigation of the throttle system on the accident aircraft throughout the entire range of travel showed the following: The air-filter housing had witness marks from the throttle lever cable (see figure 4). During investigation, the throttle lever was recycled, and it revealed that during flight, the air-filter housing is pushed back by high (strong) airflow and, as a result, it limits the movement of the throttle lever into full forward position. The throttle cable attachment bolt does not swivel; hence, the lock nut is used as the throttle cable tends to bend when the throttle lever is pushed forward. Therefore, the flexible cable does not reach full position when the throttle lever is pushed forward.

**Figure 4:** Witness marks left on the air-filter housing.

- Investigation of a further two aircraft in the same aviation training organisation (ATO) fleet indicated the same witness marks of air-filter housing and interference with the throttle lever cable.
- The cause was found to be the throttle system design which remains susceptible to the inner cable buckling not feeding through the sheath, causing loss of engine power control.
- This problem has occurred in aircraft equipped with the initial throttle system design as well as the revised SB-19 throttle cable design. However, this appears to be the first recorded accident due to this problem.

Safety recommendation: It is recommended that the DCA issue a grounding order until such time the throttle system is redesigned to eliminate the possibility of in-flight loss of engine power.

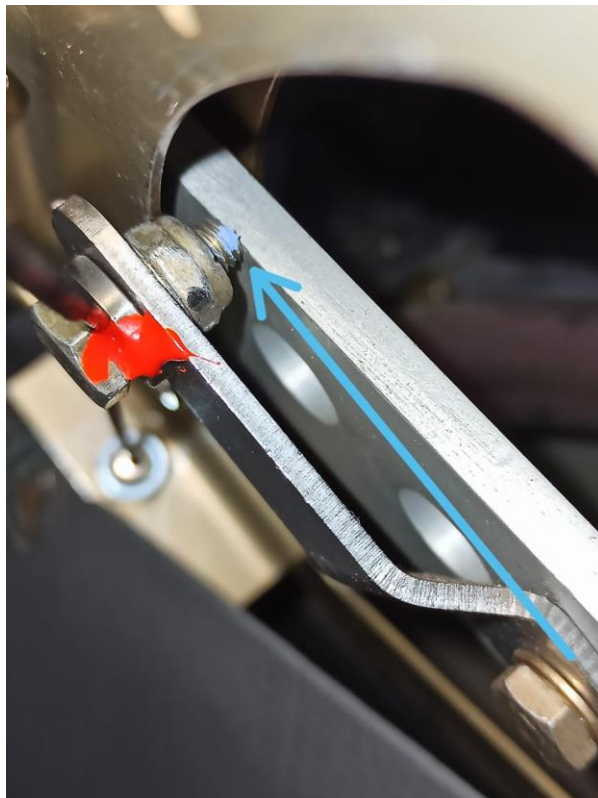
**Figure 5:** Throttle cable attachment bolt pushing against the air-filter housing.
