<b>AIRCRAFT ACCIDENT REPORT AND EXECUTIVE SUMMARY</b>
---

<b>Reference:</b>		CA18/2/3/10080	
<b>Aircraft Registration</b>	ZS-IGG	<b>Date of Accident</b>	26 November 2021		<b>Time of Accident</b>	1150Z	
<b>Type of Aircraft</b>	Cessna 421B Golden Eagle		<b>Type of Operation</b>		Private (Part 91)		
<b>Pilot-in-command Licence Type</b>	Commercial Pilot Licence		<b>Age</b>	37	<b>Licence Valid</b>	Yes	
<b>Pilot-in-command Flying Experience</b>	<b>Total Flying Hours</b>		394.8		<b>Hours on Type</b>	20	
<b>Last Point of Departure</b>	Hoedspruit Eastgate Aerodrome (FAHS) in Limpopo Province						
<b>Next Point of Intended Landing</b>	Rand Aerodrome (FAGM), Gauteng Province						
<b>Damage to Aircraft</b>	Substantial						
<b>Location of the accident site with reference to easily defined geographical points (GPS readings if possible)</b>							
On an open field, north of FAMB at Global Positioning System (GPS) co-ordinates determined to be S25° 41 08'.40" E029° 26 25'.90" at an elevation of approximately 4 886ft

<b>Probable Cause</b>							
Double-engine failure during approach for an emergency landing following the rough-running engines which were most likely induced by ice obstructing t

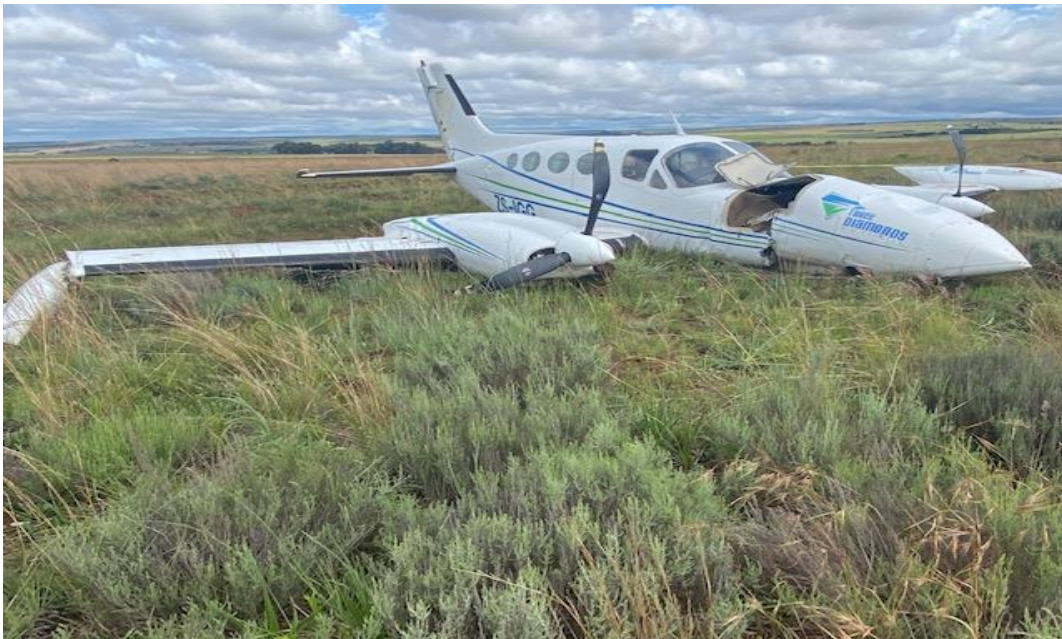
1.3.1 The aircraft sustained substantial damages during the accident sequence.

**Figure 2:** A view of the aircraft at the accident site.

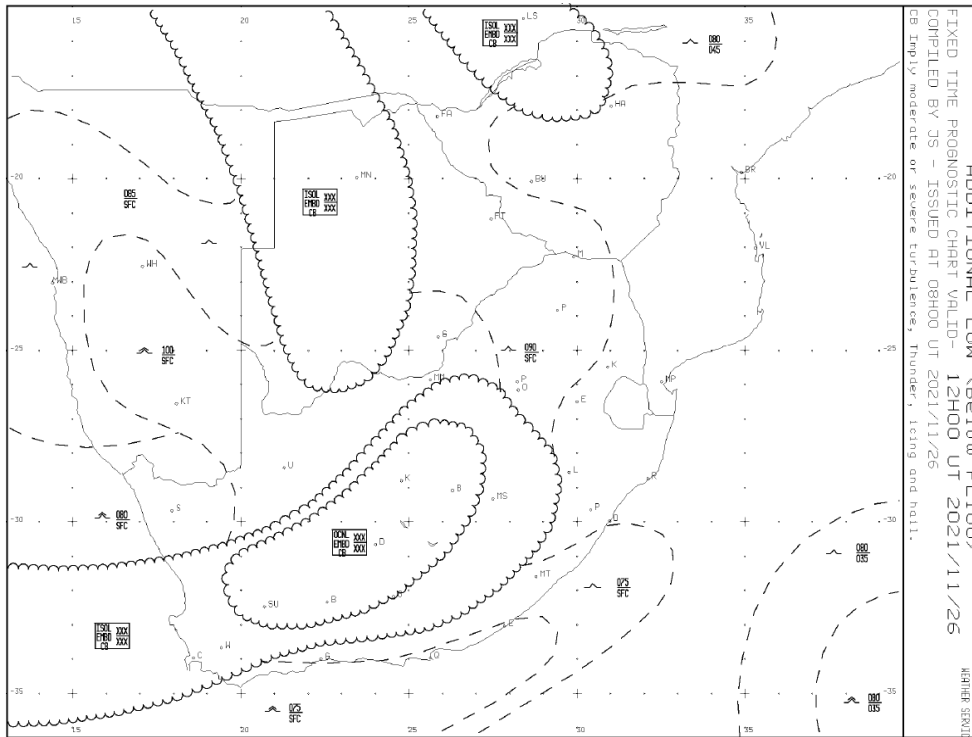
Figure 4: A satellite image showing icing conditions at the time of flight.

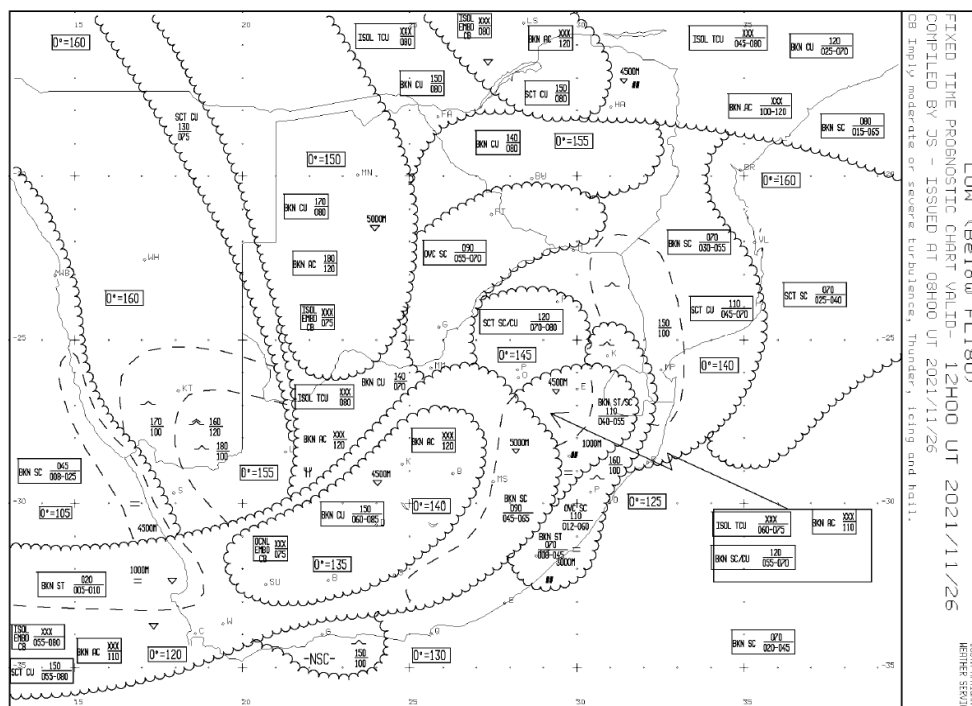
Figure 5: A satellite image showing the icing conditions at the time of flight.

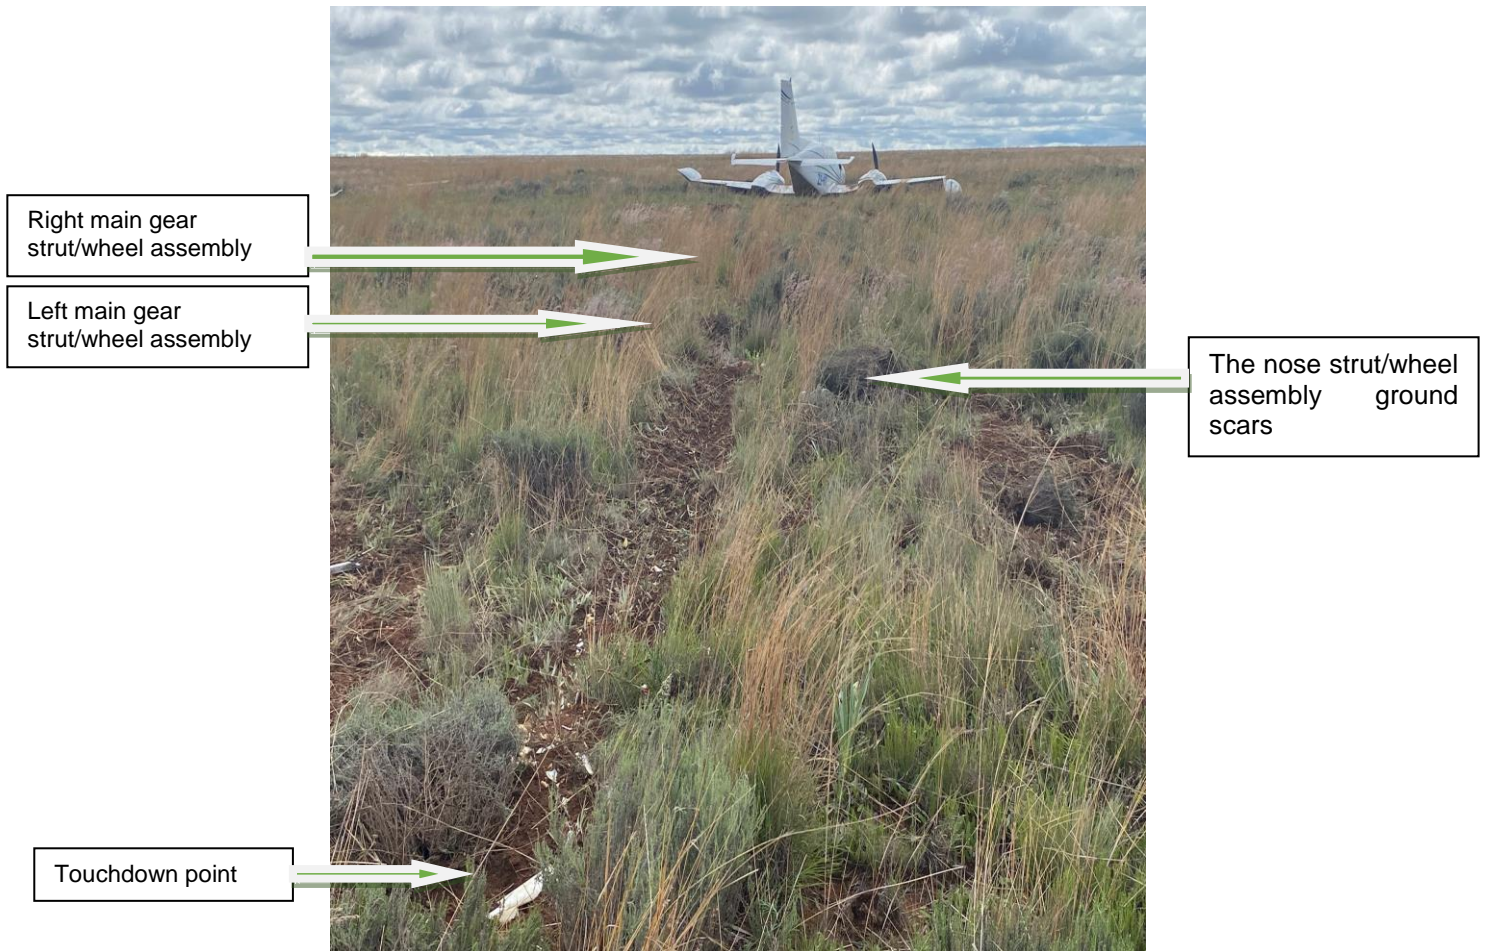
1.12.1 Examination of the accident site indicated that the aircraft landed hard on an open field. The main landing gear doors separated from their respective struts and all three landing gears broke off (at the struts) during landing. The aircraft skidded on its belly and stopped approximately 65 metres from the first point of impact. The pitot probe/tube mounted underneath the nose section broke off. The bottom fuselage skin and the antennas were damaged. The nose gear strut/wheel assembly was found approximately 12m from the first point of impact, followed by the left main gear strut/wheel assembly that was found on the left, approximately 16m; and the right main gear strut/wheel assembly, which was further away, approximately 22m from the first point of impact. All three landing gears strut oleos and the tyres had pressure. The fuselage nose-section collapsed in compression and separated on the right-side nose-cargo compartment area. The right-side main (tip) tank suffered overload failure at its attachment area, however, the fuel pipe feeding the engine was still intact. The wing structure, including the auxiliary fuel tanks and the locker tanks, was intact. All seats were found still attached to the floor boards and were undamaged. All the seat belts were accounted for and operated normally when tested. Both the left and the right fuel selector valve handles on the cockpit floor panel were found selected to the OFF position. It was the investigators' thought that the pilot selected them to the OFF position before he vacated the aircraft.

**Figure 6:** First point of impact and the final position of the aircraft.

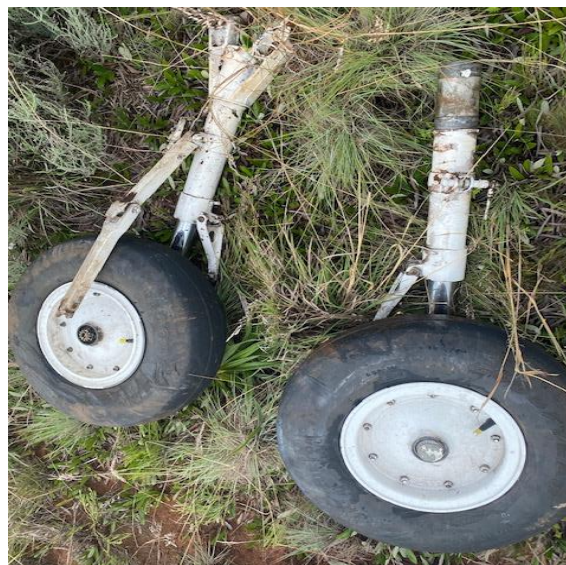
**Figure 7:** View of the broken main landing gear struts with the wheel assemblies still attached.

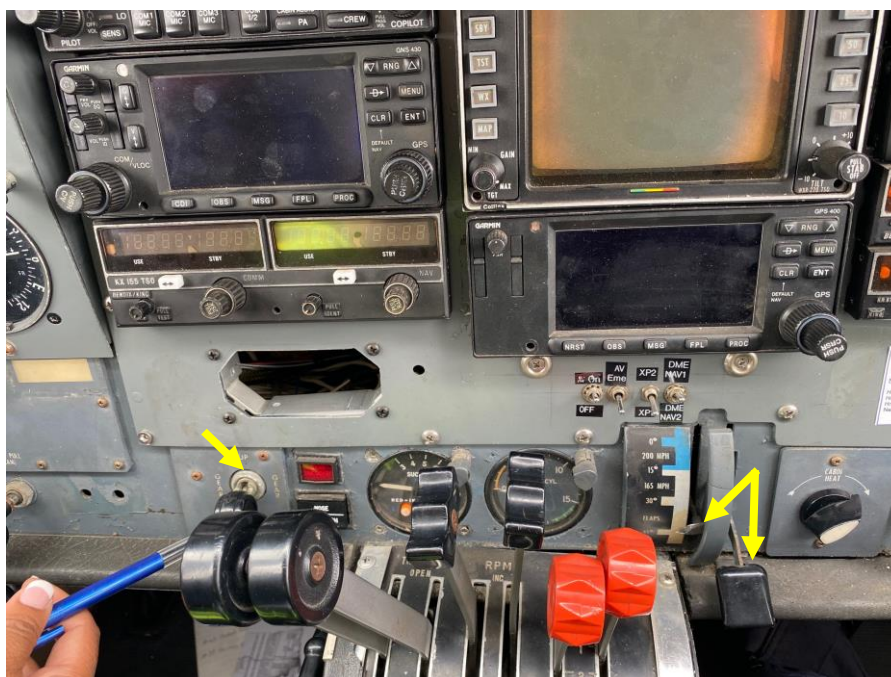
1.12.2 Examination of the engines control instruments showed both throttle levers in a closed position. The mixture control levers were both in idle cut-off position. All instruments, radios

and switches were intact. The aircraft's landing gear selector handle was in an extended position and both the flap selector and the flap position indicator were found at 45° flaps, extended. None of the circuit breakers were pulled. *The alternate air levers (T-handles on the left pilot's side below the control column) which select the induction air intake in case the primary air intake (air filters) becomes obstructed were found in the closed position despite the AFM that requires that in the event the engines' air filters become obstructed or blocked, they should be opened to allow the unfiltered air into the engines. The auxiliary fuel pumps switches on the left pilot's side-panel were selected to HIGH mode.*

**Figure 8:** A view of the aircraft's console showing the landing gear selector handle in an extended position and the flap position indicator at 45°.

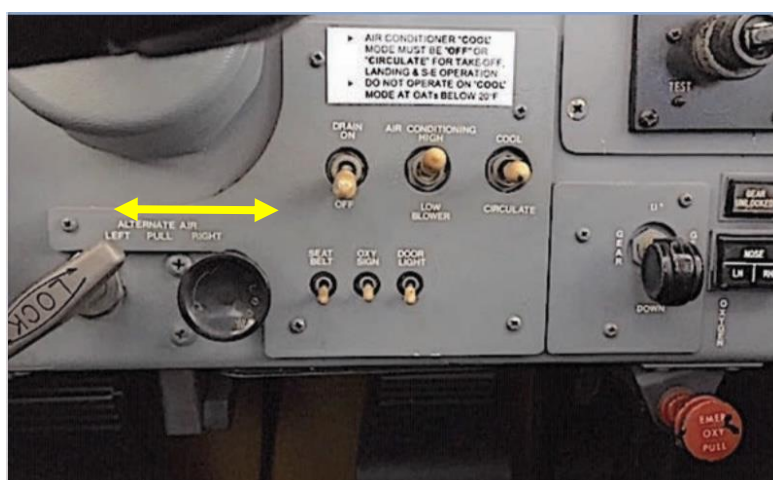
**Figure 9:** The left and right ALTERNATE AIR levers in a closed (OFF) position.

The pilot appeared to have overlooked the AFM and reverted to memory action items; thus did not consider opening the alternate air source to allow proper combustion. Instead, he selected the auxiliary fuel pumps to HIGH mode, assuming that the anomaly was caused

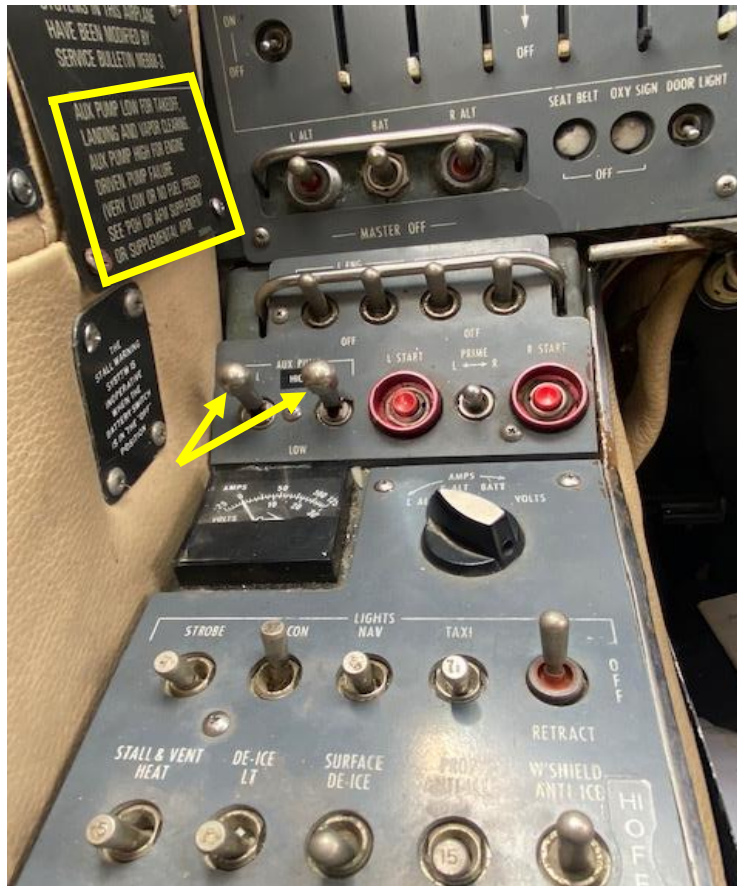
**Figure 10:** A view of the auxiliary fuel pumps in a HIGH mode setting. There is a placard (yellow window above) installed on the left pilot's side panel stating AUX PUMP HIGH FOR ENGINE DRIVEN PUMP FAILURE (VERY LOW OR NO FUEL PRESSURE).

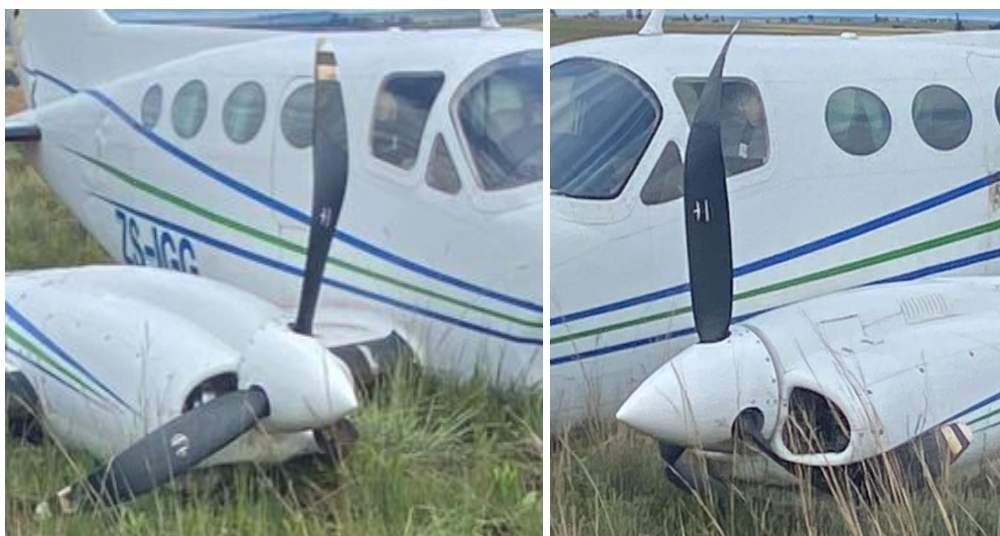
1.12.3 The engines were found still attached to their respective mountings and the propellers secured to their engine flanges. Examination of the aircraft's propellers/blades showed that the engines were not operational during landing. Neither of the propellers was feathered (turned to a very high pitch with the blades almost parallel to the airstream).

**Figures 11 and 12:** Pictures showing neither of the propellers feathered.

- 3.2.12 The investigation found that neither of the propellers was feathered.

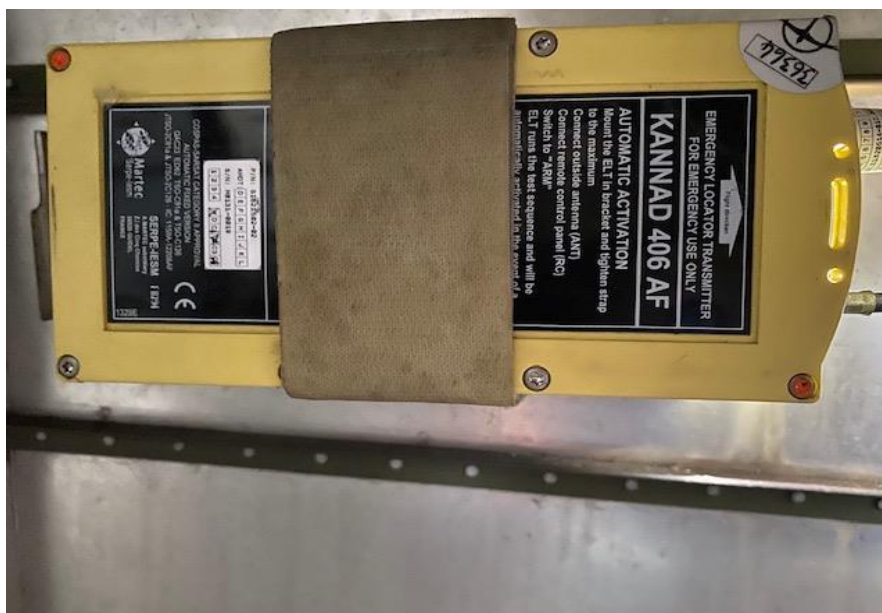
**Figure 13:** The ELT installed on the aircraft's tail-section.

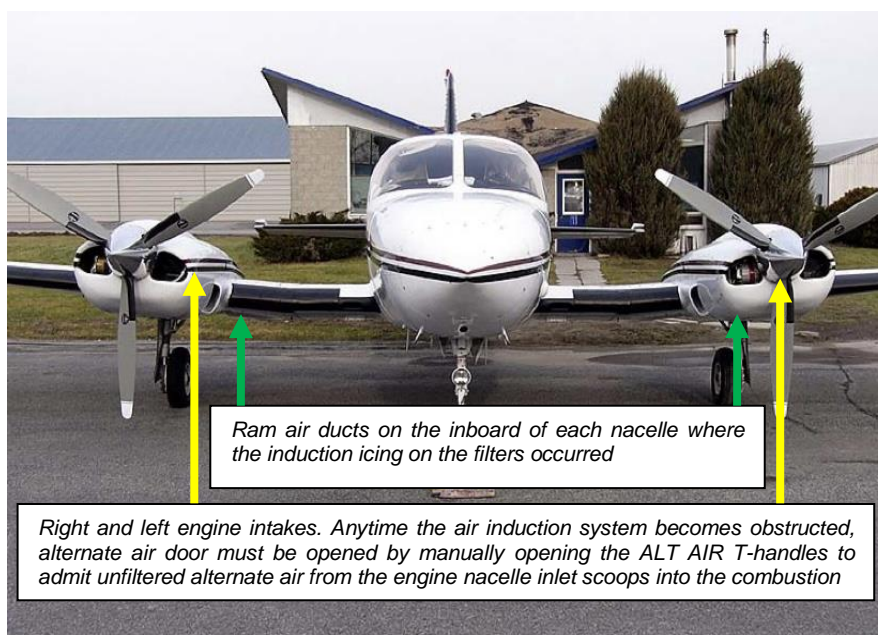
1.16.2 The weather forecast by the SAWS on the day indicated icing or freezing weather conditions overhead FAWI. The pilot stated that the engines were running normal until the aircraft entered FAWI airspace, which was concentrated with ice that seemed to have obstructed the air filters on the in-board of each nacelle and starved them of air. The aircraft was certified to operate into known icing conditions, and selecting the alternate air and allowing the unfiltered air into the engines for proper combustion was all that was needed IAW the AFM. In contrast, the pilot assumed that the engines' malfunction was caused by fuel starvation and had selected the auxiliary fuel pumps switches to HIGH mode. This did not resolve the anomaly because the engines were already starved of air. Stapled hard copies of the emergency procedures were found on top of the aircraft's instrument panel post-accident.

**Figure 14:** The file picture of the Cessna (not ZS-IGG). (Source: <https://www.jetphotos.com>) The picture shows the ram air ducts on the inboard of each nacelle and the alternate air entry point through the nacelles into the combustion.
