LIMITED ACCIDENT INVESTIGATION REPORT

Reference Number	CA18/2/3/10081						
Classification	Accident	Date	2 November 2021	Time	1130Z		
Type of Operation	Remotely Piloted Aircraft (Part 101)						
Location							
Place of Departure	Thungela Shared Services in Witbank, Mpumalanga Province		Place of Intended Landing	Thungela Shared Services in Witbank, Mpumalanga Province			
Place of Accident	Water Treatment Plant at Thungela Shared Services						
GPS Co-ordinates	Latitude	S25° 56' 37.9"	Longitude	E029°11' 20.9"	Elevation	5066 feet	
Aircraft Information							
Registration	ZT-UWG						
Model/Make	DJI Matrice M210 V2 (Serial Number: M200-01)						
Damage to Aircraft	Destroyed		Total Aircraft Hours	1065.45 hours			
Pilot-in-command							
Licence Type	Remote Pilot Licence (RPL)	Gender	Male		Age: 25		
Licence Valid	Yes						
Total Hours on Type	624.42		Total Flying Hours	624.42			
People On-board	N/A	Injuries	0	Fatalities	0	Other (on ground)	0
What Happened

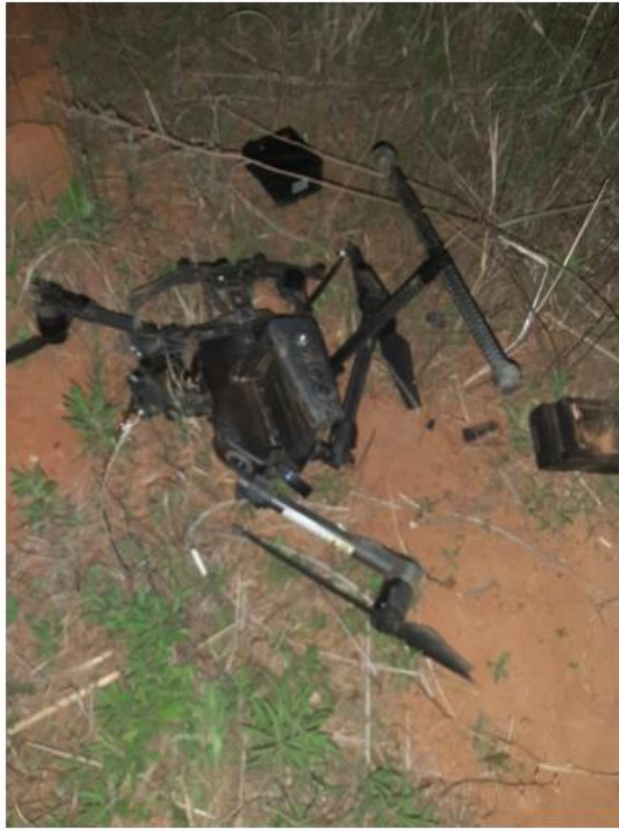
<p>On 2 November 2021, the remotely piloted DJI Matrice drone/unmanned aircraft with registration marking ZT-UWG took off from Thungela Shared Services facility in Witbank, Mpumalanga province, for aerial inspection with the intention to return to launch facility. The flight was conducted under visual flight rules (VFR) by day and under the provisions of Part 101 of the Civil Aviation Regulations (CAR) 2011 as amended.</p> <p>The pilot reported that the first flight was completed without incident. During the last flight at approximately 400 feet (ft) above ground level (AGL) and 700m from the landing zone at the facility whilst monitoring the transmitter screen, the pilot saw the drone malfunctioning and, thereafter, entered a rapid uncontrolled descent with no warnings or high wind speeds observed. The pilot then lost the drone's line of sight. According to the pilot, prior to the first flight, the drone battery was fully charged at 100%. At the time of accident, the drone had 85% battery power remaining. The drone was recovered in a nearby field, approximately 700m from the landing zone.</p> <p>The drone was destroyed on impact with the ground during the accident sequence. The body was shattered, and its internal hardware and electronic systems were destroyed. Other damage was</p>

limited to the gear skids, antenna, battery bay, propellers, arms and the four electric motors. One of the batteries (M200-246) had split upon impact.

Figure 1: The damaged RPA. (Source: Operator)

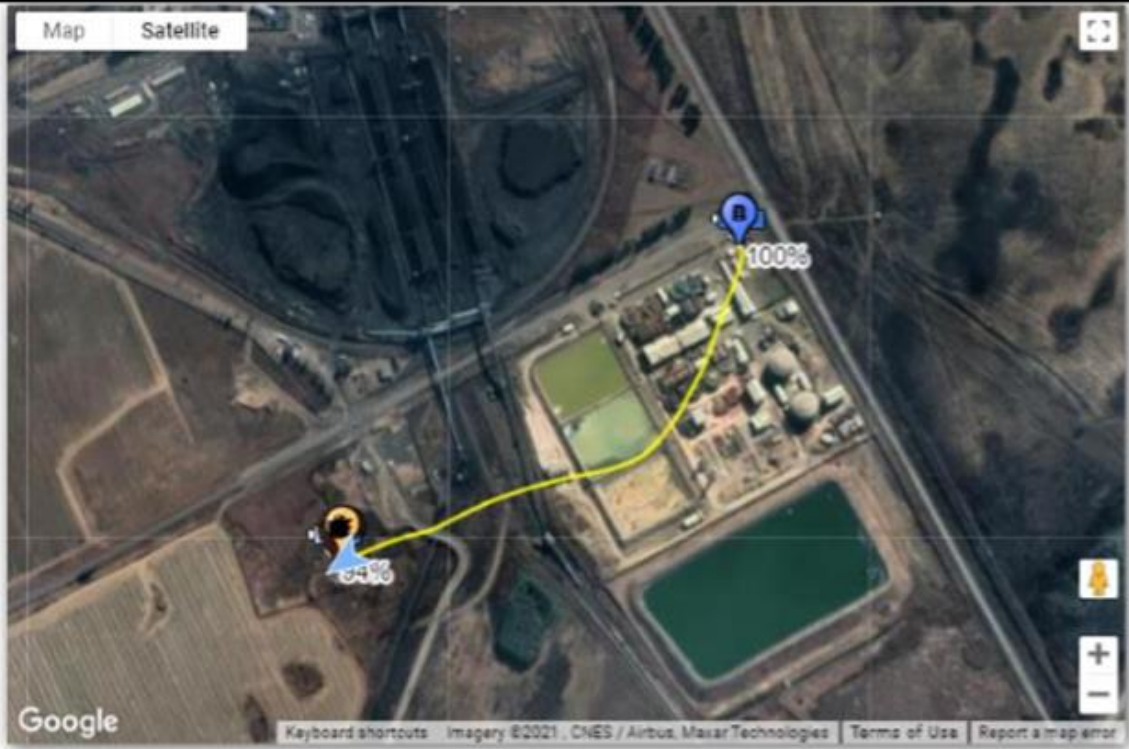
Flight time	Altitude	Home Dist	Type	Notification
A 00m 00s	0.0 m	0 m	Mode	Mode changed to Motors Started
B 00m 00s	0.0 m	0 m	Tip	<ul style="list-style-type: none"> ✓ Setting new Return-To-Home altitude to 120m (394 ft). ✓ Data Recorder File Index is 672. ✓ Setting new Maximum Flight Altitude to 500m (1640 ft)
00m 00s	0.0 m	0 m		100% Battery
C 00m 03s	0.0 m	0 m	Mode	Mode changed to Assisted Takeoff
D 00m 03s	0.0 m	0 m	Mode	Mode changed to P-GPS
E 01m 18s	122.5 m	655 m	Medium Risk	⚠ Detected side shock / possible collision, aircraft is rolling sharply to the right
F 01m 19s	121.9 m	658 m	Medium Risk	⚠ Detected forward shock / possible collision, aircraft is pitching sharply forward
G 01m 19s	120.1 m	660 m	Medium Risk	⚠ Detected side shock / possible collision, aircraft is rolling sharply to the right
H 01m 19s	118.9 m	661 m	Medium Risk	⚠ Detected forward shock / possible collision, aircraft is pitching sharply forward

I 01m 19s	117.2 m	662 m	Low Risk	⚠ Not Enough Force/ESC Error
J 01m 19s	116.4 m	662 m	Medium Risk	⚠ Detected side shock / possible collision, aircraft is rolling sharply to the right. ⚠ Not Enough Force/ESC Error

Figure 2: Airdata –The RPA experienced a problem with thrust (see number “E”). The smart motors recorded collision and electronic speed control (ESC) error (see number “I”). (Source: Operator)

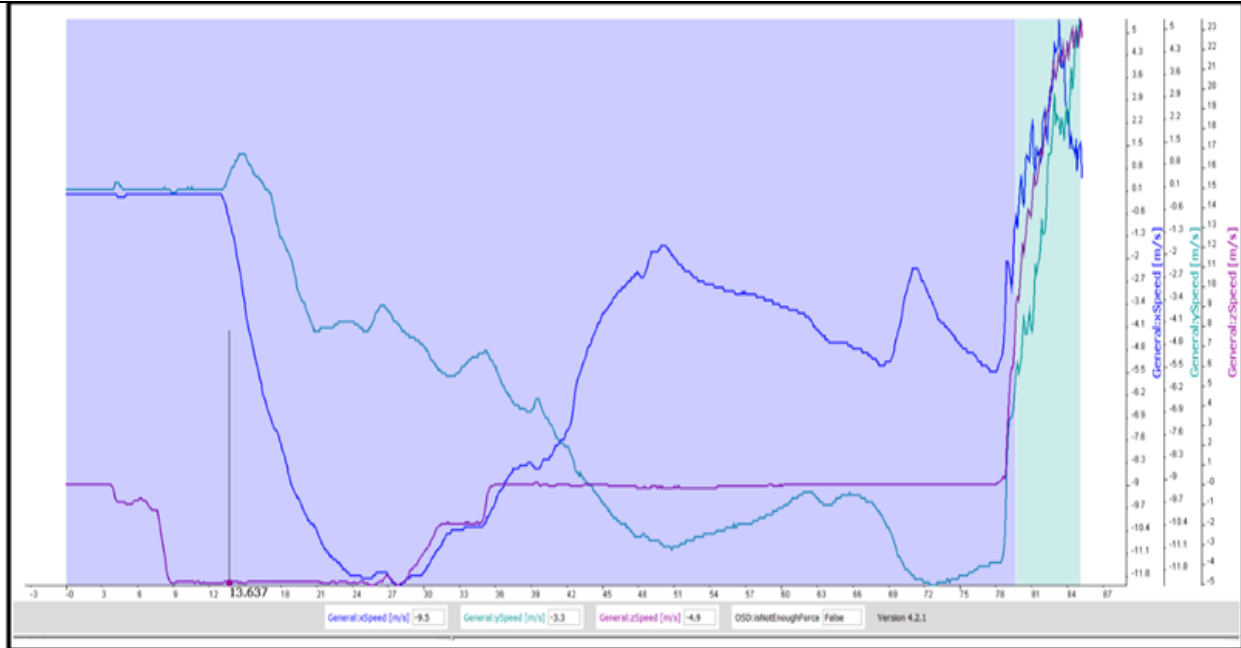
Figure 3 – CSV (comma-separated values) View –The IMU (inertial measurement unit) log shows that no impact was recorded in-flight. The RPA started falling faster than normal. The log retrieved does not show which motor caused the whole system to go out of sync. Only .DAT files show information relating to the motor. (Source: Operator)

The aqua hue as the background is the internal flight command or IMU confirming that there is a thrust lost being recorded as the RPA is flying beyond the manufacturing specifications or beyond the programmed parameters, thus, confirming an ESC failure.
