LIMITED ACCIDENT INVESTIGATION REPORT

Reference Number	CA18/2/3/10083						
Classification	Accident	Date	19 November 2021	Time	0802Z		
Type of Operation	Remotely Piloted Aircraft (Part 101)						
Location							
Place of Departure	Andrew's Field (FAAF), Western Cape province		Place of Intended Landing	Andrew's Field (FAAF), Western Cape province			
Place of Accident	Runway 11 FAAF						
GPS Co-ordinates	Latitude	S 34° 45' 47"	Longitude	E 20° 2' 13"	Elevation	35 ft	
Aircraft Information							
Registration	ZT-UOI						
Model/Make	Astus II Tellumet (Serial Number: 301)						
Damage to Aircraft	Substantial		Total Aircraft Hours	1876.2			
Pilot-in-command							
Licence Valid	Yes	Gender	Male	Age	28		
Licence Type	Remote Pilot Licence (RPL)						
Total Hours on Type	41.6		Total Flying Hours	41.6			
Pilots Controlling	2 + 0	Injuries	0	Fatalities	0	Other (On Ground)	0
What Happened							
<p>On 19 November 2021, two pilots (internal and safety) operating an Astus II unmanned aerial vehicle (UAV) with registration ZT-UOI took off on a test flight for automatic take-offs and landings (ATOLs) at Andrew's Field (FAAF) in the Western Cape province. A flight plan was not filed. The flight was

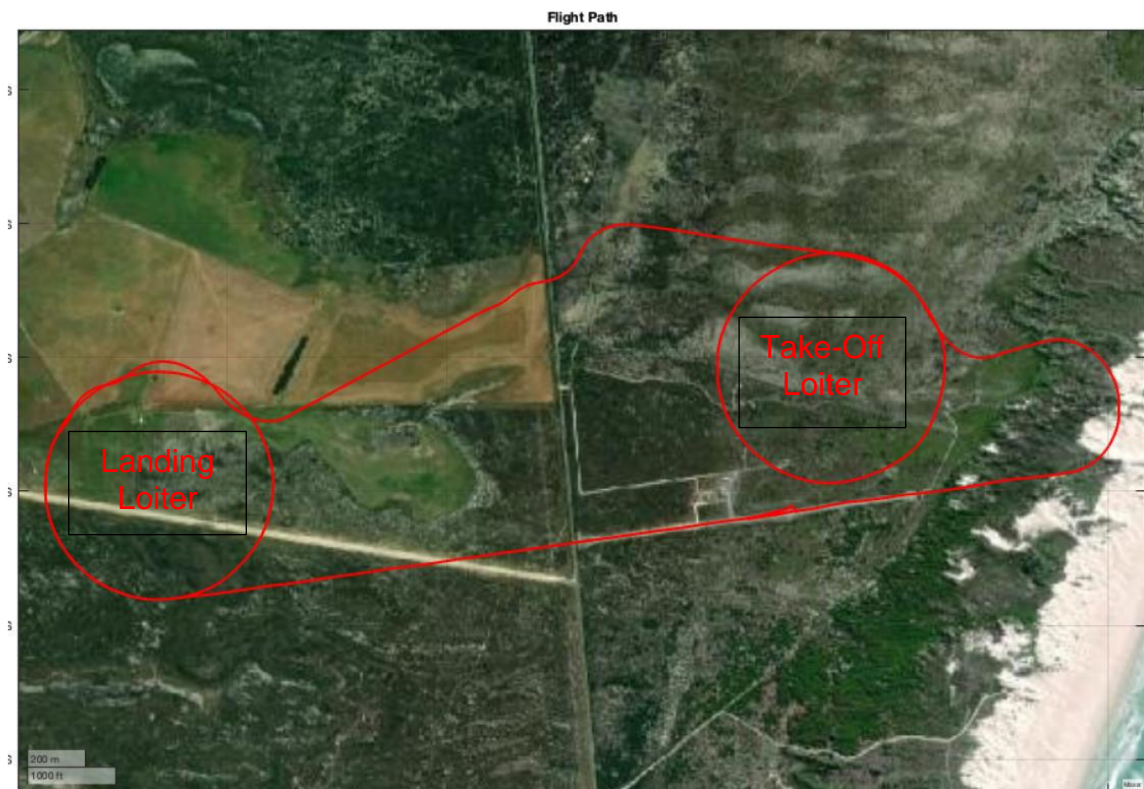
proceeded to the landing Loiter position and completed two patterns before continuing to long final for Runway 11.

Figure 1: Flight pattern of the automatic take-off and landing circuit. (Source: Operator)

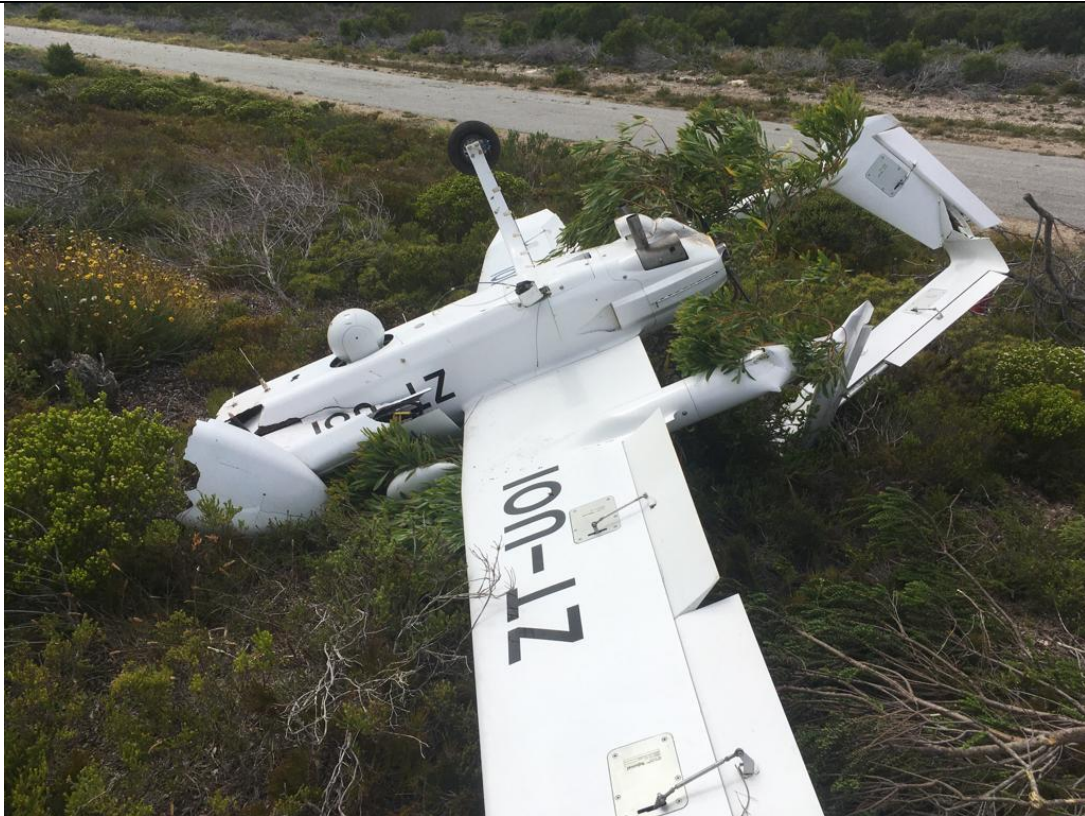
The approach for landing was uneventful until the flare phase, which was approximately 5ft above ground level (AGL) whereupon the safety pilot observed the aircraft yaw to the left and drifted away from the centreline. The safety pilot switched from ATOL to Manual mode via remote-controlled transmitter to execute a manual go-around; he observed the aircraft correcting for the heading drift based on the manual control inputs. Approximately a second later, the internal pilot switched from Manual mode to Setpoint mode via the container-based main controller with the same intention as the safety pilot, which was to conduct a go-around. In the Setpoint mode, the aircraft was being commanded to pitch up with no guidance control on banking. The safety pilot immediately noticed that his manual inputs differed from what the aircraft was doing and that he had lost control of the aircraft. Due to a crosswind from the right, the aircraft drifted to the left of the runway and the left-wing tip impacted shrubs, resulting in the aircraft flipping over and impacting the ground. The aircraft came to a halt on the left of the runway in an inverted position.

Figure 2: The aircraft at the accident site. (Source: Operator)

Loss of control of the aircraft in an abrupt manoeuvre due to conflicting control inputs by the internal and safety pilots, resulting in the aircraft impacting the shrubs.

Pilots should communicate clearly as to who has control of the aircraft at a given time.
