LIMITED ACCIDENT INVESTIGATION REPORT

Reference Number	CA18/2/3/10084						
Classification	Accident	Date	24 November 2021	Time	1415Z		
Type of Operation	Private (Part 94)						
Location							
Place of Departure	Mawala Lodge Airstrip, Limpopo Province		Place of Intended Landing	Mawala Lodge Airstrip, Limpopo Province			
Place of Accident	On a private farm approximately 3km from Mawala Lodge, Limpopo Province						
GPS Co-ordinates	Latitude	24°59'17" S	Longitude	027°18'33" E	Elevation	3464.6ft	
Aircraft Information							
Registration	ZU-APS						
Model/Make	Thunderbird MKII (Serial Number: TDE53)						
Damage to Aircraft	Destroyed		Total Aircraft Hours	479			
Pilot-in-command							
Licence Valid	Yes		Gender	Male		Age	63
Licence Type	Private Pilot Licence (PPL) Aeroplane						
Total Hours on Type	8		Total Flying Hours	839			
People On-board	1+0	Injuries	1	Fatalities	0	Other (On ground)	0
What Happened							
<p>On Wednesday afternoon, 24 November 2021 at approximately 1415Z, a pilot on-board a Thunderbird MKII aircraft with registration ZU-APS took off on a private flight from Mawala Lodge Airstrip Runway (RWY) 16 in Limpopo province with the intention to perform two touch-and-go

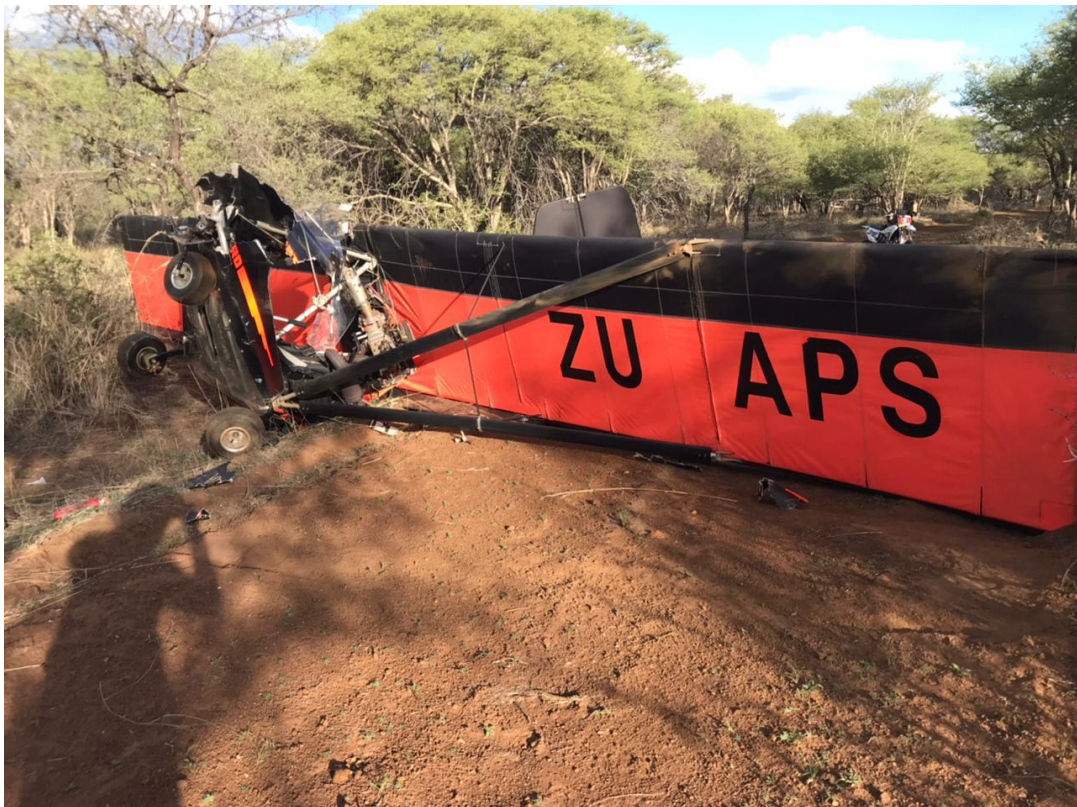
Figure 2: The aircraft post-accident.

During the on-site investigation, the investigating team found that the propeller turned freely by hand. Fuel was found in the carburettor bowls and in the fuel lines that feed fuel to the engine. The fuel tanks had approximately 10 litres each. A fuel sample was taken and there was no evidence of fuel contamination that could have led to the accident.

The aircraft lost lift caused by turbulent weather condition at approximately 500ft AGL, which led to an unsuccessful forced landing.
