LIMITED ACCIDENT INVESTIGATION REPORT

Reference Number	CA18/2/3/10085						
Classification	Accident	Date	31 July 2021	Time	1140Z		
Type of Operation	Private (Part 94)						
Location							
Place of Departure	Drakensberg Gardens Aerodrome (FADZ), KwaZulu-Natal Province		Place of Intended Landing	Barkley East (FABF), Eastern Cape Province			
Place of Accident	Barkley East Aerodrome						
GPS Co-ordinates	Latitude	S 30°58'12.08"	Longitude	E 027°36'44.48"	Elevation	5676 feet	
Aircraft Information							
Registration	ZU-DAS						
Model/Make	Bushbaby, Kit Planes for Africa (Serial no. 38)						
Damage to Aircraft	Substantial		Total Aircraft Hours	734.0			
Pilot-in-command							
Licence Type	Airline Transport Pilot Licence (ATPL)		Gender	Male	Age	32	
Licence Valid	Yes						
Total Hours on Type	42.6		Total Flying Hours	5637.3			
People On-board	1 + 0	Injuries	0	Fatalities	0	Other (on ground)	0
What Happened							
<p>On 31 July 2021 at approximately 1140Z, a pilot on-board a Bushbaby aircraft with registration ZU-DAS took off from Drakensberg Gardens (FADZ), KwaZulu-Natal province, to Barkley East (FABF), Eastern Cape province. This was a private flight conducted under visual meteorologi

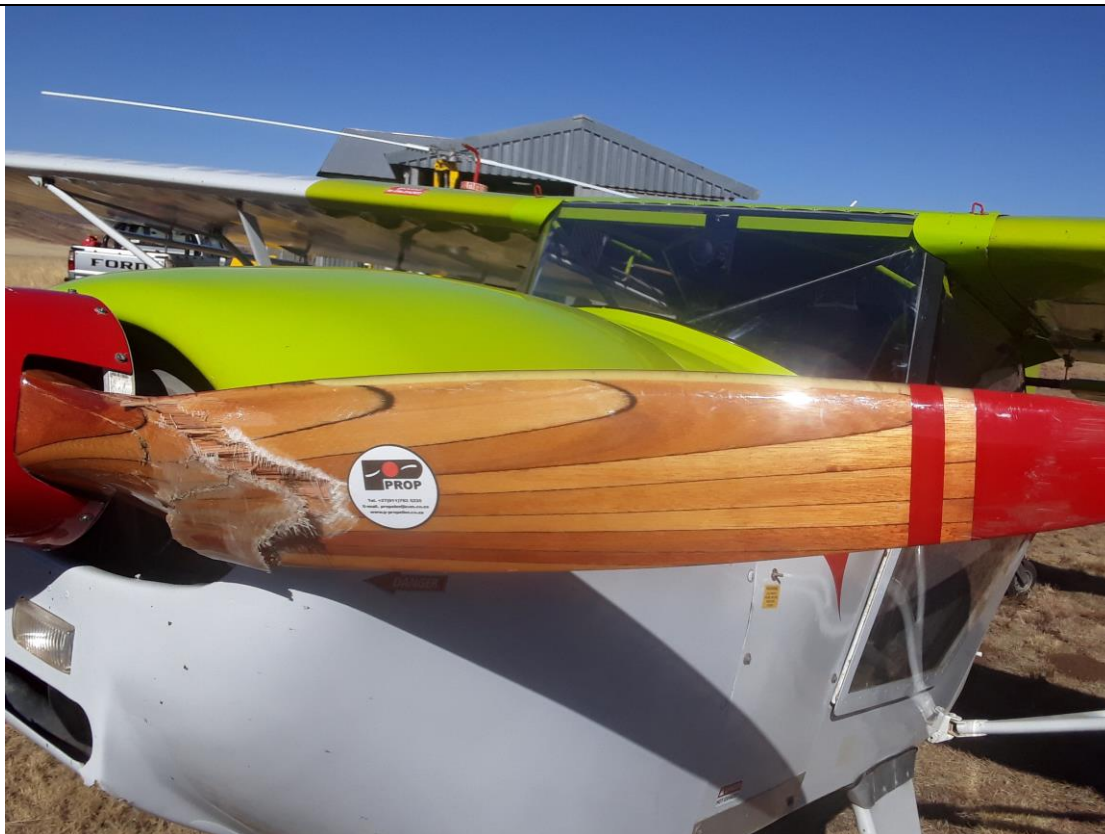
Figure 1: The damaged propeller. (Source: Pilot)

- The aircraft was damaged during the accident sequence at (FABF) and was recovered to New Tempe for repairs.
- The left- and right-side main landing gear axles were bent due to the aircraft running over a ditch, and the propeller was also damaged.
- The last annual inspection was carried out on 3 May 2021 at 719.2 hours and the aircraft was flown a further 14.8 hours since the last annual inspection. The bent left- and right-side main landing gear axles were removed and replaced with new ones. The right-side wheel assembly was found to be unserviceable; it was removed and replaced with a new one; the tyre was fitted to the new wheel assembly and balanced; the brake system was topped up and bled.

The aircraft veered off to the left-side of the runway; the left wheel ran over a shallow ditch which caused the aircraft to tilt forward and the stationery propeller to contact the ground.
