<b>LIMITED ACCIDENT INVESTIGATION REPORT</b>
--

<b>Reference Number</b>		CA18/2/3/10086					
<b>Classification</b>	Accident	<b>Date</b>	3 December 2021	<b>Time</b>	0750Z		
<b>Type of Operation</b>	Training Flight (Part 141)						
<b>Location</b>							
Place of Departure	Wonderboom Aerodrome (FAWB)		Place of Intended Landing	Wonderboom Aerodrome (FAWB)			
Place of Accident	FAWB, Runway 11 during the landing roll						
GPS Co-ordinates	Longitude	S 26° 39' 11.73"	Latitude	E 028° 13' 0.11"	Elevation	4095ft	
<b>Aircraft Information</b>							
Registration	ZS-MHG						
Model/Make	PA34-200T/ Piper (Serial Number: 34-7770126)						
Damage to Aircraft	Substantial		Total Aircraft Hours	6825.8			
<b>Pilot-in-command</b>							
Licence Type	ATPL	Gender	Male		Age	60	
Licence Valid	Yes						
Total Hours on Type	328.8		Total Flying Hours	27335			
People On-board	2+1	Injuries	0	Fatalities	0	Other (on ground)	0
<b>What Happened</b>							
<p>On 3 December 2021 at approximately 0750Z, a Piper PA-34-200T Seneca twin-engine aircraft with registration ZS-MHG was engaged in a training flight. On-board the aircraft were the instructor and two student pilots. Their intention was to conduct multi-recipro

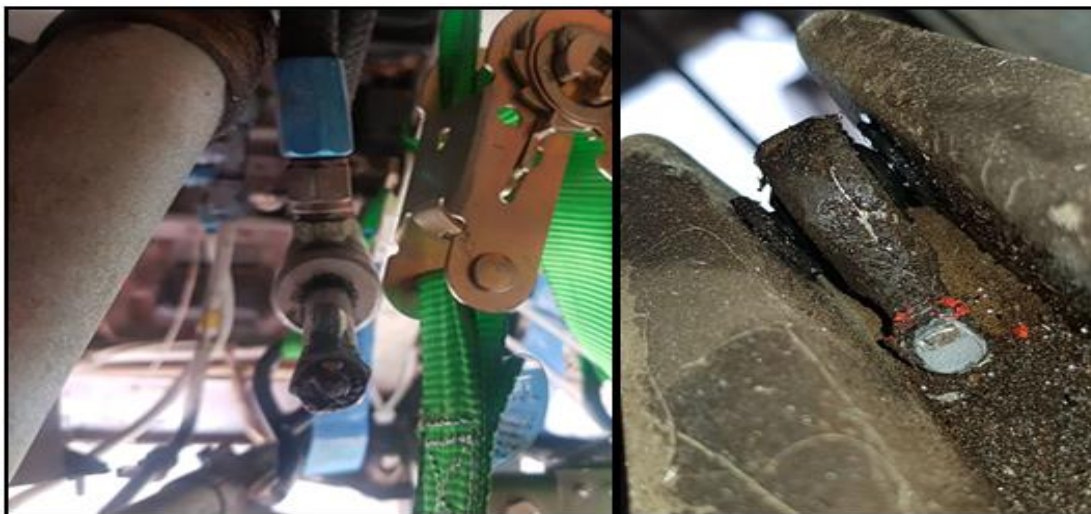
Post-accident, the aircraft maintenance engineer (AME) who was rated on the aircraft type conducted a visual inspection and found that the nose landing gear actuator bottom rod end had fractured just above the lock nut and jam nut.

**Figure 1:** Retraction and extension actuator failure on the bottom connecting rod end (left) and the bearing (right).

The nose landing gear actuator bearing is used to set the landing gear position by adjusting the length of the rod end. The rod end bearing's two nuts (lock nut and jam nut) are utilised when attaching a rod end onto a piston rod. However, when the nose landing gear cannot be properly adjusted, it is allowable to use one nut (removing the jam nut), but the maximum length of the exposed threads should be 0.28 inches (approximately seven millimetres). According to the evidence on the failed component, the exposed length was close to the maximum allowable exposure length, based on the number of threads of the exposed part, which was within limits.

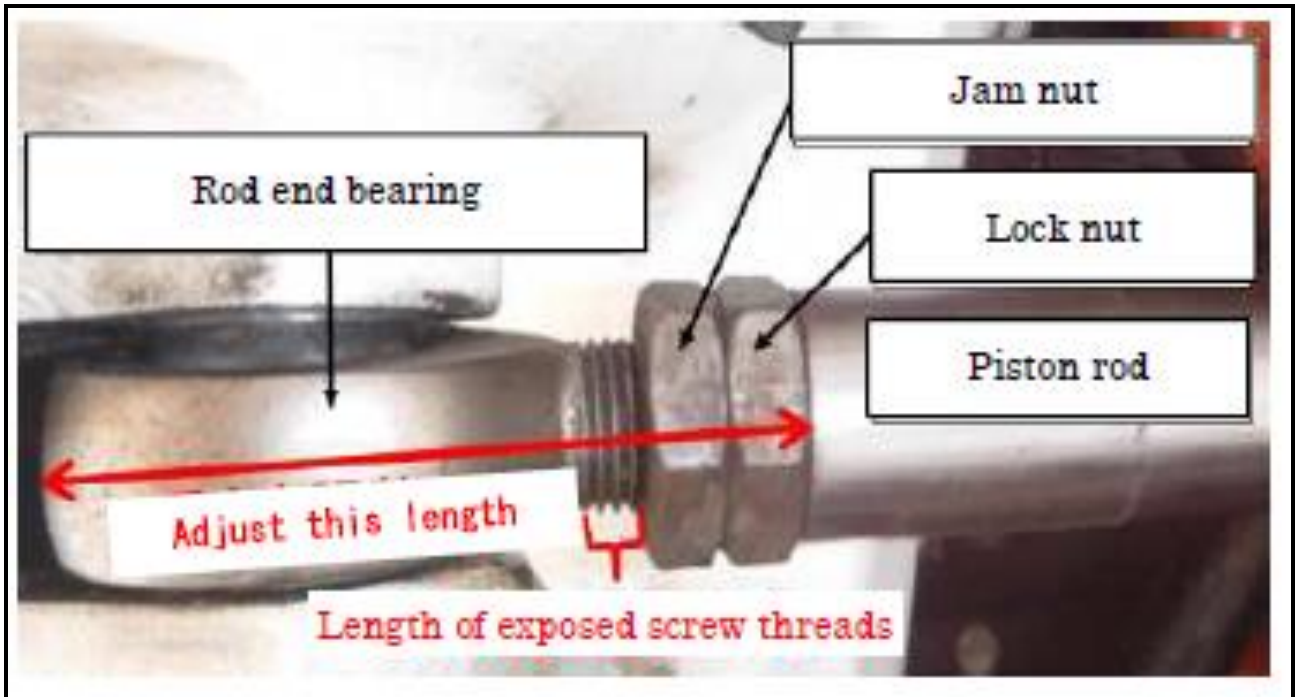
maintenance records, all necessary maintenance required was carried out accordingly. (A similar occurrence with reference AI2018-4 was investigated by Japan Transport Safety Board on a different aircraft type PA46-310P which had the similar nose landing gear configuration. See Figures 2 and 3).

**Figure 2:** The rod end bearing with jam nut and lock nut attached to a piston rod. (Source: AI2018-4 report)

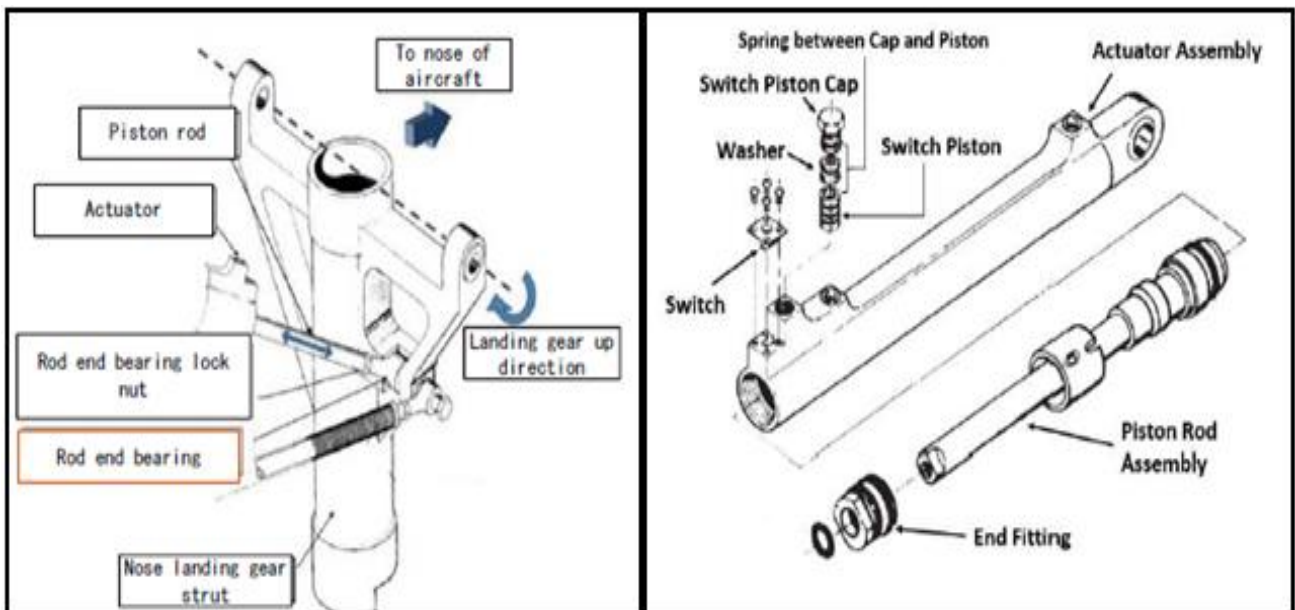
**Figure 3:** The schematic of the actuator type and its assembly. (Source: AI2018-4 report)
