LIMITED ACCIDENT INVESTIGATION REPORT
--

Reference Number		CA18/2/3/10088					
Classification	Accident	Date	7 December 2021	Time	1615Z		
Type of Operation	Private (Part 91)						
Location							
Place of Departure	Kimberly Aerodrome FAKM, Northern Cape Province		Place of Intended Landing		Waterval Safari Private Airstrip, Northern Cape Province		
Place of Accident	Waterval Safari Private Airstrip, South of Kimberly, Northern Cape Province						
GPS Co-ordinates	Longitude	S 29°07'59.02"	Latitude	E 024°32'44.01"	Elevation	3743 ft	
Aircraft Information							
Registration	ZS-LUB						
Model/Make	Cessna T210M (Serial Number: 210-61936)						
Damage to Aircraft	Substantial		Total Aircraft Hours		2906.5		
Pilot-in-command							
Licence Type	Private Pilot Licence (Aeroplane)		Gender	Male	Age	57	
Licence Valid	Yes						
Total Hours on Type	11		Total Flying Hours		618.4		
People On-board	1 + 3	Injuries	1	Fatalities	0	Other (on Ground)	0
What Happened

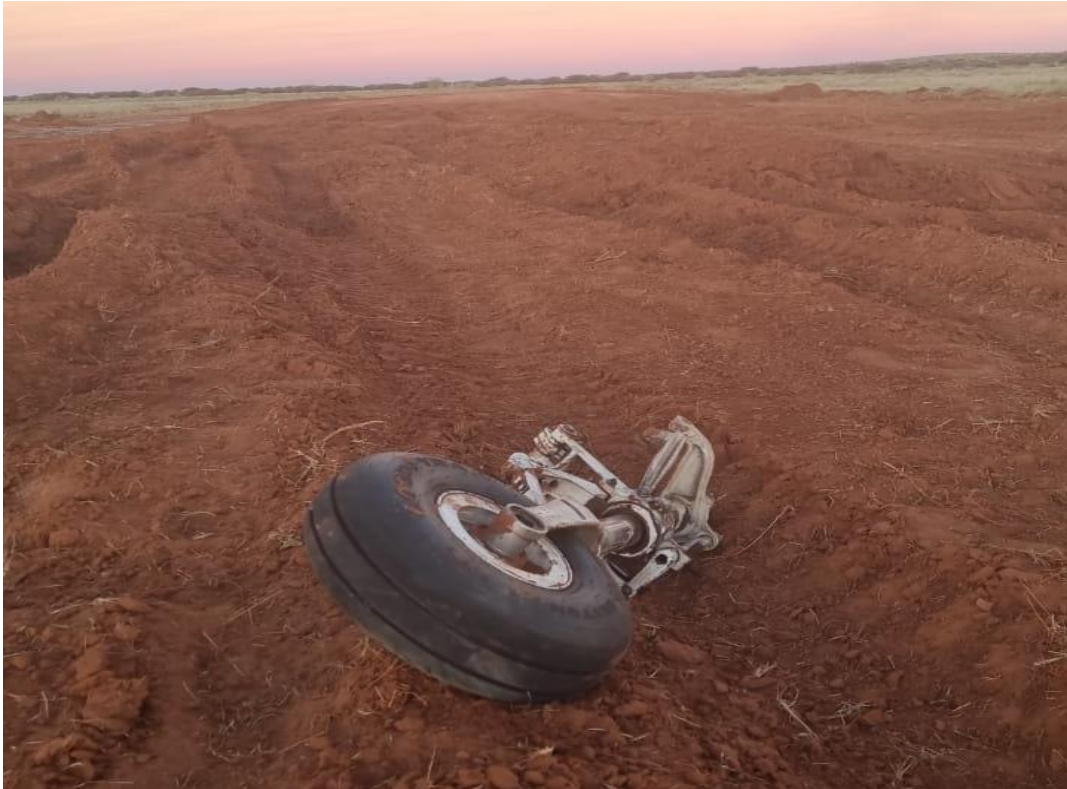
Figure 1: Heap of sand on RWY28 and the detached nose gear assembly. (Source: EMS)

- The pilot confirmed that there were no mechanical anomalies or weather conditions that contributed to the accident.
- The 1.2km long gravel runway was recently prepared, and a 50m heap of sand was placed on the left-side of the threshold of RWY28.

The aircraft touched down before the runway threshold and the speed was abruptly reduced by hard uneven soil during landing, resulting in the aircraft being jerked forward, breaking its nose gear assembly before coming to rest in an inverted position.

Pilots to ensure that they conduct thorough runway inspections prior to landing at unfamiliar aerodromes.

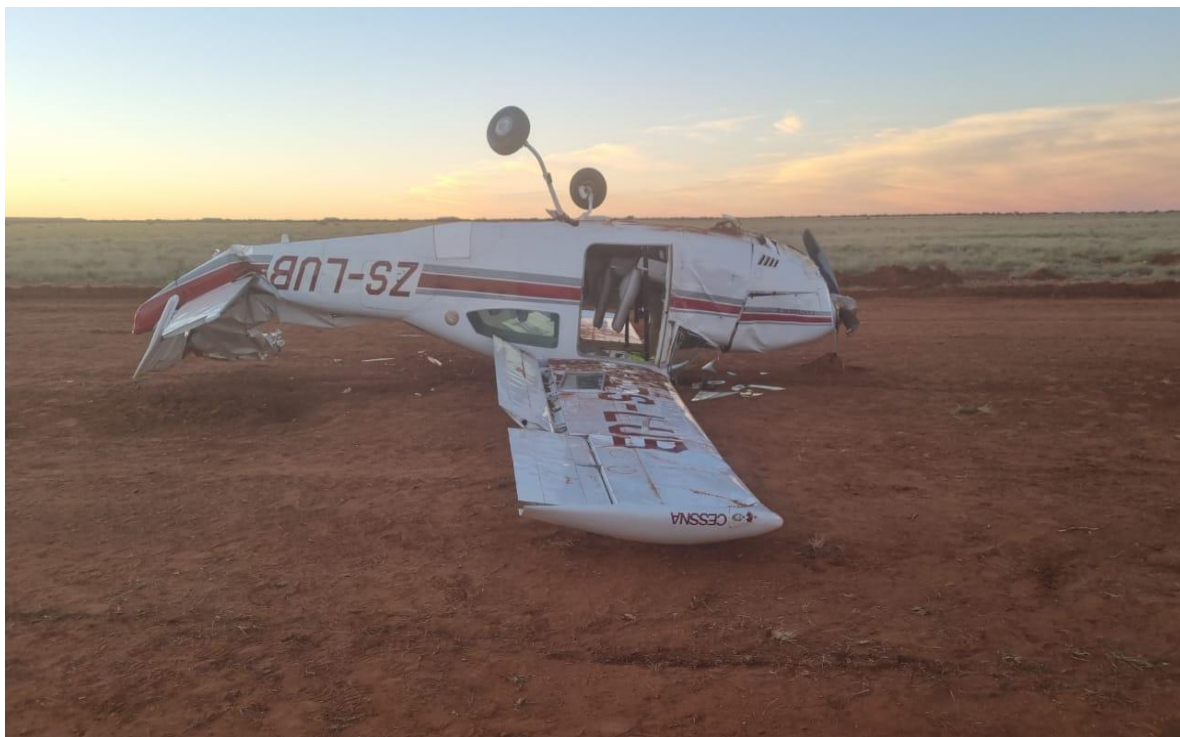
Figure 2: The aircraft as it came to rest on the runway. (Source: EMS)

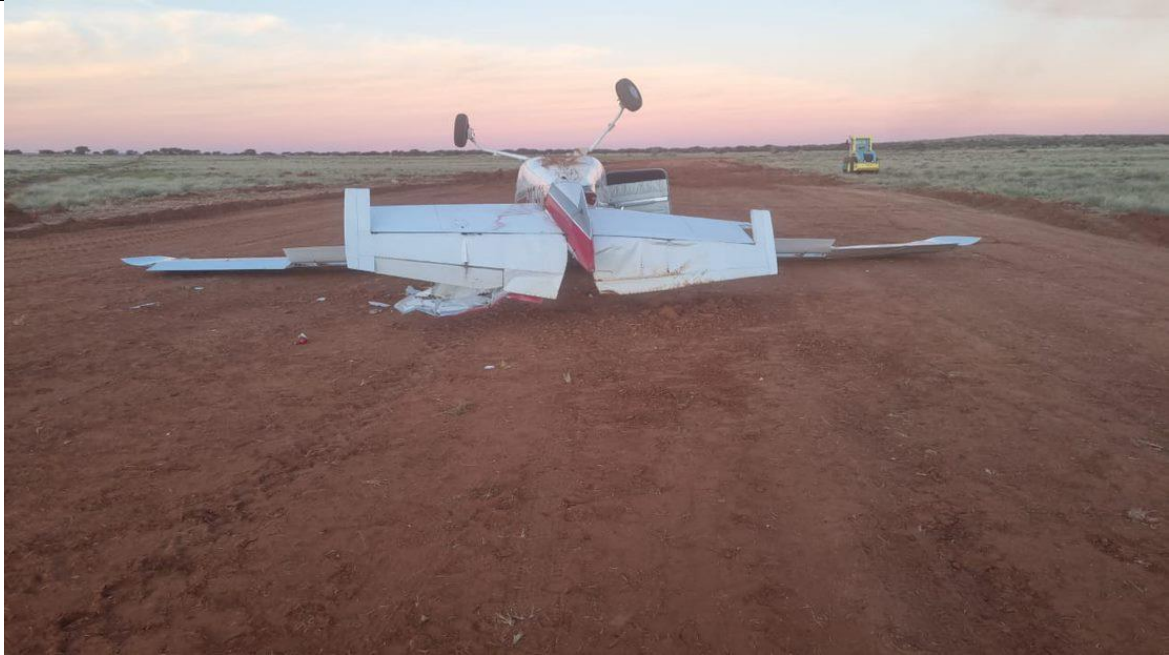
Figure 3: The aircraft in an inverted position on the runway. (Source: EMS)
