LIMITED ACCIDENT INVESTIGATION REPORT
--

Reference Number	CA18/2/3/10089						
Classification	Accident	Date	8 December 2021	Time	0720Z		
Type of Operation	Private (Part 94)						
Location							
Place of Departure	Broodkraal Farm Private Airstrip, Piketberg, Western Cape			Place of Intended Landing	Broodkraal Farm Private Airstrip, Piketberg, Western Cape		
Place Accident	Piketberg, Western Cape						
GPS Co-ordinates	Latitude	S32° 57'47.5"	Longitude	E18°39'55.3"	Elevation	4547'	
Aircraft Information							
Registration	ZU-DUY						
Model/Make	RAF 2000 GTX/Rotary Air force SA (Serial Number: M2-04-15-628)						
Damage to Aircraft	Destroyed	Total Aircraft Hours			756.3		
Pilot-in-command							
Licence Type	NPL	Gender	Male	Age	59		
Licence Valid	Yes						
Total Hours on Type	1222.6			Total Flying Hours	2112.5		
People On-board	1+0	Injuries	1	Fatalities	0	Other (on Ground)	0
What Happened							
<p>On Wednesday, 8 December 2021, the pilot on-board a RAF 2000 GTX Gyrocopter with registration ZU-DUY was conducting a proficiency flight for crop-spraying as recommended by his company's operational manual (OM). The pilot intended to take-off from Broodkraal farm private airstrip in Piket

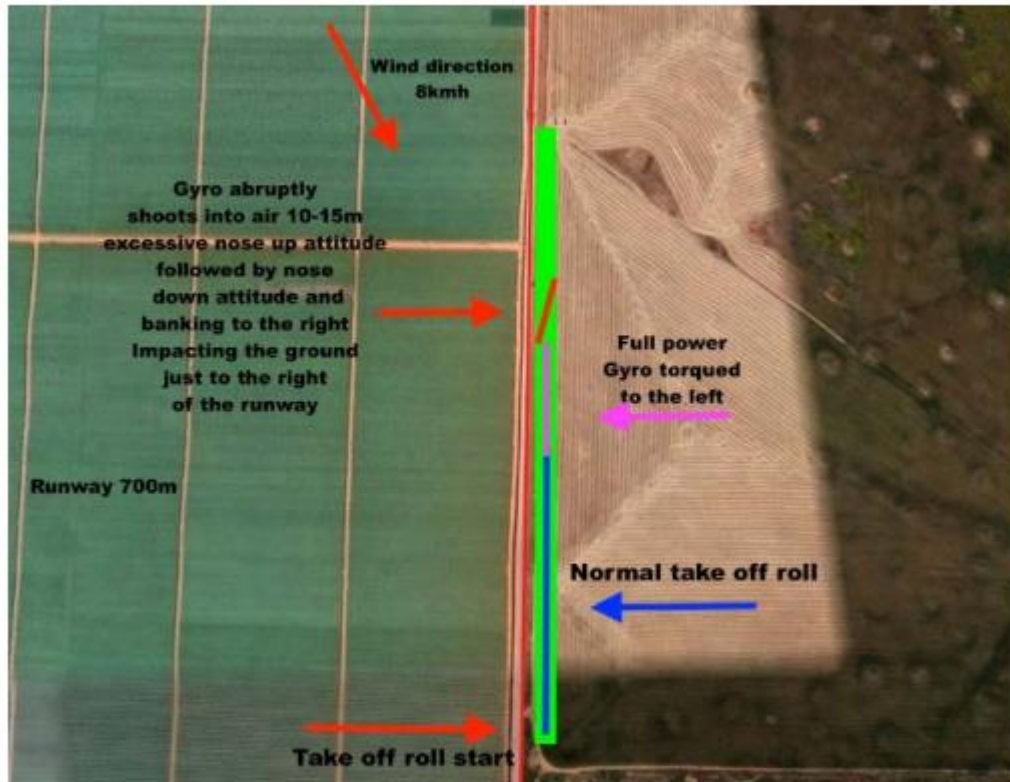
Illustration 1: The take-off run and accident illustration. (Source: Assessor)

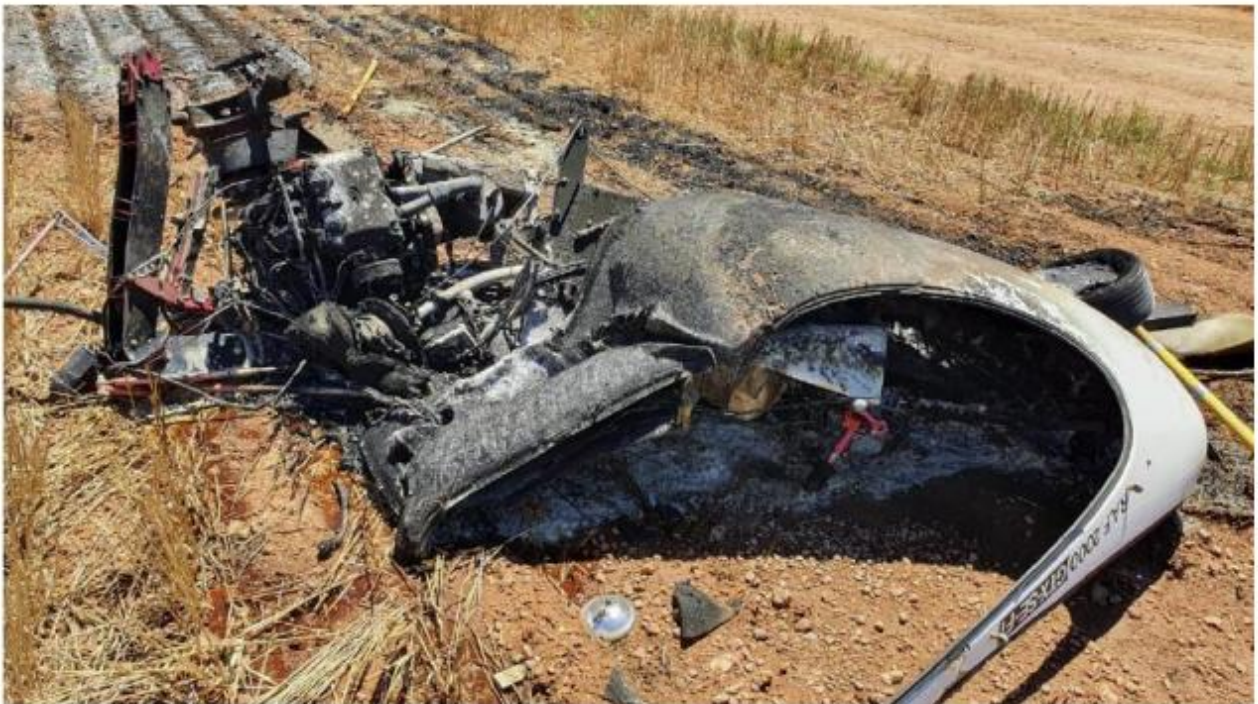
After impact, there was black smoke followed by fire. The assessor rushed to pull out the pilot from the burning wreckage. The pilot suffered multiple injuries and was airlifted to hospital. The assessor also suffered burn wounds on both hands; the gyrocopter was destroyed during the accident sequence.

Figure 2: Burnt wreckage of ZU-DUY.
