HELICOPTER ACCIDENT REPORT AND EXECUTIVE SUMMARY

Reference:		CA18/2/3/10090	
Helicopter Registration	ZS-HXG	Date of Accident	11 December 2021		Time of Accident	0420Z	
Type of Helicopter	Bell 206L-3		Type of Operation		Private (Part 91)		
Pilot-in-command Licence Type	Private Pilot Licence (Helicopter)		Age	56	Licence Valid	Yes	
Pilot-in-command Flying Experience	Total Flying Hours		314.0		Hours on Type	282.1	
Last Point of Departure	Ultimate Heliport, Midrand, Gauteng Province						
Next Point of Intended Landing	New Tempe Aerodrome, Free State Province						
Damage to Helicopter	Substantial						
Location of the accident site with reference to easily defined geographical points (GPS readings if possible)							
Short of final approach and take-off (FATO) area at Ultimate Heliport, Midrand, at Global Positioning System (GPS) determined to be S 26° 1'42.98", E 028° 6'38.82" at a field elevation of 4828ft AMSL							
Meteorological Information	Surface wind: 017°/ variable; temperature: 17°C; visibility: 9999m

DESCRIPTION OF THE ACCIDENT

Reference Number : CA18/2/3/10090
Name of Owner/Operator : Long Trail Investment 109 CC
Manufacturer : Bell Helicopter
Model : B206L-3
Nationality

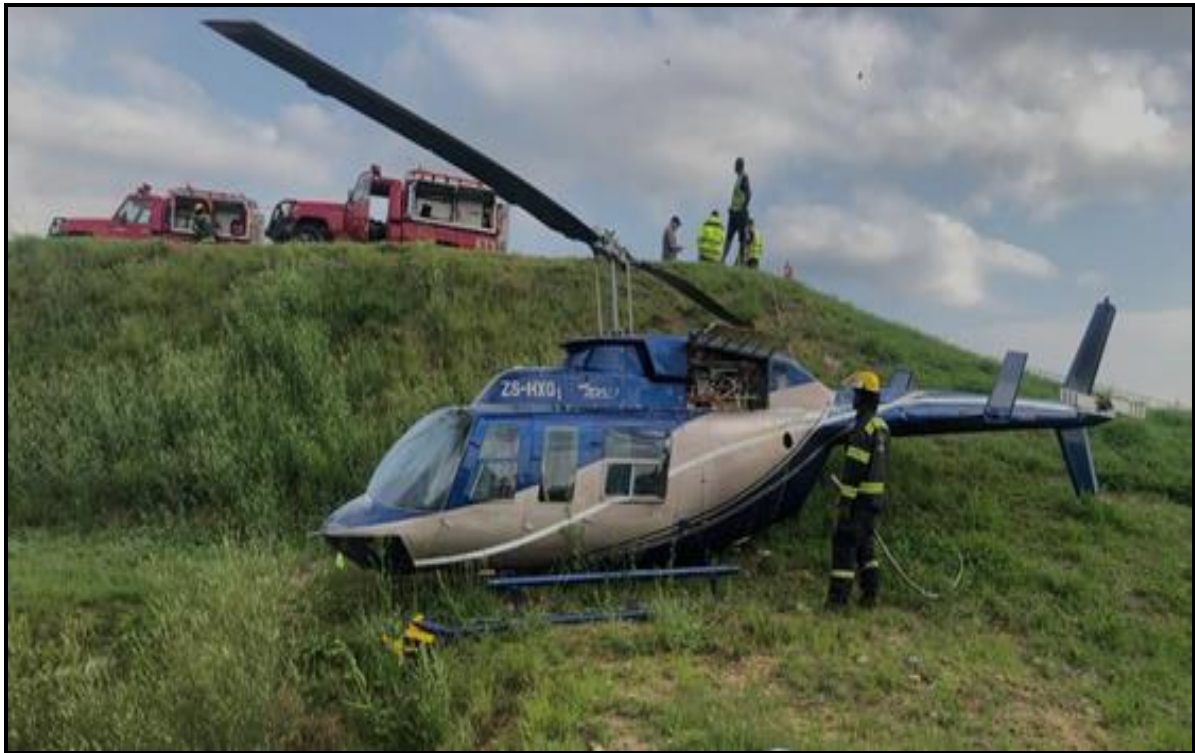
1.3.1 The helicopter was substantially damaged during the accident sequence.

Figure 2: The helicopter at the accident site.

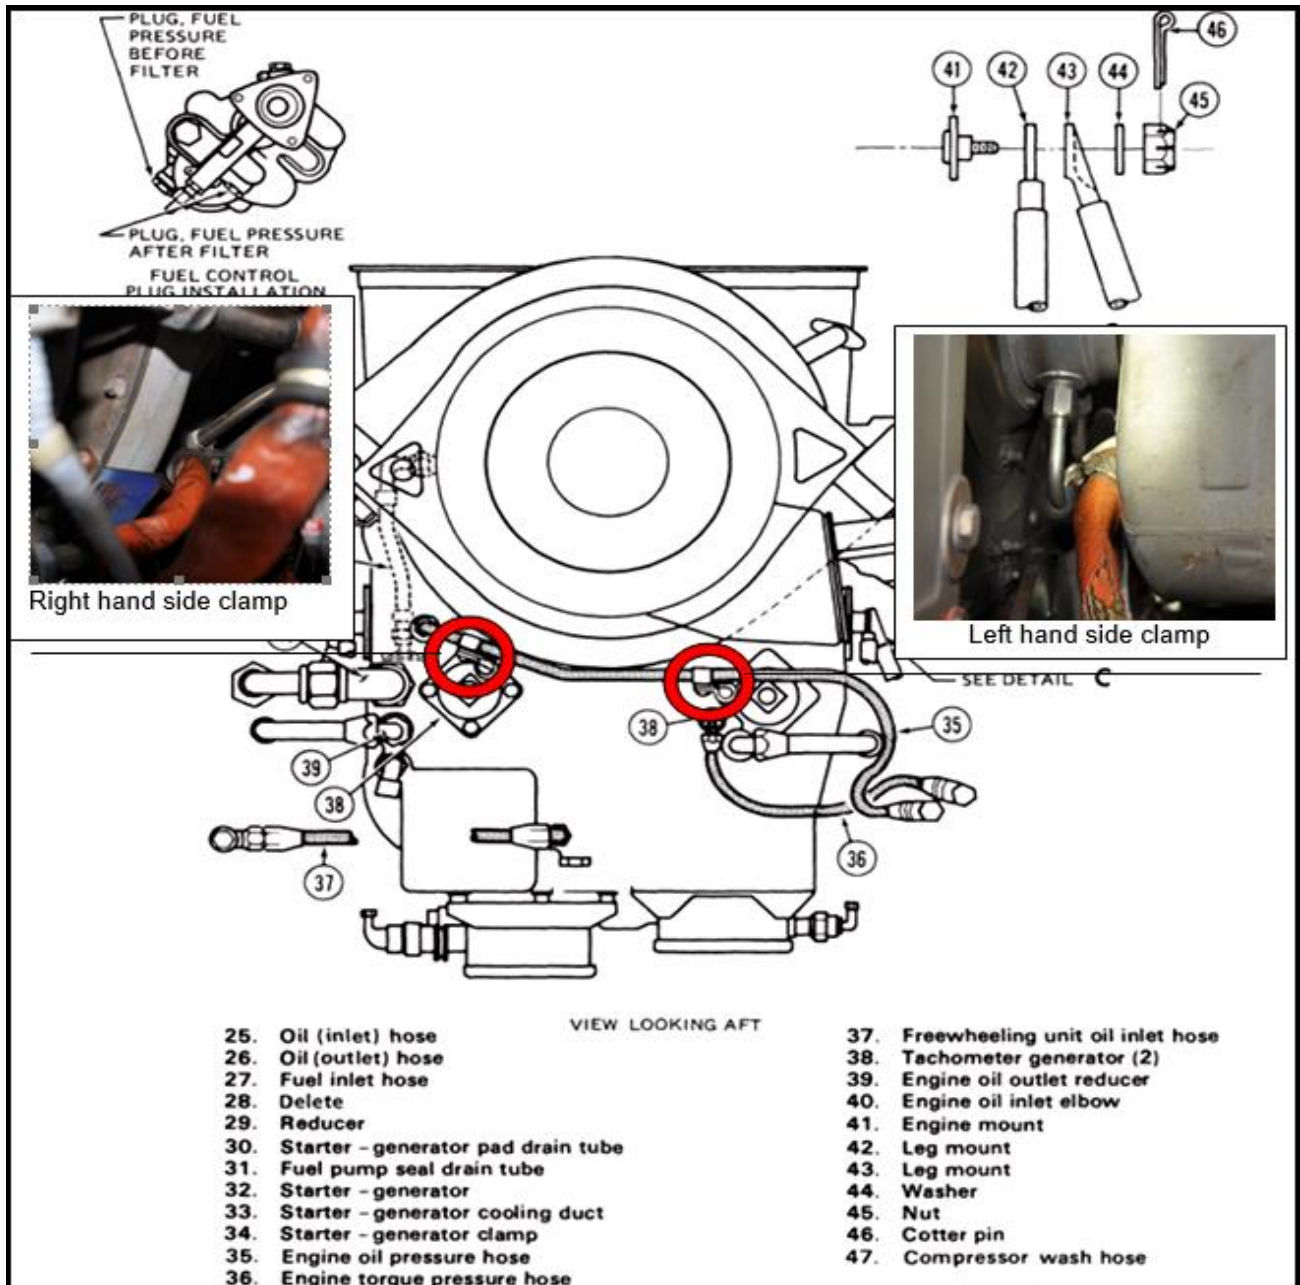
Illustration 2 : The illustrated parts of the oil hose routine and the two missing security clamps circled in red; and the engine oil pressure hose/pipeline (35) that was damaged (in this report).

brake disc attachment bolt and was chafed (see Figure 8). The hose was missing two securing P-clamps as indicated in Figure 4. The two P-clamps which were missing are indicated in the two red circles. The P-clamps are mounted Tachometer generators indicated by number (38) which are secured with a bolt on each. According to document BHT-206L-SERIES-IPB of the IPC breakdown, the engine oil pressure hose with Part Number 70-009E000D236 was replaced with oil pressure hose Part Number 70-009E000D236A. According to the maintenance personnel, the hoses are interchangeable as there was no significant change (difference) on the product specifications.

The AMO should adhere to the aircraft's maintenance procedures as per the manufacturer prescribed manual. It is also recommended that the AMO embarks on an annual maintenance training which would help to enhance safe maintenance practises. This accident could have been prevented if the correct engine assembly installation procedures were followed.

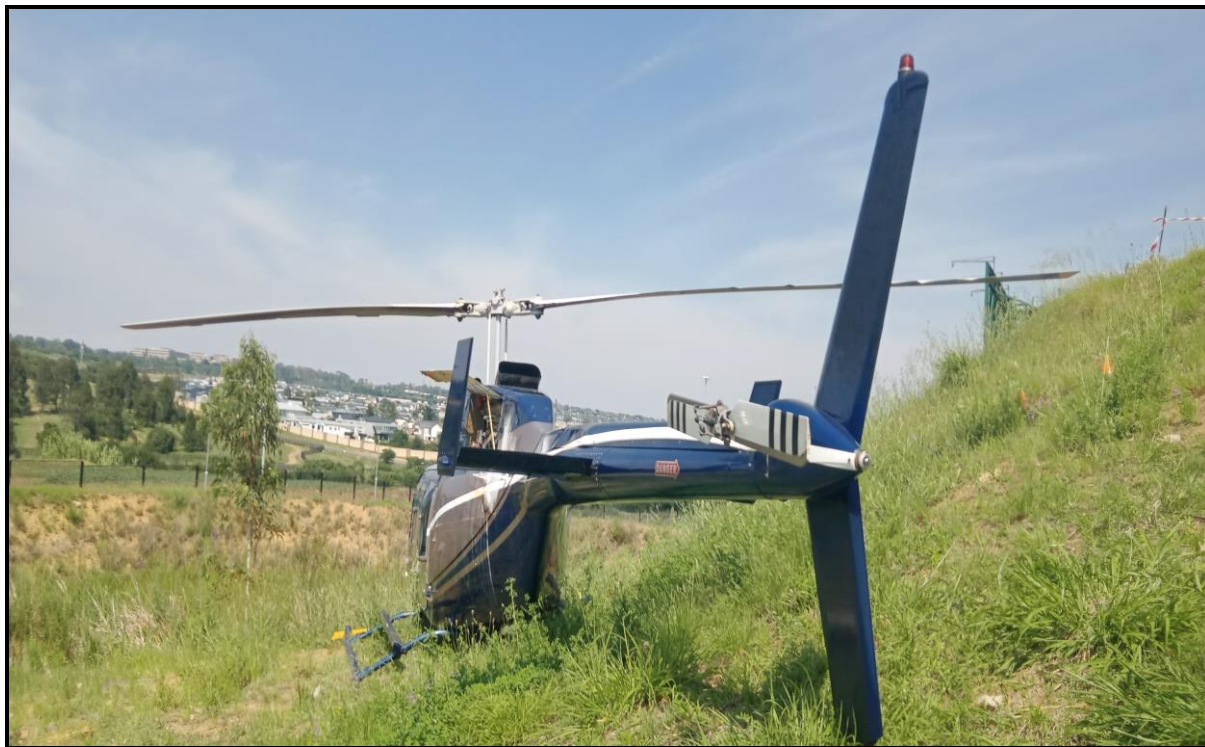
Figure 3: The helicopter as it came to rest.

1.12.1 The accident occurred on the grass next to the embankment just short of Ultimate Heliport helipad.

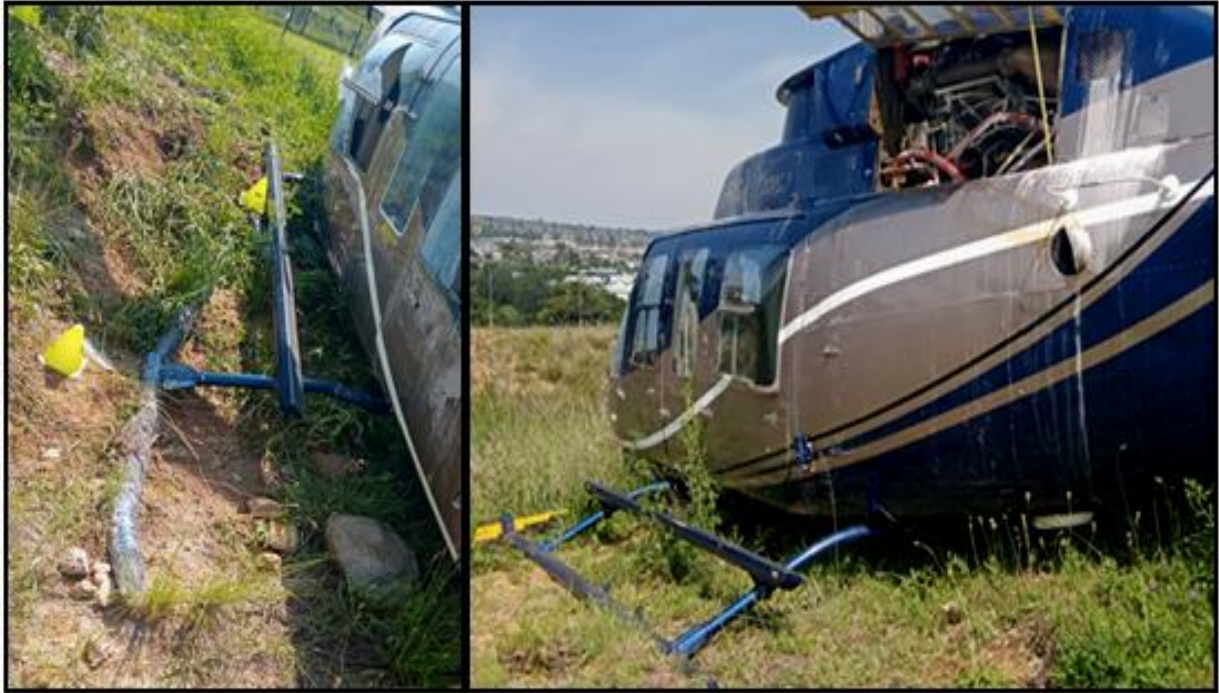
- The helicopter was found resting on its left skid gear facing west and part of the belly (fuselage) was near the elevated terrain due to the fractured right-side skid gear. The left-side skid gear was stretched sideways and was deformed from its original design.

Figure 4: The right- and left-side skid gear damages sustained during the accident

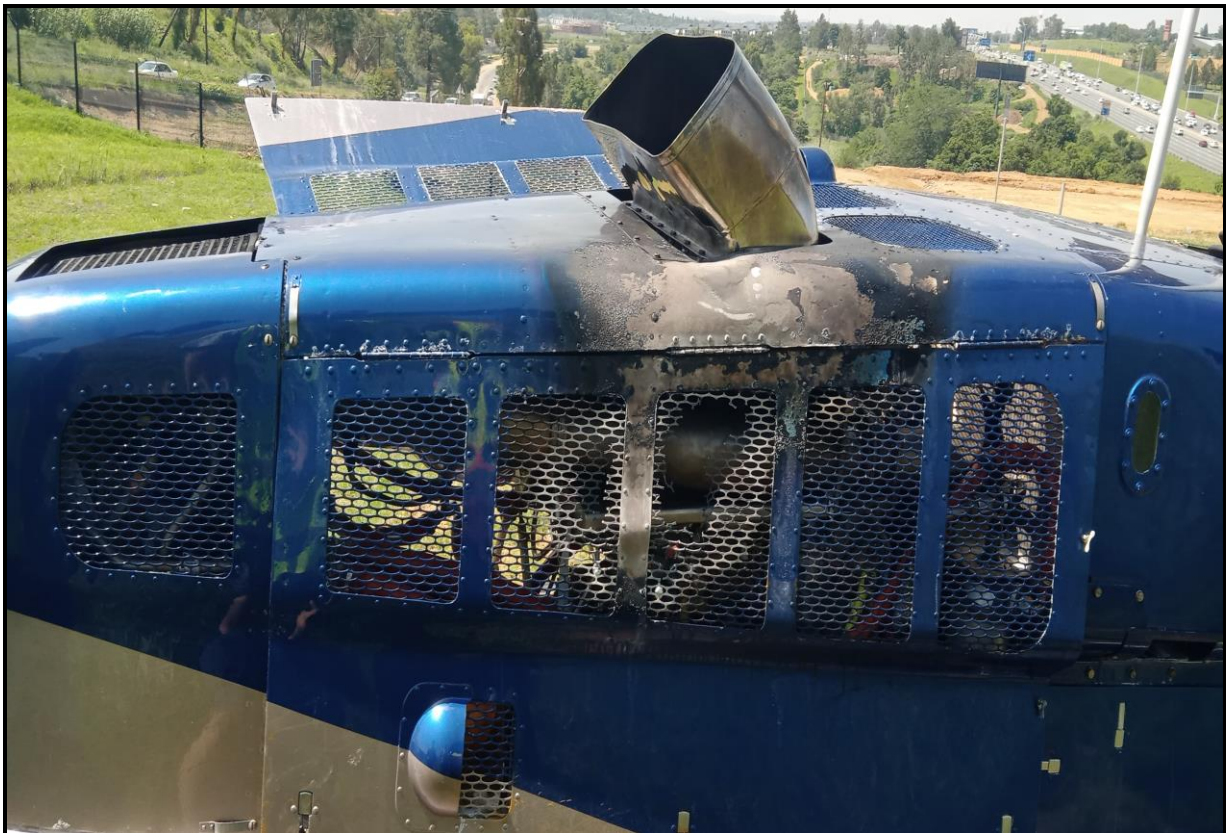
- The engine compartment's right-side door had traces of fire damage. The smoke soot was visible on the upper section of the main rotor blades' root at similar position on each blade near the engine compartment. The helicopter's windshield and the right-side cabin door window were also damaged due to hard landing.

Figure 5: Heat damage on the right-side engine cowling.

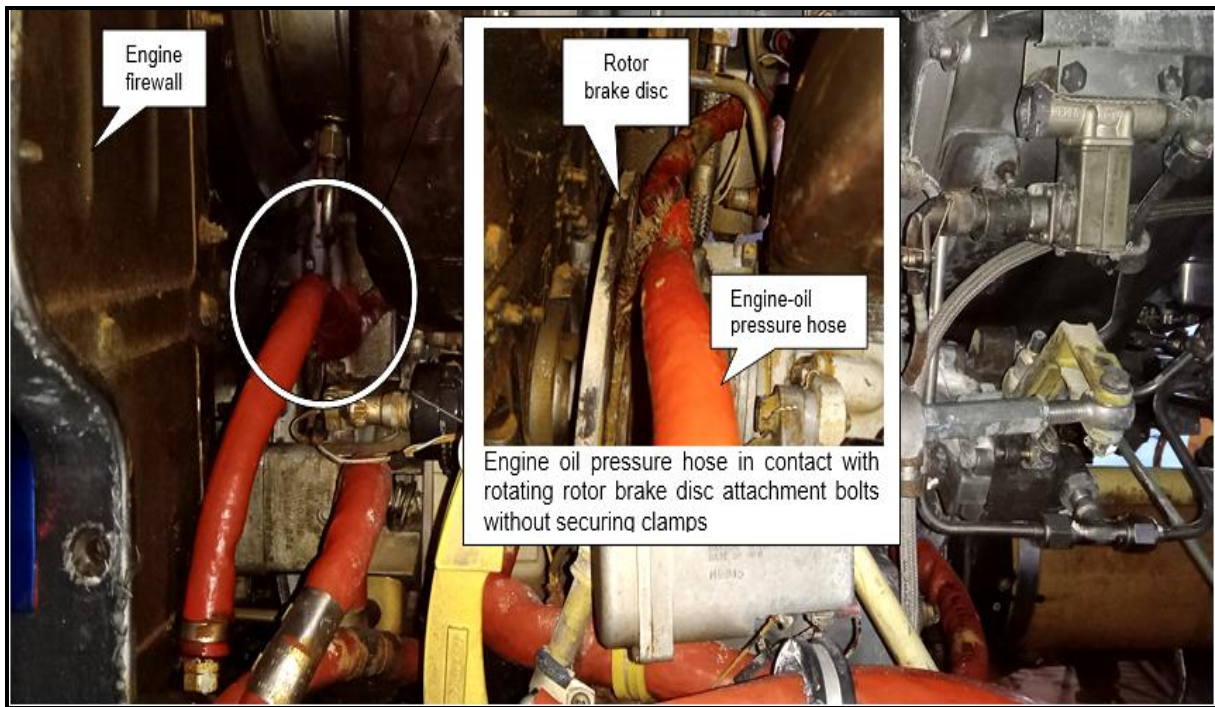
1.6.8 Post-accident investigation revealed that the engine oil pressure hose/flexible pipeline with Part Number 70-009E000D236 indicated as numbered (35) was damaged during operation (see Figure 4). The engine oil pressure hose was found leaning against the rotating rotor-

- There were signs of oil spillage inside the engine compartment. This was consistent with oil loss/leak at high pressure during engine operation.

Figure 6: The engine oil pressure hose/pipeline chafing against the rotating rotor brake disc attachment bolt.

2.2.4 Post-accident investigation revealed that the engine oil pressure supply pipeline was damaged due to chafing against the rotating rotor brake disc during operation. As a result, the pipeline damages subsequently caused significant loss of oil, and the lubrication system to be starved of oil supply. The pipeline was not secured with the required two P-clamps as per the manufacturer's maintenance manual. This damage occurred over a period during operation.

- 3.2.7 The engine oil pressure hose was chafing against the rotor brake disc during operation, resulting in an engine oil leak.
- 3.2.8 The engine oil pressure hose was not secured properly with two P-clamps as prescribed in the maintenance manual following a compressor removal for maintenance and installation on 28 April 2021.

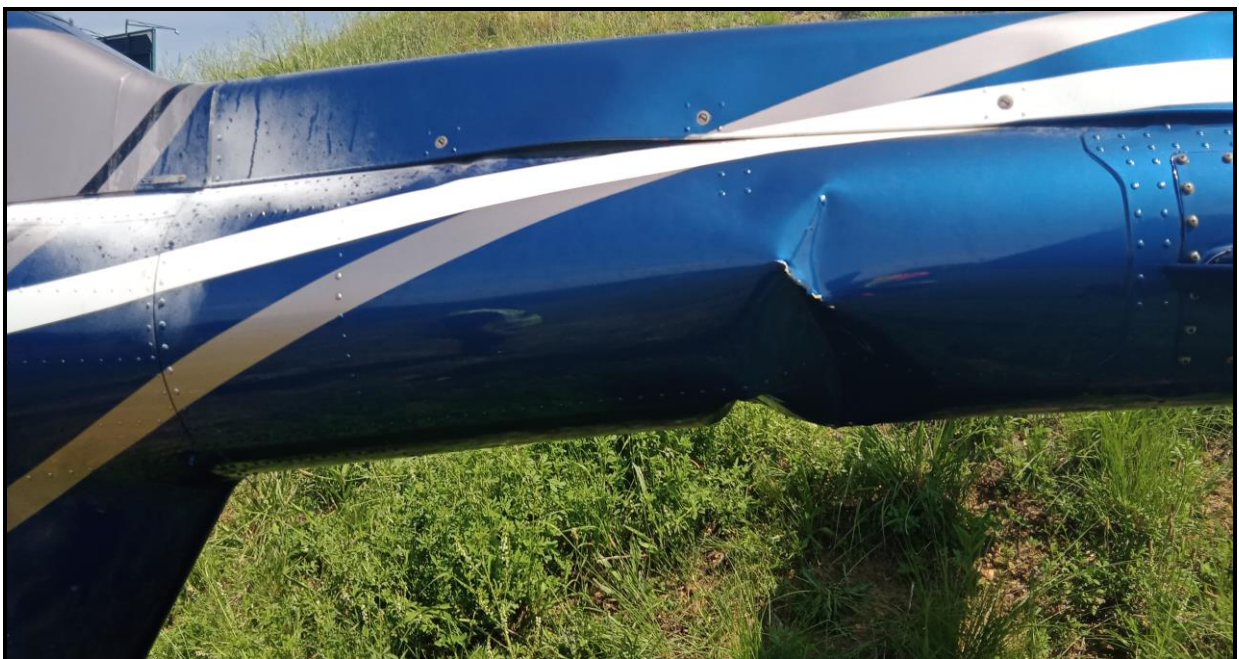
Figure 7: The damaged tailboom.

- The tailboom section near the fuselage attachment point was bent due to hard landing.

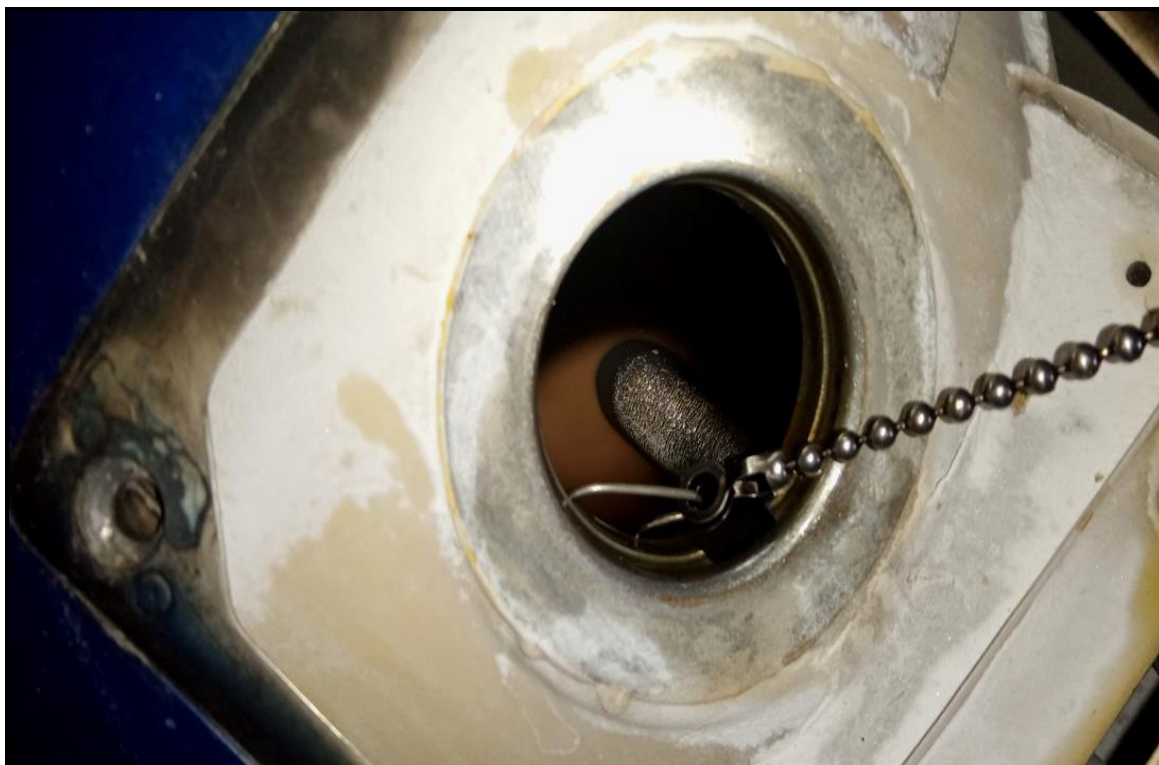
Figure 8: Some oil at the bottom of the engine oil reservoir.

- The oil reservoir had a small amount of oil post-accident.

- 3.2.14 The engine oil reservoir contained a small amount of oil following the accident.
- 3.2.15 The eyewitness observed white smoke during start-up and take-off, which was associated with oil coming into contact with a hot surface.

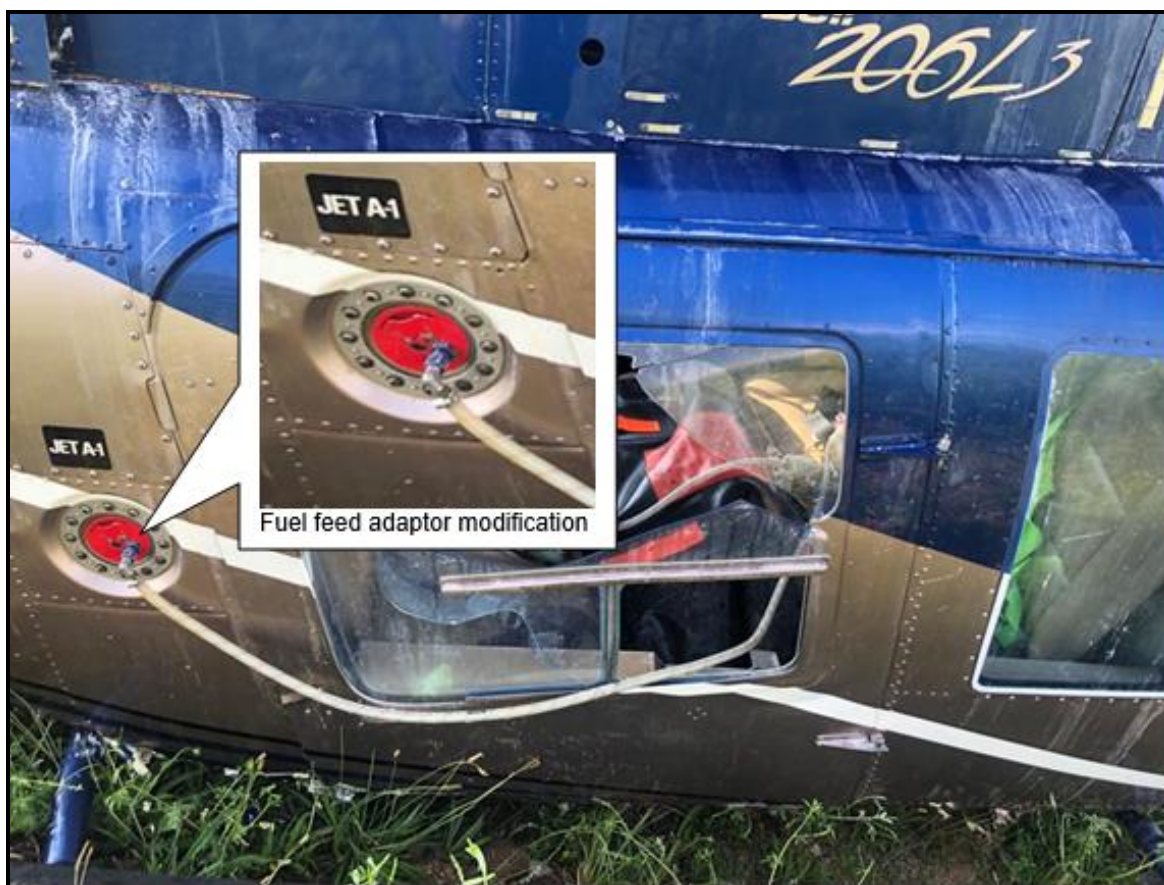
Figure 9: The fuel feeder line connected to the right-side fuel tank cap with a connecting adaptor.

- A bladder type fuel tank was connected to the right-side main fuel tank to feed fuel during the flight. The fuel transfer motor was connected to the helicopter's electrical supply point.

4.2.2 The operator used a bladder type fuel tank that was carried on-board the helicopter, which was dangerous goods, without the approval by the manufacturer and proper modification approvals by the Regulator. Therefore, AIID recommends that operators utilise manufacturer-approved and compatible components in accordance with the approved procedures for modifications as well as the Civil Aviation Regulations (CAR) requirements.

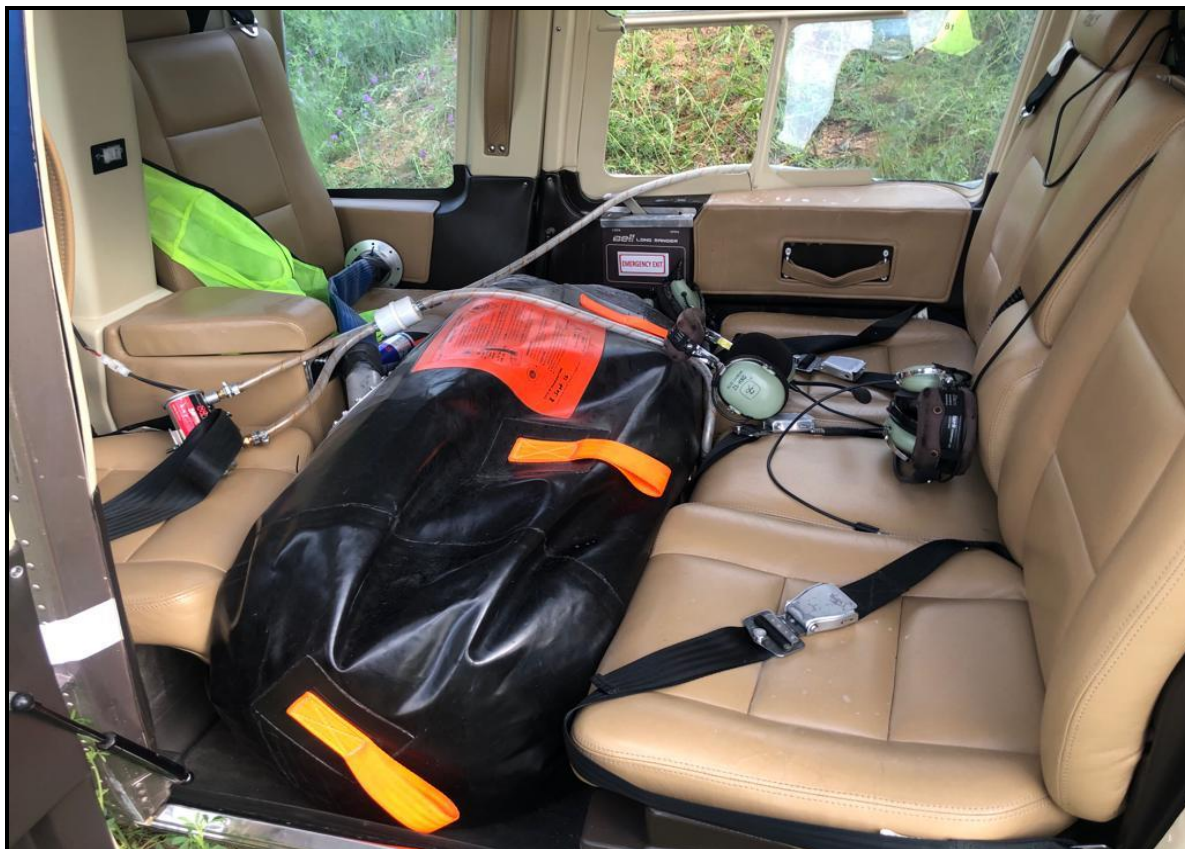
According to the pilot, he bought the aviation-approved (Turtle Pac) bladder type fuel tank and had been using it without attaining approval from the Regulator for fuel cap adaptor modification or enquiring from the helicopter manufacturer for compatibility. The pilot stated that he had used the fuel tank several times after purchase as he believed it did not require any modification for fuel transfer and installation on the helicopter. The investigation revealed that there was an adaptor modification on the right-side fuel tank cap for fuel feed. There was no modification approval (STC) or Service Bulletin (SB) approval attained from either the Regulator or the manufacturer. Also, the helicopter manufacturer stated that they do not have any approval or any modification for the ferry fuel tank on the helicopter type.

Figure 10: The bladder type fuel tank in the helicopter cabin.

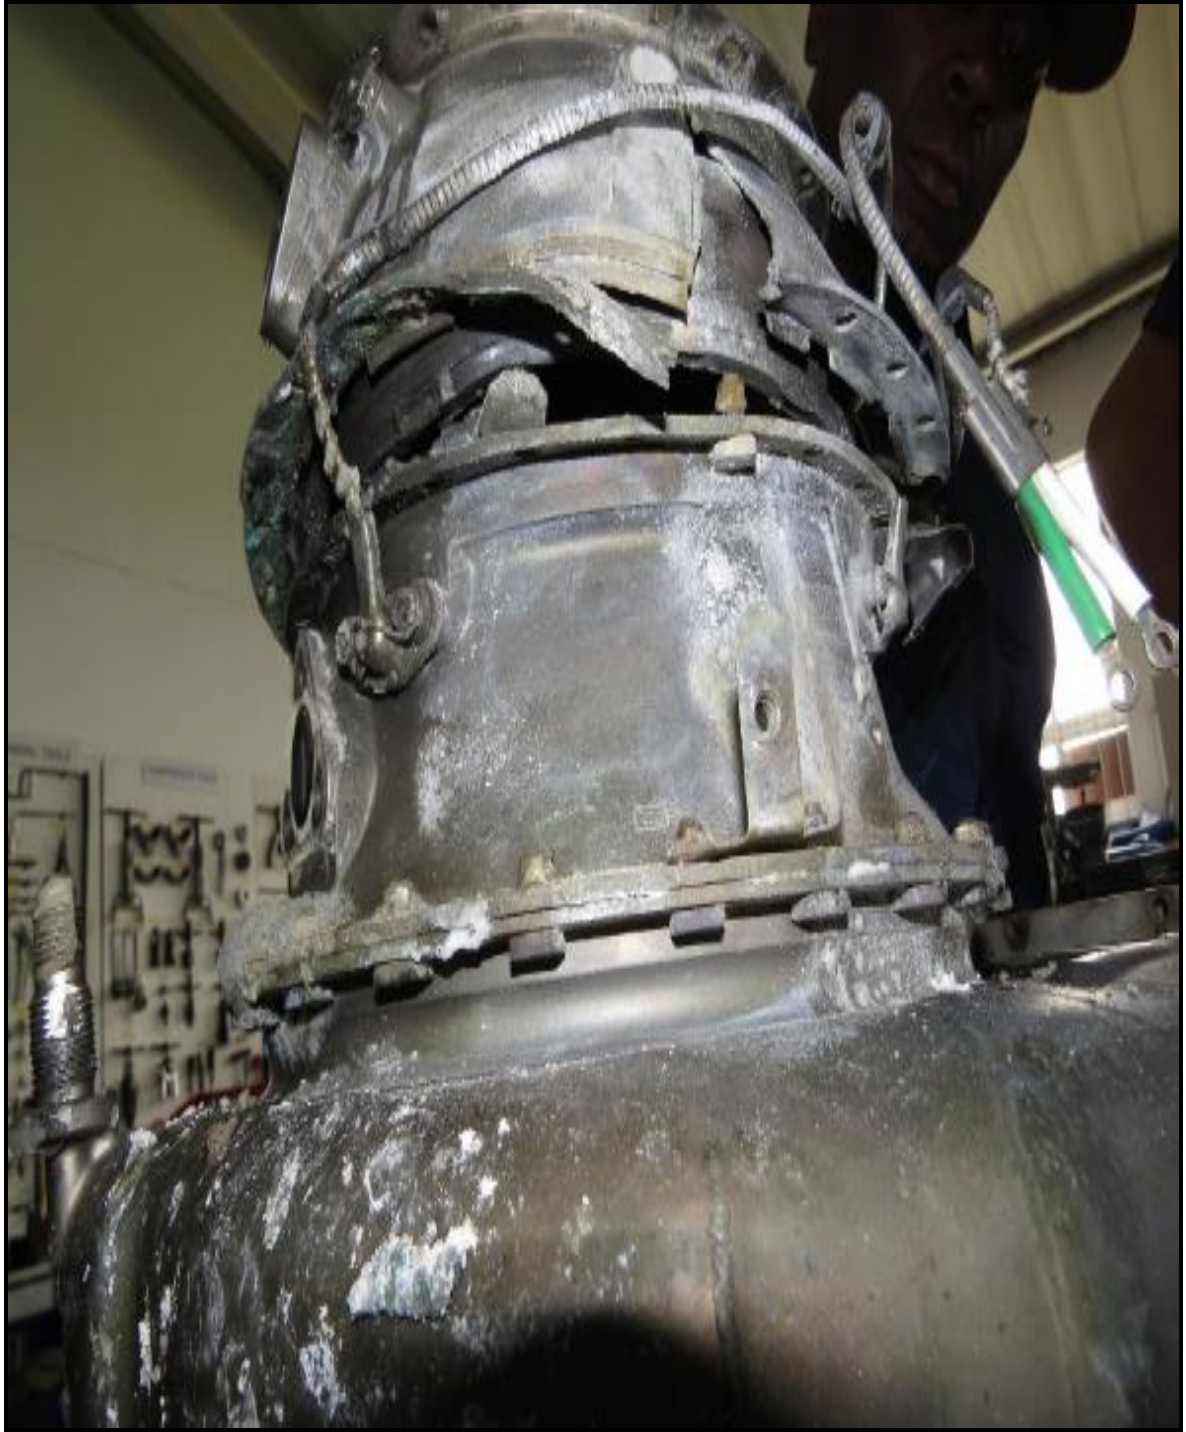
Figure 11: Turbine section damages.

- *Bulging of the turbine case and energy absorption ring was consistent with a contained burst of one or both N1 (1st/2nd stage) turbine wheel/s.*
- *The upper and lower magnetic chip detectors (MCD) were removed and examined. The lower chip detector was free of contaminants, whilst the upper detector was found to be heavily contaminated with ferrous material.*
- *The gas generator turbine (N1) was separated from the power turbine (N2) and revealed that the 1st stage turbine wheel had high fragment with subsequent impact to remaining turbine components.*

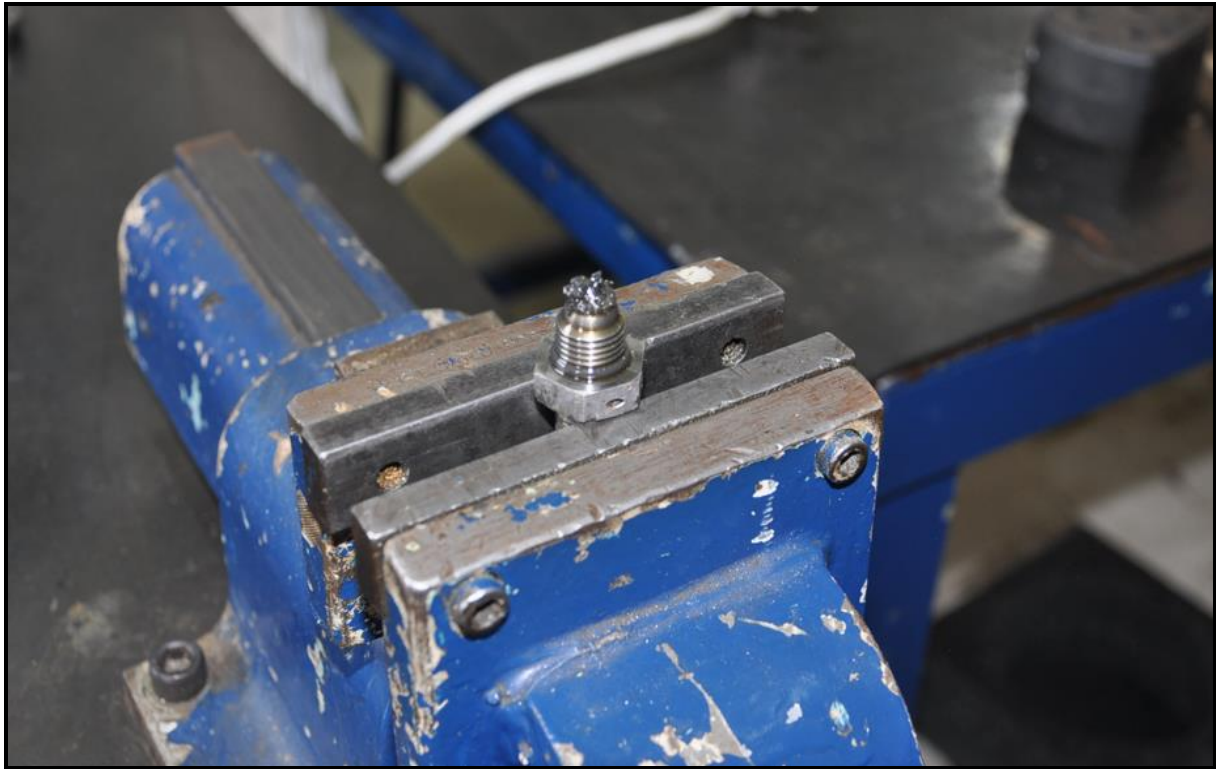
Figure 12: Upper magnetic chip detector.

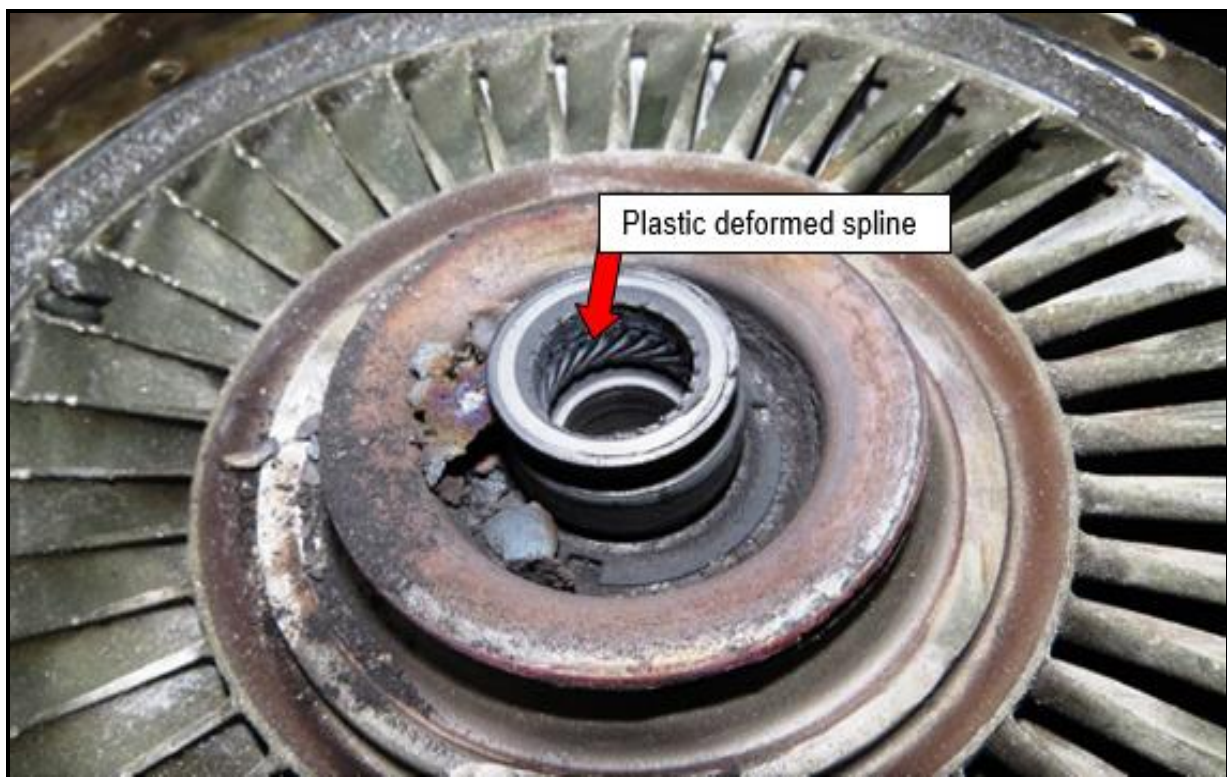
- *Plastic deformation of the splined coupling suggested extreme high temperature was reached in the turbine, softening the metal to the point where the gas generator turbine decoupled from the compressor.*

Figure 13: Shows the plastic deformation of the splined coupling due to overheating the turbine section
(Source: Manufacture Report)

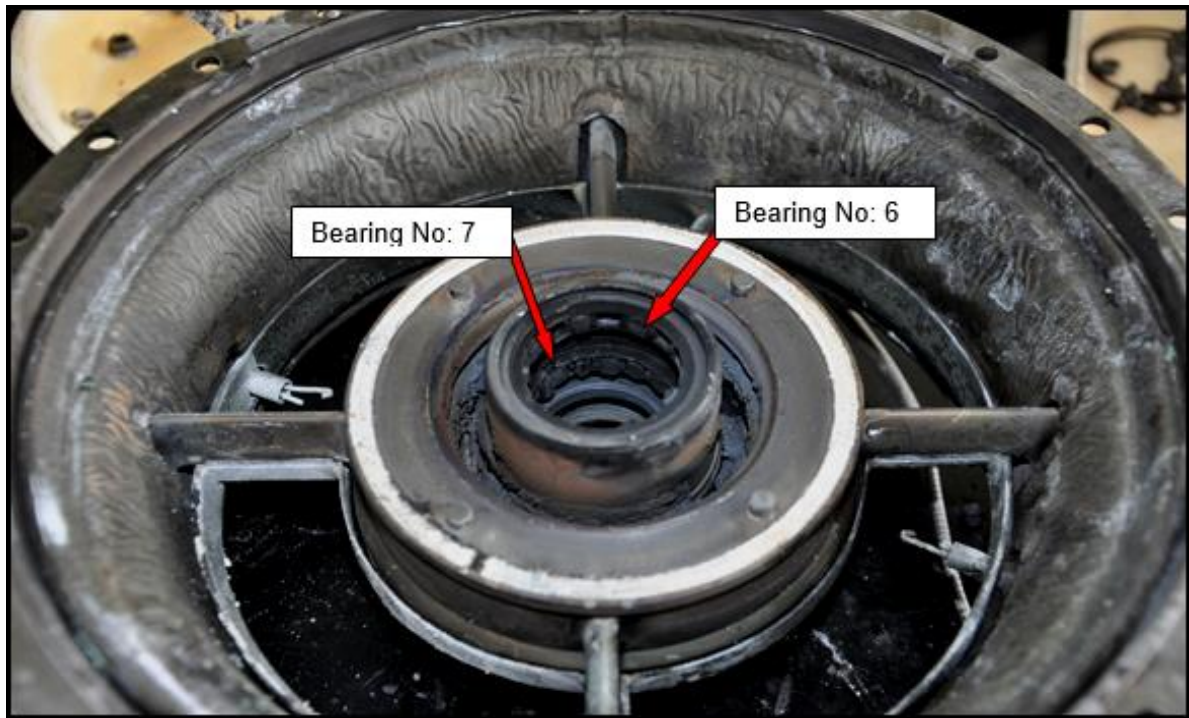
- *All the turbine bearings were found dry and blackened, the Number 6 and 7 bearings were found to have been mostly vaporized within their bearing chamber.*

Figure 14: The damaged number 6 & 7 bearings. (Source: manufacture's report)

- 2.2.6 The engine teardown and assessment inspection revealed that the Number 6 and 7 bearing failure was due to overheating associated with lack of proper/sufficient lubrication because of oil starvation. The bearing failure resulted because of the high-speed turn of the turbine wheel which subsequently failed. The engine lost power as a result of turbine wheel failure. The turbine wheel burst was inevitable due to the internal clash of rotating components following the thermal destruction of the Number 6 and 7 bearings, as well as the decoupling of splined coupling adaptor from the compressor drive shaft due to thermal weakening and distortion (of the splined coupling).

- 3.2.12 The engine teardown inspection revealed that the Number 6 and 7 bearings failed due to overheating associated with insufficient lubrication because of oil starvation.
