<b>LIMITED ACCIDENT INVESTIGATION REPORT</b>
--

<b>Reference Number</b>		CA18/2/3/10092					
<b>Classification</b>	Accident	<b>Date</b>	12 November 2021		<b>Time</b>	1115Z	
<b>Type of Operation</b>		Private (Part 91)					
<b>Location</b>							
Place of Departure		Kiesmet, Theunissen Farm, Free State Province		Place of Intended Landing		Mooipan Farm, Free State Province.	
Place of Accident		Private Airstrip near Mooipan Farm, Free State Province					
GPS Co-ordinates		Latitude	28°17'07.5"S	Longitude	26°37'56.0"E	Elevation	1398 feet
<b>Aircraft Information</b>							
Registration		ZS-MDO					
Model/Make		Piper 25-235 (Serial Number: 25-7556025)					
Damage to Aircraft		Substantial		Total Aircraft Hours		4 146.3	
<b>Pilot-in-command</b>							
Licence Type		Commercial Pilot Licence (CPL)		Gender		Male Age: 38	
Licence Valid		Yes					
Total Hours on Type		577.70		Total Flying Hours		1571.70	
People On-board		1 + 0	Injuries	0	Fatalities	0	Other (on ground) 0

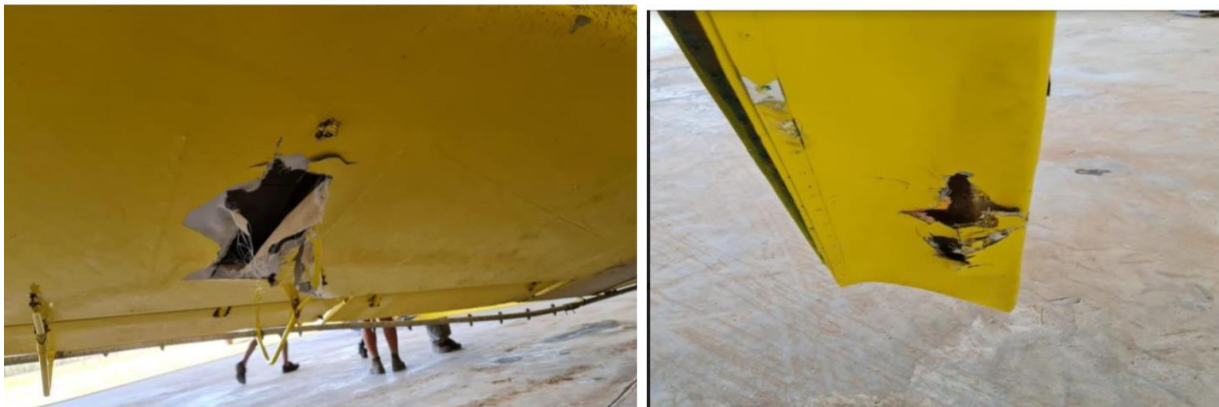
The fabric on the wing was damaged. The right wing went over the fence while the left wing dropped; and the fabric on the left-wing tip was also damaged.

The aircraft sustained damage to the left-side wing tip and the right-side wing fabric. The pilot was not injured during the accident.

**Figure 2 and 3:** Damage on the left wing (left picture); damage on the right wing (right picture). (Source: Operator)

The aircraft experienced a sudden gust of wind during a low taxi speed which pushed the aircraft to the left of the RWY, causing the pilot to lose control and the aircraft to impact the fence.

Following the accident, the AMO reported that the aircraft's wings were removed from the aircraft to be repaired. The wings were repaired and reinstalled to the aircraft.

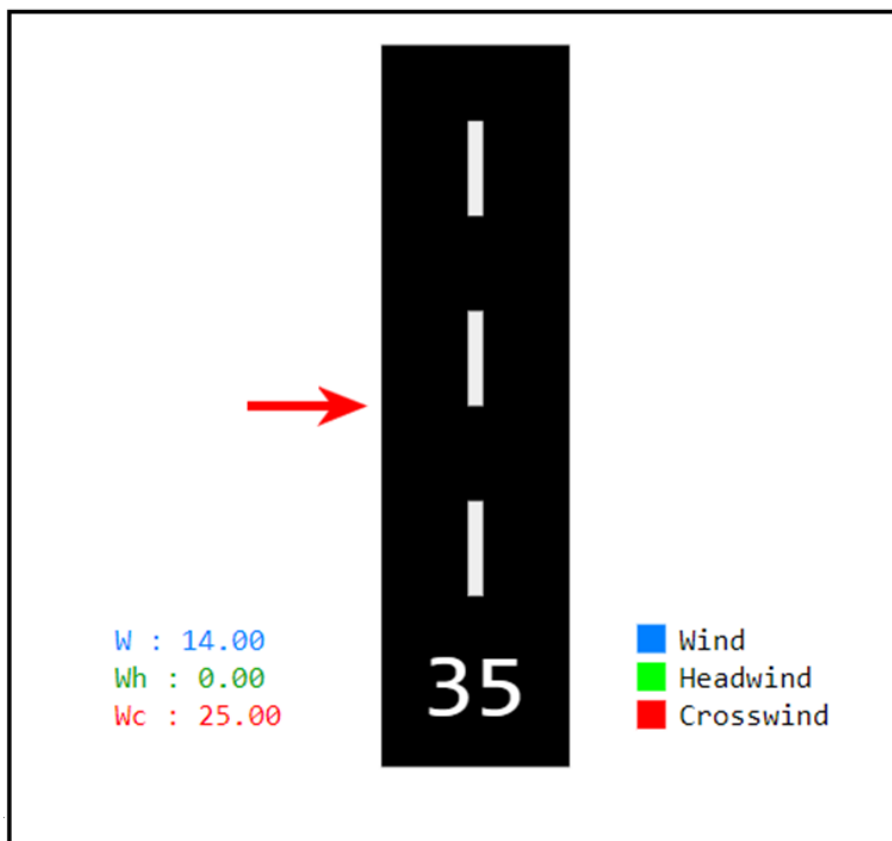
The aircraft's maximum crosswind component is 15 knots. (Source: Darling Downs Soaring Club, [DDSC] Pawnee 235 SWR Flying Notes, Page 4, Rev 1, 10 Nov 2003)

**Figure 4:** Crosswind component.

According to the South African Weather Service, the weather at Welkom Aerodrome (FAWM) on 12 November 2021 around 1100Z was as follows: Wind: 260° at 14kts gusting 24kts; Temperature: 32°C; Due point: -01°C and QNH: 1016hPa. The aircraft was exposed to a crosswind of 25kts (see Figure 4). FAWM is approximately 17 nautical miles (NM) south-west of the accident site.
