<b>LIMITED ACCIDENT INVESTIGATION REPORT</b>
--

<b>Reference Number</b>		CA18/2/3/10093					
<b>Classification</b>	Accident	<b>Date</b>	19 December 2021	<b>Time</b>	0939Z		
<b>Type of Operation</b>	Private (Part 94)						
<b>Location</b>							
Place of Departure	Plettenberg Bay Aerodrome (FAPG), Western Cape Province		Place of Intended Landing	FAPG), Western Cape Province			
Place of Occurrence	Erica PI Drive, Plettenberg Bay Residential Area, Western Cape Province						
GPS Co-ordinates	Latitude	34°02'.55. 4" S	Longitude	023°21'.57.8" E	Elevation	475 feet	
<b>Aircraft Information</b>							
Registration	ZU-FYG						
Make/Model	Van's RV-7 (Serial No. 70120)						
Damage to Aircraft	Substantial		Total Aircraft Hours	283.04			
<b>Pilot-in-command</b>							
Licence Valid	No	Gender	Male	Age	49		
Licence Type	Invalid Commercial Pilot Licence (CPL)						
Total Hours on Type	71		Total Flying Hours	992			
People On-board	1 + 1	Injuries	1	Fatalities	0	Other (On Ground)	0

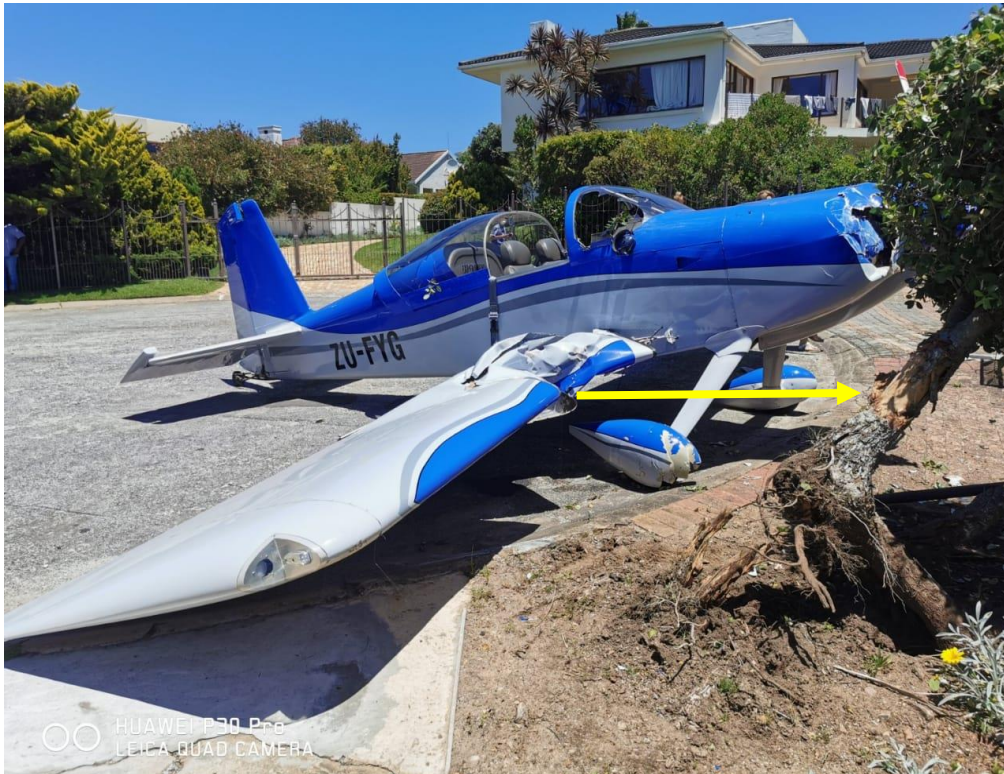
**Figure 2:** Damage to the right wing after it uprooted a tree. (Source: Fire Chief)

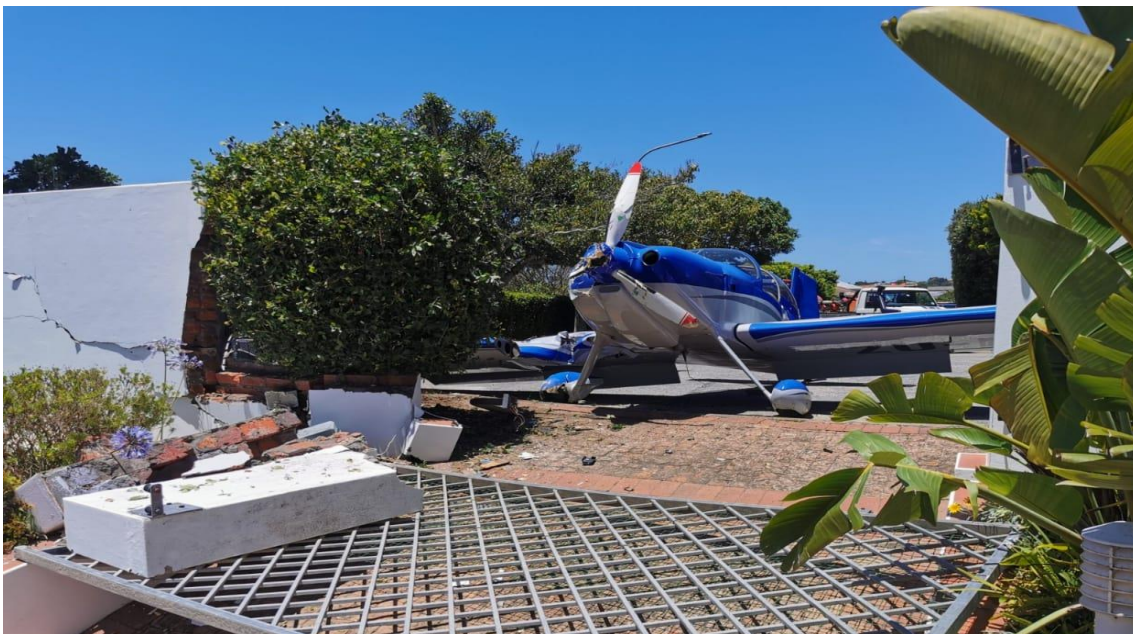
**Figure 3:** Damaged perimeter wall and motorised access gate. (Source: Fire Chief).

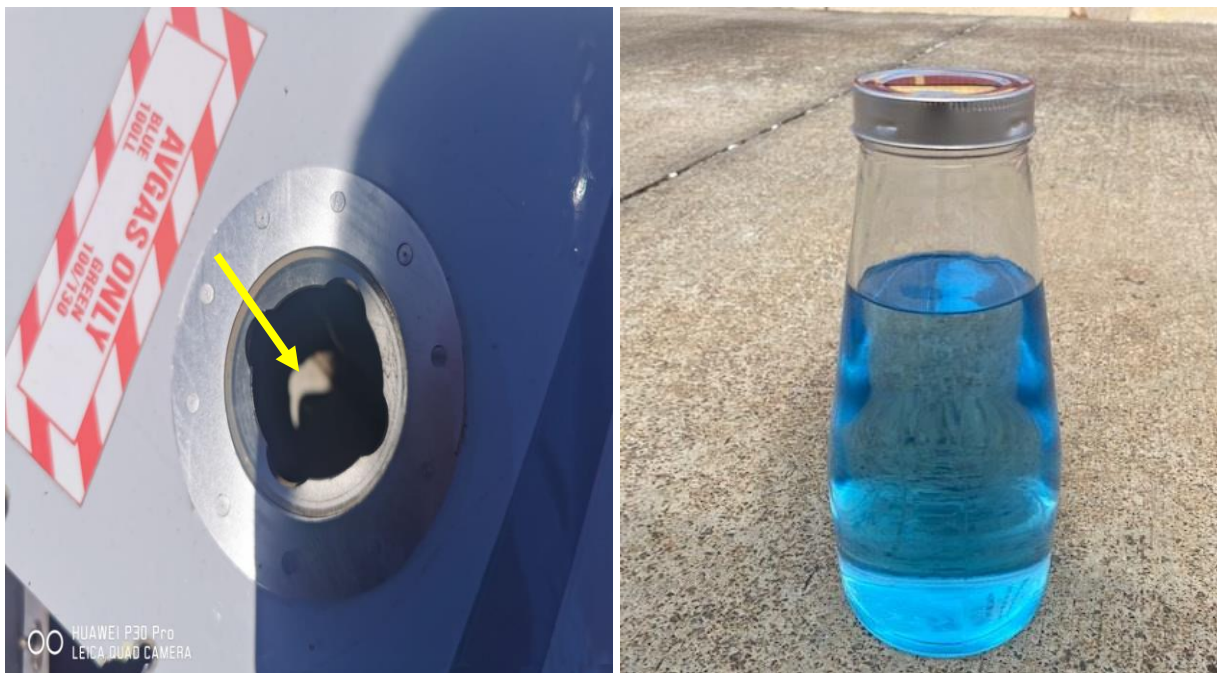
**Figures 5 and 6:** Dry/empty left tank (left picture). Unusable fuel drained from the left tank drain valve post-accident in a one litre bottle. (Source: Fire Station Chief)

- VII. A visual on-site inspection of the aircraft's fuel tanks revealed that there was no useable fuel on-board at the time of the accident.
- VIII. The fuel system was examined and there was no evidence of a system defect or malfunction prior to or during the flight.

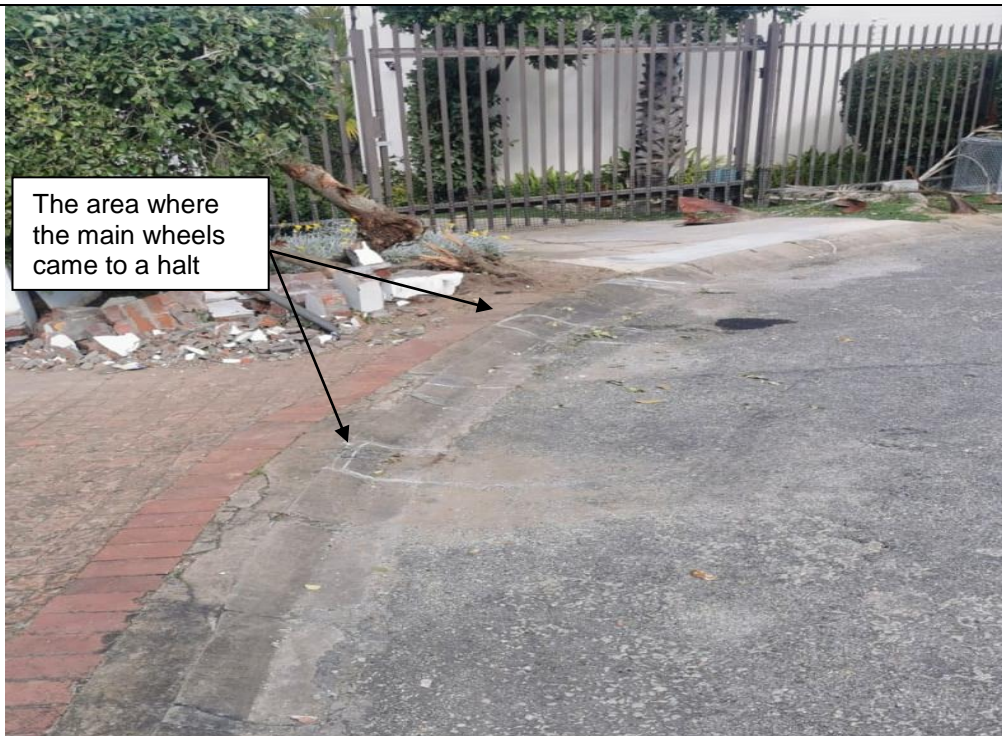
**Figure 7:** The area where the aircraft stopped on Erica PI Drive showing no evidence of fuel spillage. (Source: Fire Station Chief)

- IX. The accident scene showed no evidence of fuel leak or spillage on the tarmac and no signs of post-impact fire.
- X. The aircraft was certified, equipped and maintained IAW with the existing regulations and approved procedures. Scrutiny into the aircraft's flight folio/logbook showed no entries

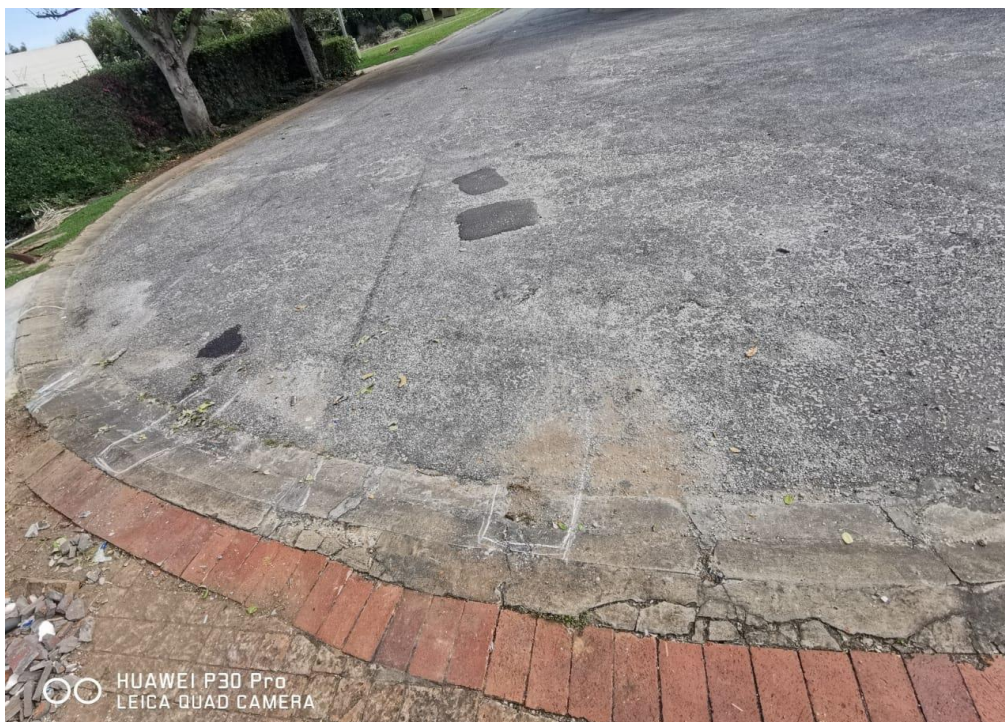
**Figure 8:** The tarred Erica PI Drive post-accident showing no evidence of fuel spillage. (Source: Fire Station Chief)

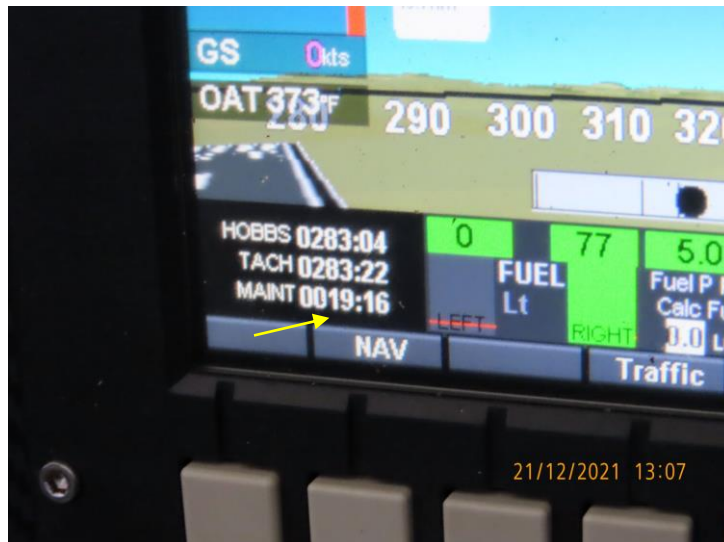
**Figure 11:** The left-side EFIS glass panel showing fuel indications, fuel pressure at 5.0 bar, and 19 minutes flight time.

- IV. The pilot's evidence (Page 11) and the information displayed on the left-side EFIS glass panel picture (Figure 11) taken two days after the accident contradicted the findings of the EFIS glass panels and Dynon fuel level converters.

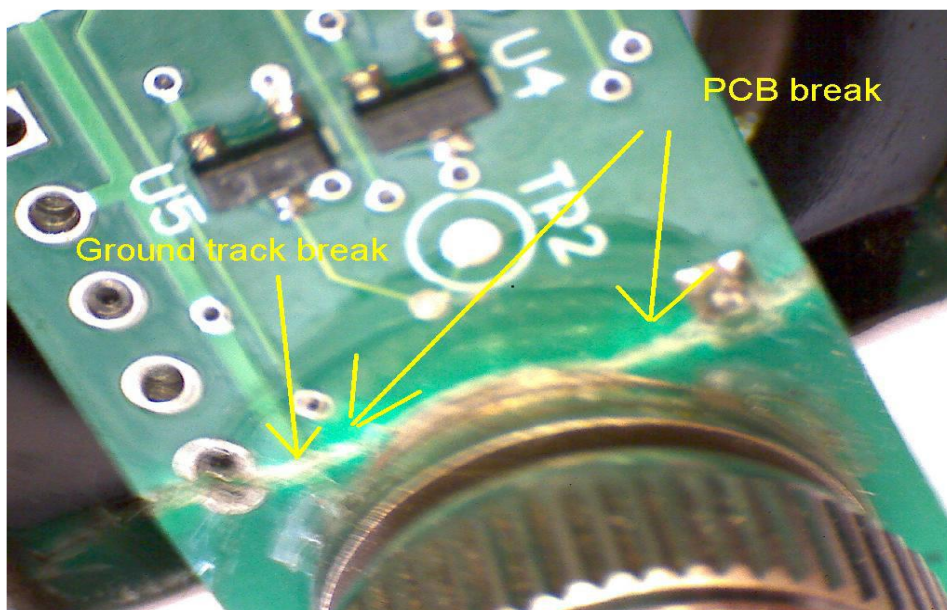
The printed circuit board (PCB) for the right-side tank fuel level converter was severely damaged, most probably from impact during the accident sequence and had broken in half at the connector point. The converter would have given a “zero” reading as it disconnected from one of the probe plates.

**Figure 13:** A damaged right-side tank fuel level converter PCB.

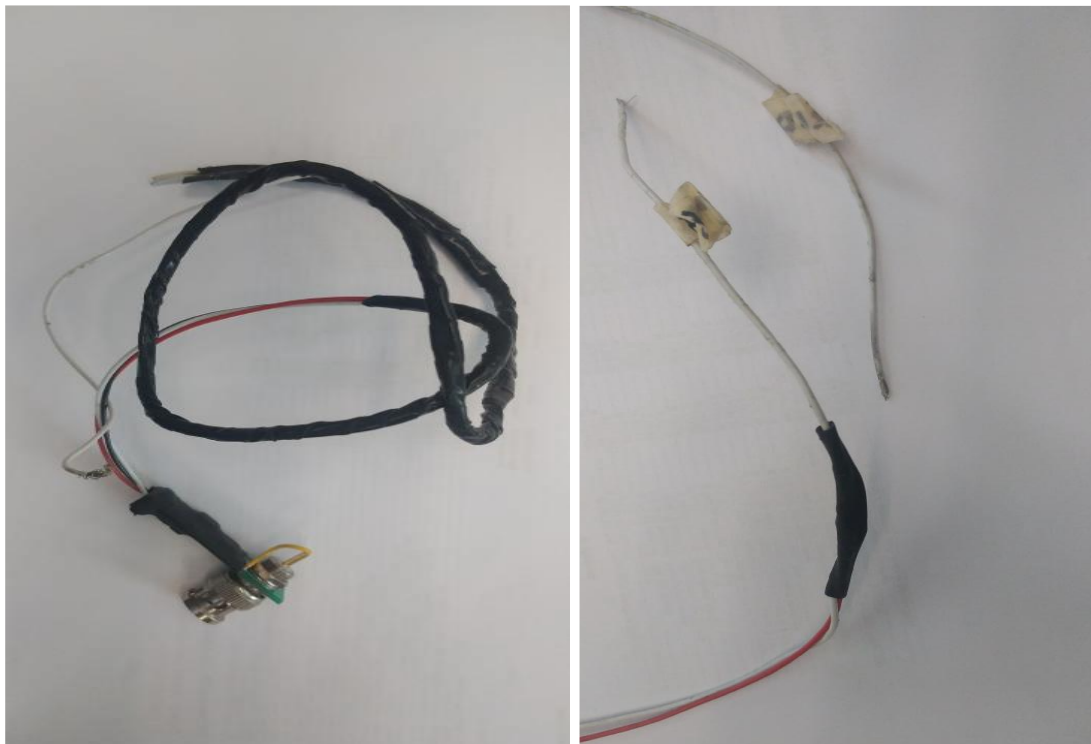
The left-side fuel level converter appeared to be in good condition. The three wires (ground, power and signal) had been extended. The extension was wrapped in black electrical insulation tape. The wiring harness extension, still attached, could not have provided any meaningful reading as the output lead had no electrical connection to the converter. This meant that the Remote Data Acquisition Computer (RDAC) input was electrically floating (high impedance) and will return a reading related to other electrical leakage currents that may be induced by other wiring. In other words, the reading was meaningless. The black electrical insulation tape was removed. The joints of all the wires where they were extended had about one inch of heat shrink sleeve. The signal wire could easily be slipped out of the heat shrink sleeve.

**Figures 14 and 15:** The left-side tank fuel level converter (left picture). The wires on the converter after the removal of the heat shrink sleeve (right picture).

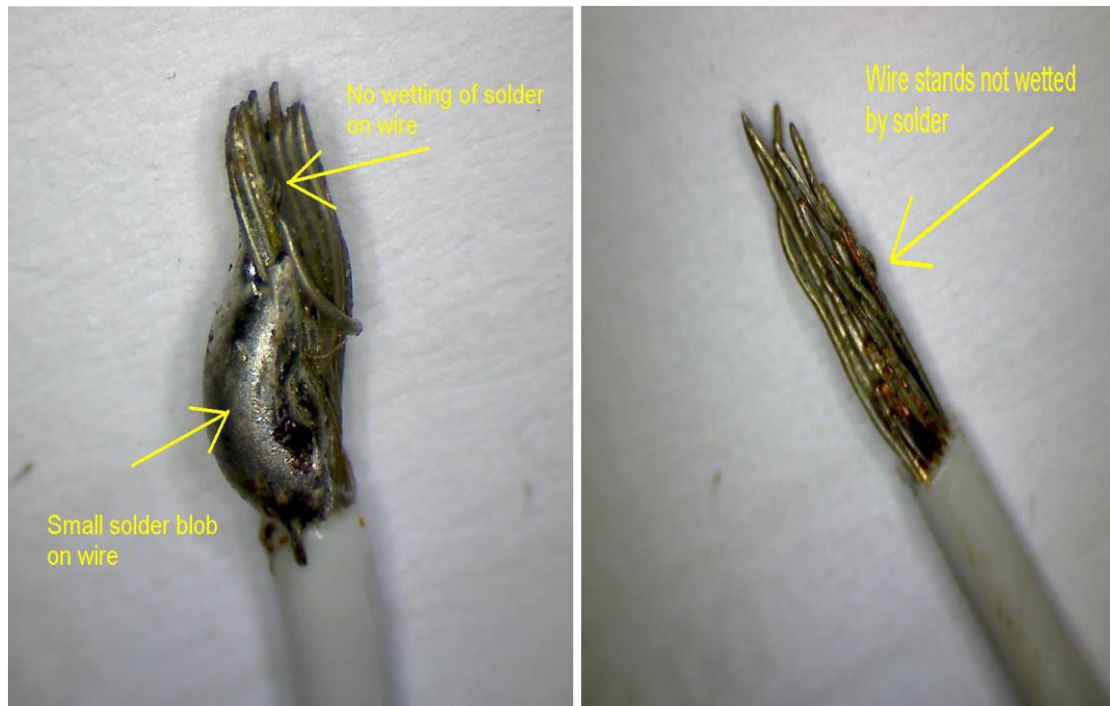
**Figures 16 and 17:** Pictures of the left-sided tank fuel converter after removal of the heat shrink sleeve – these images were of each wire end.

In brief, according to the report, the left-side tank fuel converter wire joint was not properly soldered; a small amount of solder was present on one of the ends, but this was not allowed to flow onto the second wire, leaving a “cold” wire junction. This typically works for a while until the build-up of oxide on the wire stands or mechanical movement breaks the electrical connection. According to the report, this may well have resulted in an intermittent fault but eventually tends to become a permanent break. In this form, the fuel level reading on the EFIS will be incorrect and will likely vary with the quality of the remaining electrical contact (if any). In closing, none of the converters worked in the form in which they were presented and a question regarding the status of fuel in the tanks at departure time remains unanswered.
