LIMITED ACCIDENT INVESTIGATION REPORT

Reference Number	CA18/2/3/10094						
Classification	Accident	Date	15 December 2021	Time	0926Z		
Type of Operation	Training (Part 141)						
Location							
Place of Departure	Rand Aerodrome (FAGM), Gauteng Province		Place of Intended Landing	Rand Aerodrome (FAGM), Gauteng Province			
Place of Accident	Runway 35 at FAGM, Germiston, Gauteng province.						
GPS Co-ordinates	Latitude	26°14'26.5" S	Longitude	28°08'57.49" E	Elevation	5 476 feet	
Aircraft Information							
Registration	ZS-BRO						
Make/Model	Cessna 310Q (Serial Number: 310Q-0257)						
Damage to Aircraft	Substantial		Total Aircraft Hours	4 554			
Pilot-in-command							
Licence Type	Commercial Pilot Licence (CPL)		Gender	Male	Age	67	
Licence Valid	Yes						
Total Hours on Type	19.3		Total Flying Hours	7900			
People On-board	2 + 0	Injuries	0	Fatalities	0	Other (on ground)	0
What Happened							
<p>On Wednesday morning, 15 December 2021, a flight instructor (FI) and a student pilot (SP) on-board a Cessna 310Q aircraft with registration ZS-BRO departed Rand Aerodrome (FAGM) in Germiston, Gauteng province, on a training flight to the Johannesburg South General Flying area (GFA) with

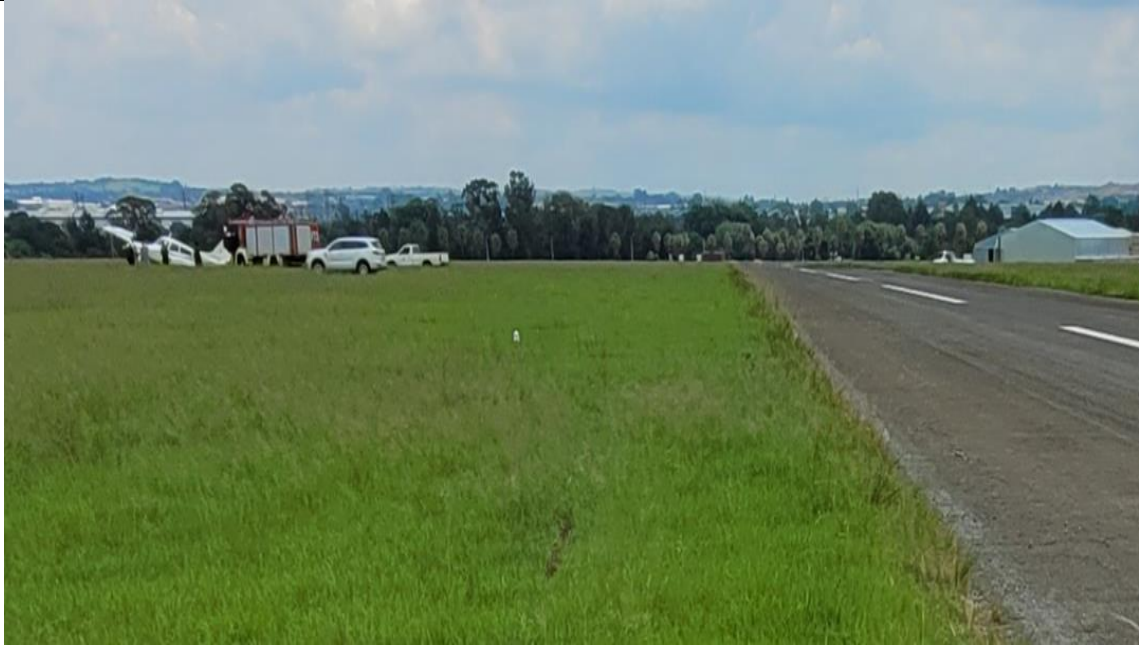
The aircraft was substantially damaged. Both occupants were not injured during the accident; they exited the aircraft without any assistance.

Figure 2: The aircraft at the accident site. (Source: Operator)

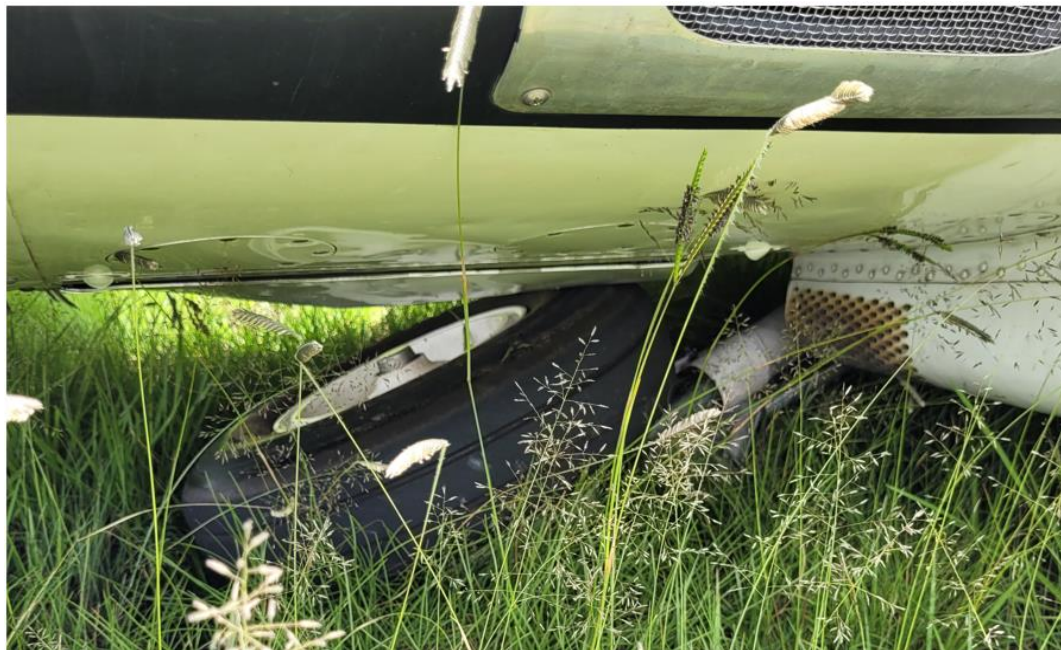
- During visual inspection of the aircraft at the accident site, the left main landing gear had almost retracted inside the wheel well and both lugs attachments of the drag brace had broken off from the oleo strut; as a result, the aircraft had leaned towards the left-side, sustaining scratches along the bottom of the left wing and propeller tips. The aircraft also sustained substantial damage to the left main landing gear, which collapsed (see Figure 3); the left landing gear bell crank lower lug; and the trunnion upper clevis which fractured (Figures 4 and 5). One of the fractured lugs as well as the clevis were found on the runway (Figures 6 and 7), and the landing gear lever was found inside the cabin in the down and locked position.

Figure 3: The collapsed left main landing gear. (Source: Operator)

- An examination of the landing gear revealed that the only visible damage to the left main landing gear was the bell crank lug on the lower side brace and the upper trunnion clevis.

- Although the flight instructor reported that the landing was normal with no crosswind, side load or hard landing during the landing roll, it is likely that the aircraft landed hard on the left main gear, inducing overload on the upper trunnion clevis. This resulted in the left main landing gear upper trunnion clevis and bell crank lower lug breaking, followed by the left wing tip and left propeller striking the ground.

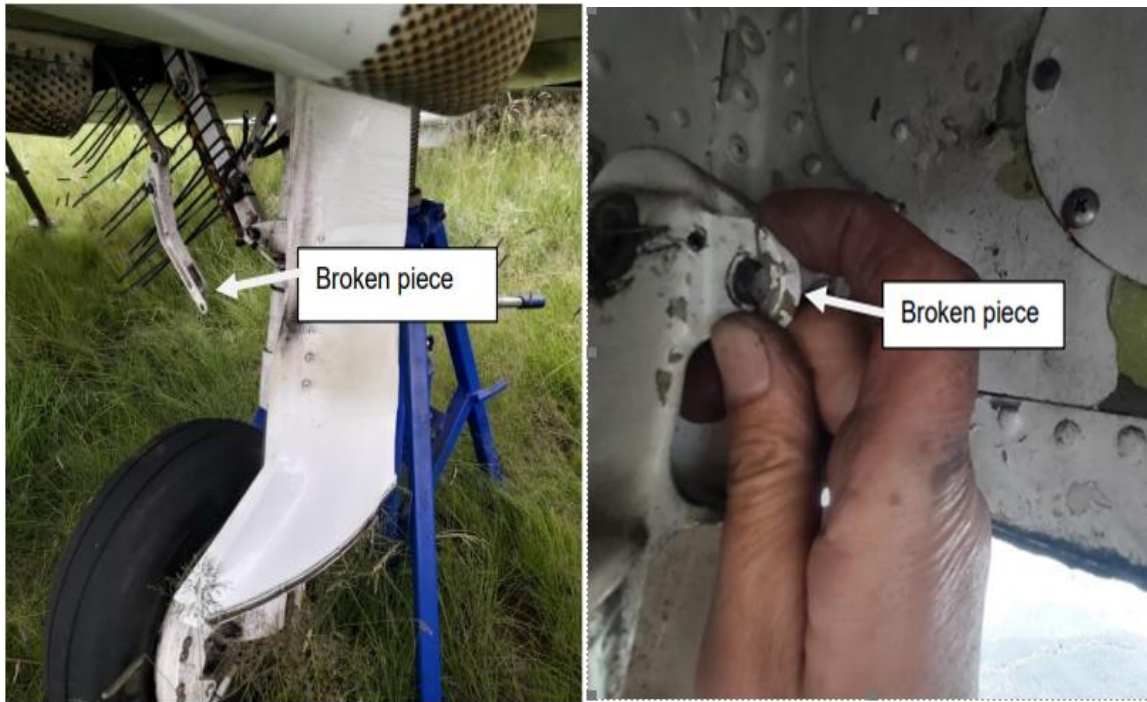
Figures 4 and 5: The fractured bell crank lower lug (left) and the upper trunnion clevis (right).
(Source: Operator)

- Diagram 1 shows a detailed illustration of the left landing gear in an extended position.
 - Following the accident, the fractured bell crank lower lug and upper trunnion clevis were examined under microscope. The fractured *surface morphology showed no clear indication/s of fatigue (pre-existing fracture/s) which meant that the components failed as a result of exposure to a single overload during landing.*

- It is likely that the clevis was subjected to mechanical shearing due to hard landings, which could have happened over time. However, there were no recorded hard landings in the airframe logbook and the aircraft was not fitted with a G-meter. Therefore, the cause of failure could not be supported with certainty.

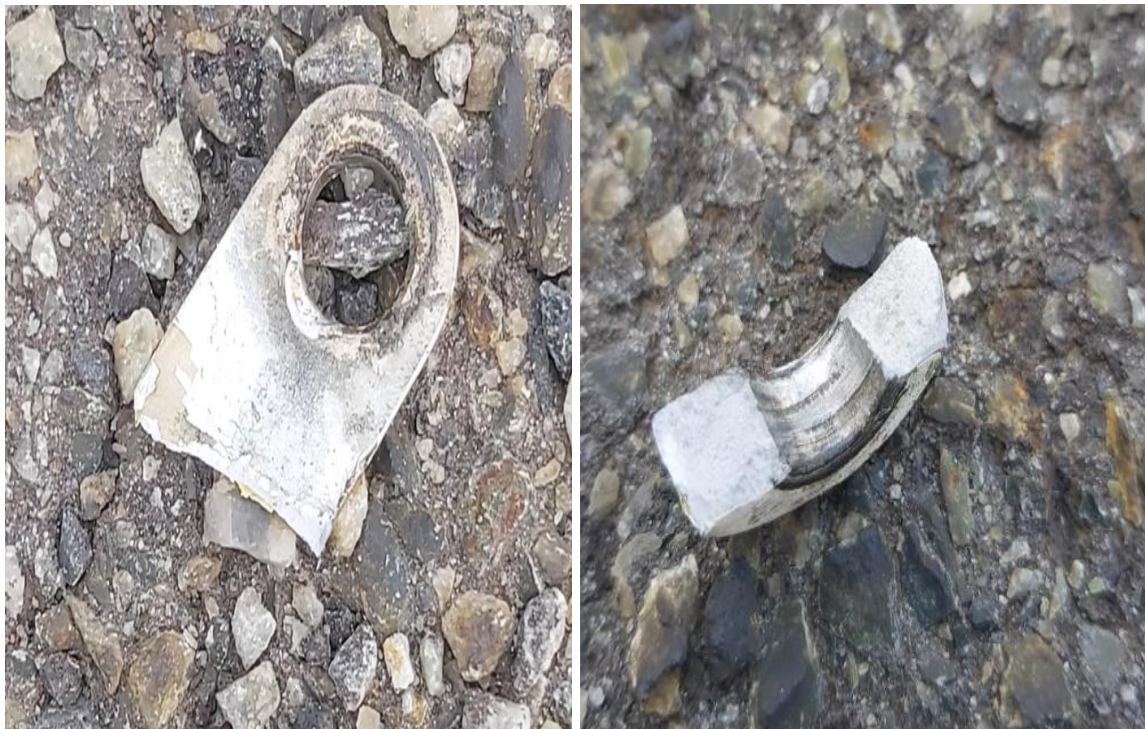
Figures 6 and 7: The clevis (left) and a piece of fractured lug (right). (Source: Operator)

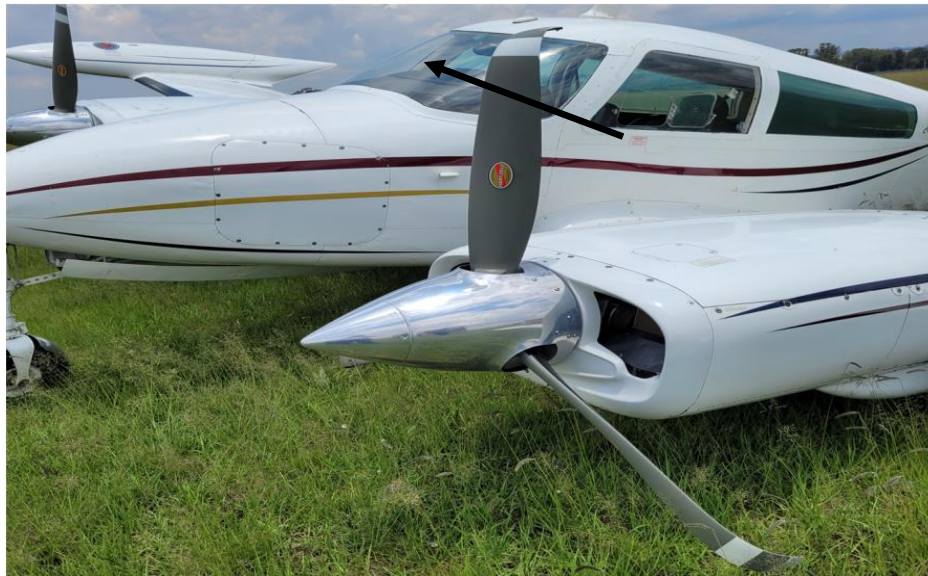
- General external visual inspection of the engine was carried out, and it revealed no defects. All three left propeller blades tips were bent backwards and exhibited abrasion marks; an indication that they came into contact with the runway surface several times.

Figure 8: The bent propeller blades. (Source: Operator)

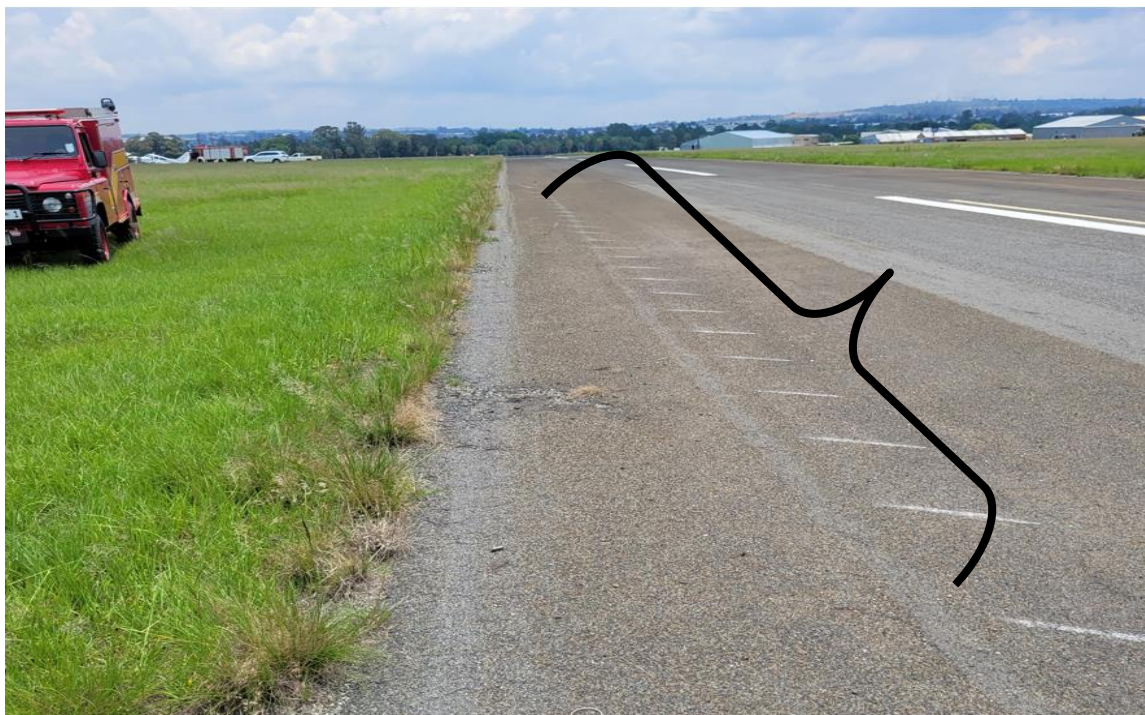
- After the left main landing gear trunnion upper clevis and bell crank lower lug broke, the aircraft sank on its left-side. As a result, the left propeller contacted the ground, leaving several indentations on the runway which spanned approximately 10 metres (m). The propeller strike marks also indicated that the aircraft was likely unstable upon landing as the marks were off the centreline on the left of the runway (see Figure 9).

Figure 9: Propeller marks on the runway.
