LIMITED ACCIDENT INVESTIGATION REPORT
--

Reference Number		CA18/2/3/10096					
Classification	Accident	Date	1 January 2022	Time	1550Z		
Type of Operation	Private (Part 94)						
Location							
Place of Departure	Lunsklip Fisheries Private Airstrip, Mpumalanga Province		Place of Intended Landing	Potloodspruit Private Airstrip, Mpumalanga Province			
Place of Accident	Lunsklip Fisheries Private Airstrip, Runway 11						
GPS Co-ordinates	Longitude	S 24°02'09.72"	Latitude	E 029°10'26.23"	Elevation	4603 feet	
Aircraft Information							
Registration	ZU-ERK						
Model/Make	Bushbaby Explorer (Serial Number:117-09-06)						
Damage to Aircraft	Destroyed		Total Aircraft Hours	591			
Pilot-in-command							
Licence Type	Private Pilot Licence (Aeroplane)		Gender	Male	Age	45	
Licence Valid	Yes						
Total Hours on Type	450		Total Flying Hours	1572			
People On-board	1 + 1	Injuries	2	Fatalities	0	Other (on ground)	0
What Happened							
<p>On Saturday, 1 January 2022 at 1530Z, a pilot and a passenger on-board a Bushbaby Explorer with registration ZU-ERK took off from Lunsklip farm routing to Potloodspruit private airstrip in Mpumalanga province. This was a private flight conducted under visua

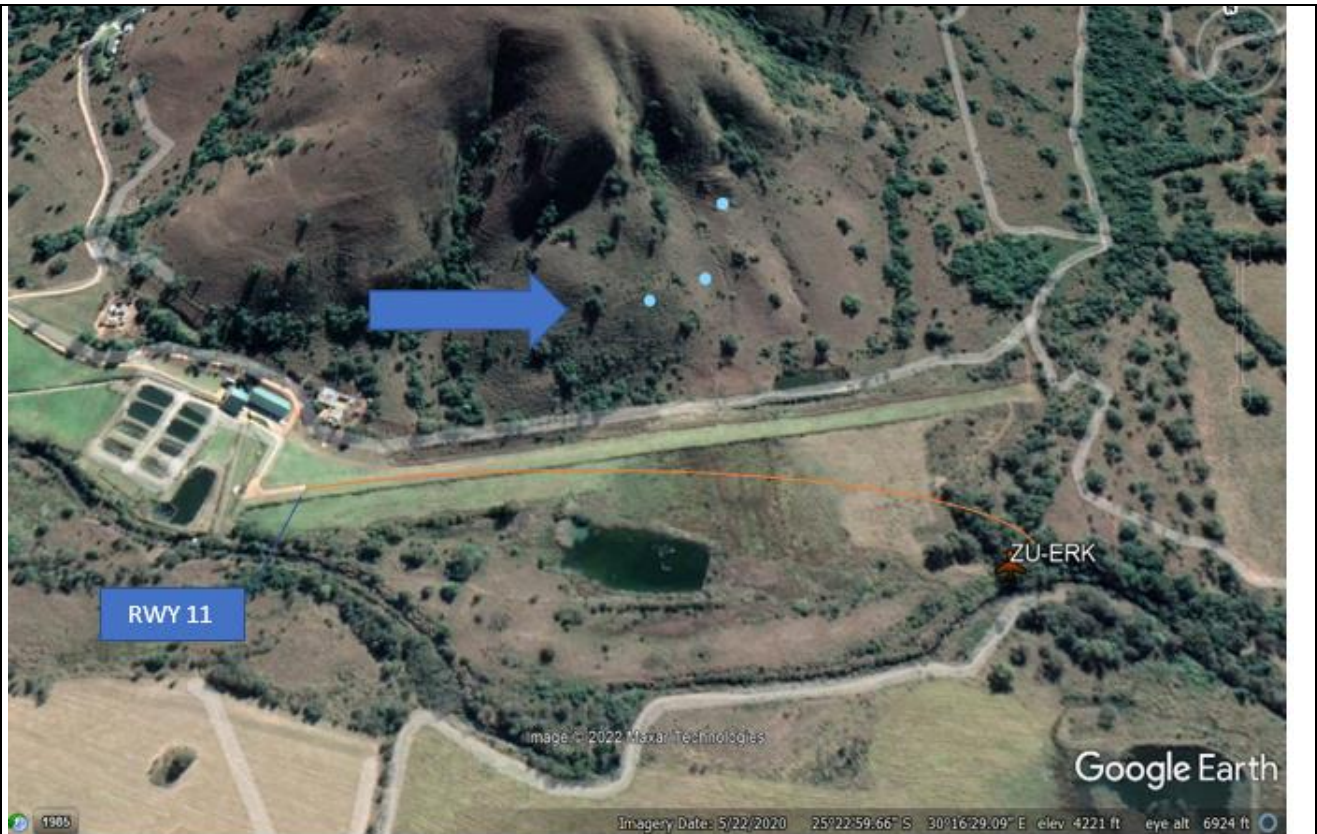
Figure 1: Aerial view of Lunsclip farm and the path followed by the ZU-ERK aircraft. (Source: Google Earth)

4. The runway designation is 11/29 which is 700 metres long and 12 metres wide. The aircraft's weight and balance calculation was 13.84" of the centre of gravity, and was within limit for the flight. The runway is situated adjacent the mountainous terrain (Figure 1). It is likely that the aircraft experienced a down draft on the lee side of the mountain which prevented a positive climb rate and caused airspeed decay (Figure 3).

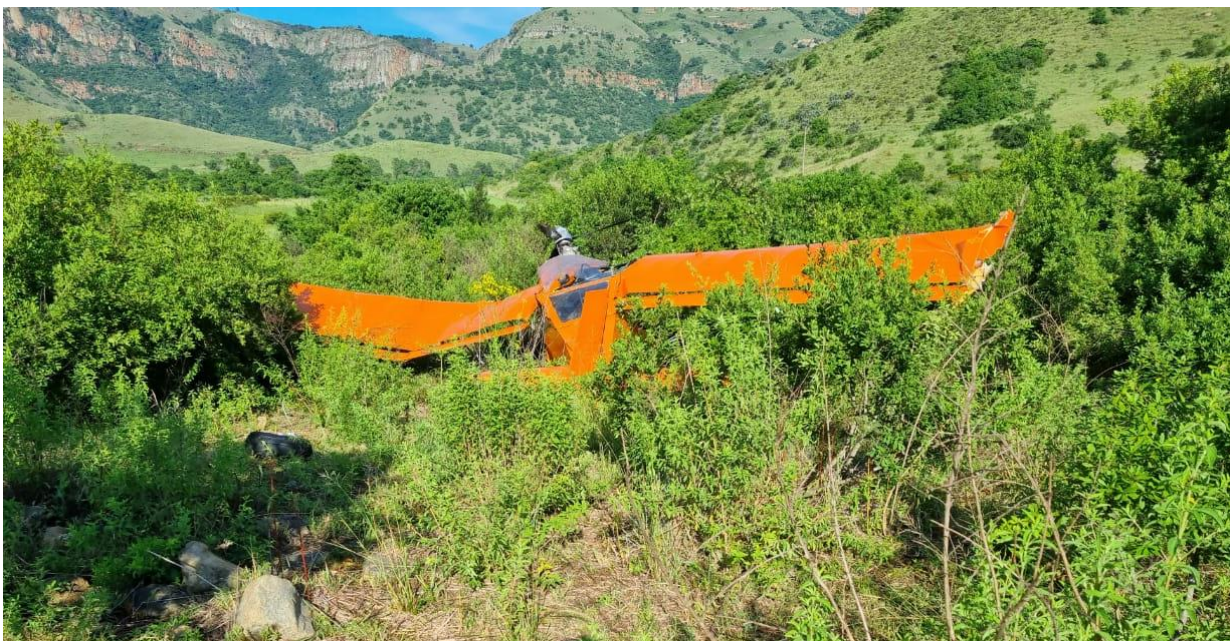
Figure 2: The aircraft as it came to rest on a bushy terrain. (Source: EMS)

3. The pilot reported that he experienced a down draft after take-off from RWY 11 and elected to execute a forced landing on the right-side of the runway. The aircraft crash-landed on a bushy terrain and was destroyed on impact. The pilot and the passenger were injured during the landing sequence.

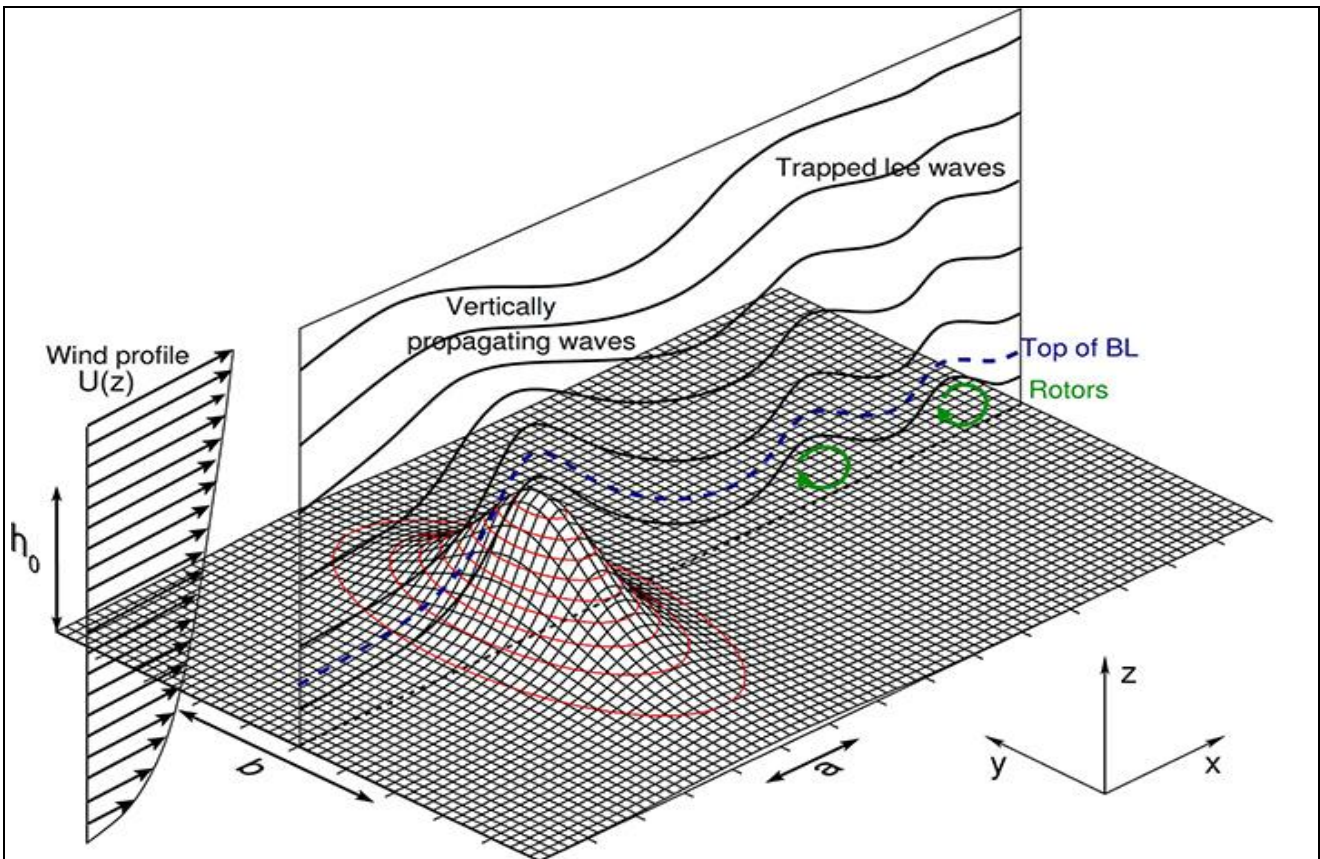
Diagram 1: A schematic diagram of a mountain wave. (Source: ResearchGate)

The aircraft experienced a down draft on the lee side of the mountain during take-off, preventing the aircraft from attaining a positive rate of climb. The pilot attempted an unsuccessful emergency landing on a bushy terrain.

Pilots are encouraged to take precautions when operating aircraft at airfields situated in proximity to mountainous terrain as flights may be affected by mountain waves/down draft.
