**LIMITED ACCIDENT INVESTIGATION REPORT**

<b>Reference Number</b>	CA18/2/3/10098					
<b>Classification</b>	Accident	<b>Date</b>	4 January 2022	<b>Time</b>	2305Z	
<b>Type of Operation</b>	Remotely Piloted Aircraft (Part 101)					
<b>Location</b>						
Place of Operation	2.2 nm from TFR station around Pullens Hope, near Hendrina Power Station in Mpumalanga Province					
GPS Co-ordinates	Latitude	S26°1'39.80"	Longitude	E028°36'10.77"	Elevation	5390 ft
<b>Aircraft Information</b>						
Registration	ZT-XEJ					
Model/Make	DJI Mavic Advanced (Serial number: Mav0036)					
Damage to Aircraft	Destroyed		Total Aircraft Hours	117		
<b>Pilot-in-command</b>						
Licence Type	Remote Pilot Licence	Gender	Male	Age	22	
Licence Valid	Yes					
Total Hours on Type	128.4		Total Flying Hours	128.4		
<b>What Happened</b>						
<p>On 4 January 2022, a pilot was conducting security surveillance work using a DJI Mavic Advanced drone with registration mark ZT-XEJ. The pilot was operating the drone 2.2 nautical miles (nm) from station, which is around Pullens Hope near Hendrina Power Station in Mpumalanga Province. The operation was conducted under visual flight rules (VFR) and under the provisions of Part

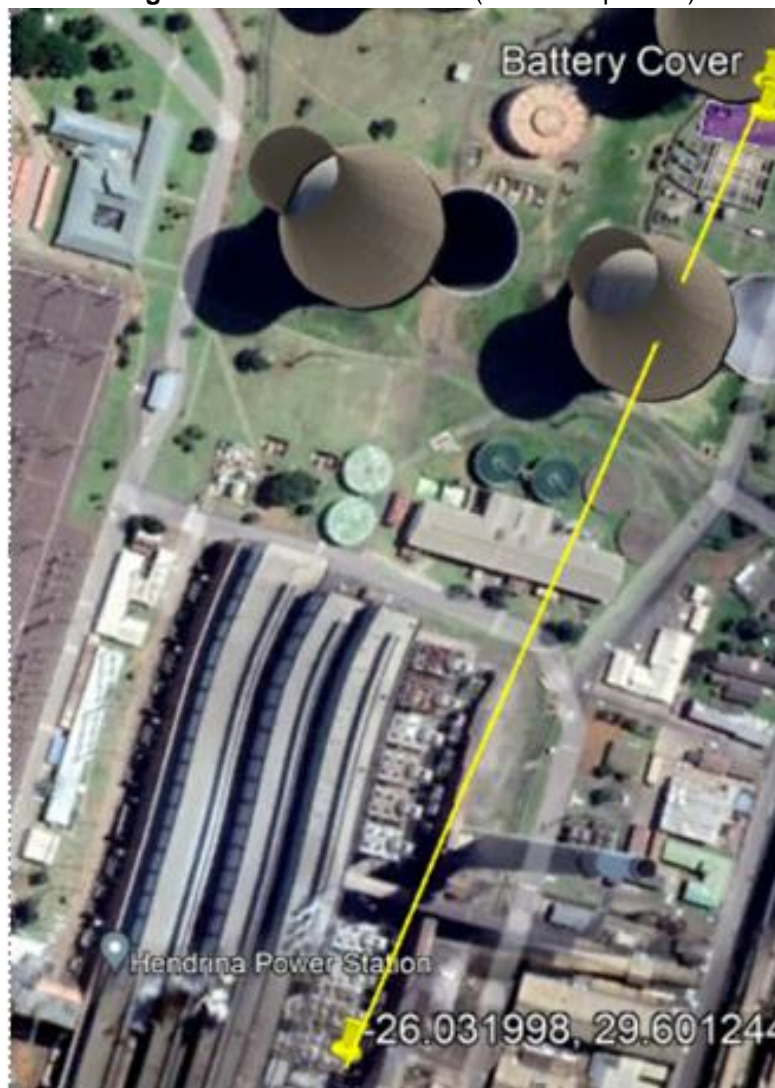
The drone is programmed to return to launch (RTL) point using the most direct route; the drone responded as programmed. However, because of the position at which the drone was launched, it routed directly overhead the power station; it is suspected to have collided with an Eskom water tower.

**Figure 2:** Flight path of the drone. (Source: Pilot)

- *The pilot explained the following: the aircraft lost signal when it was behind Hendrina Power Station. The aircraft Returned to Launch (RTL) from its location directly to the home point (1609m elevation) and the cooling towers (1642m elevation) were in the direct flight path (Figure 2), he then further explained that the aircraft came to a stop prior to hitting the tower and that is where it stayed and lost signal again shortly after that.*
- *His assessment of what happened given all the fact of where they found the battery cover, the flight path, altitude, take-off elevation and tower elevation, the aircraft lost signal for 70.3 seconds and the self- return to launch engaged. The aircraft flew its path back to the home point, as it reached the cooling tower (which is semi-lit during the night) the aircraft*

vision sensors engaged and the aircraft stopped dead in its tracks (with the reduced ambient light it would probably have stopped about +/-2 to 3 metres from the tower), with no further data coming from the aircraft we are not able to determine for how long it hovered there or at what stage it went into auto land.

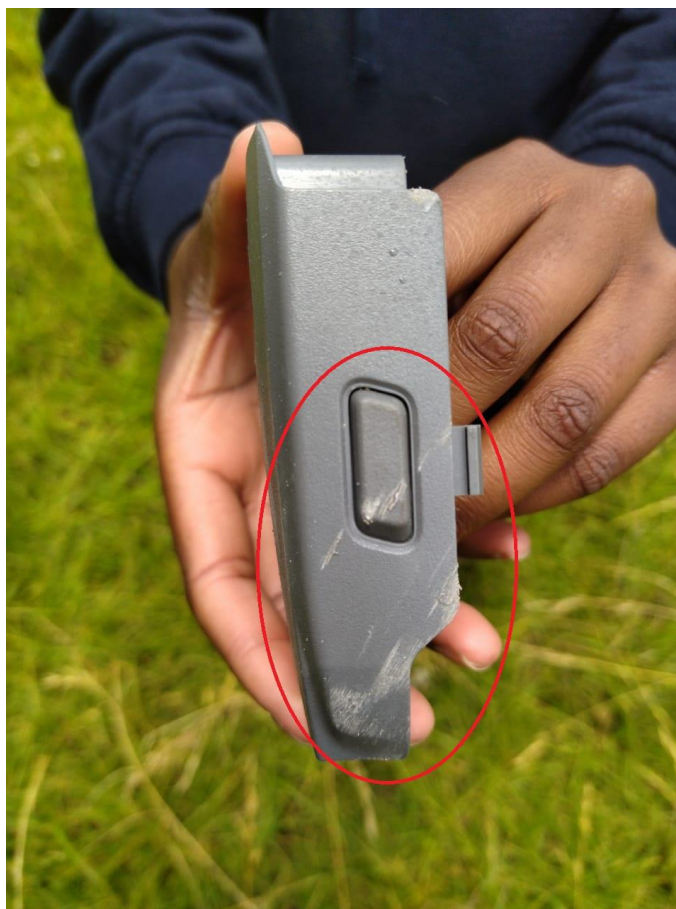
When the team went in search of the drone, only the battery cover was found (see Figure 3). The fuselage of the drone is suspected to have fallen into the water reservoir at the base of Eskom water tower as the drone was not recovered.

**Figure 3:** Battery cover that was recovered with scuff marks. (Source: Pilot)

- Due to the way the cooling towers are built, they have a large base with a concave wall. From him standing next to the tower he would estimate it to be +/-140m tall, add an additional +33m elevation difference from home point would put the aircraft hovering near the top of the tower. During the auto landing stage, the aircraft would not have fully landed as the ultrasonic sensor at the bottom of the aircraft will not recognise the shape for the wall. Eventually the aircraft would have remained in a hover until the battery depleted and would then fall along the wall and into the large water reservoir. Somewhere in the fall, the battery must have dislodged from the aircraft, tumbling down along the wall. At some stage, the battery cover came apart from the battery and that is why it was found with scuff marks.

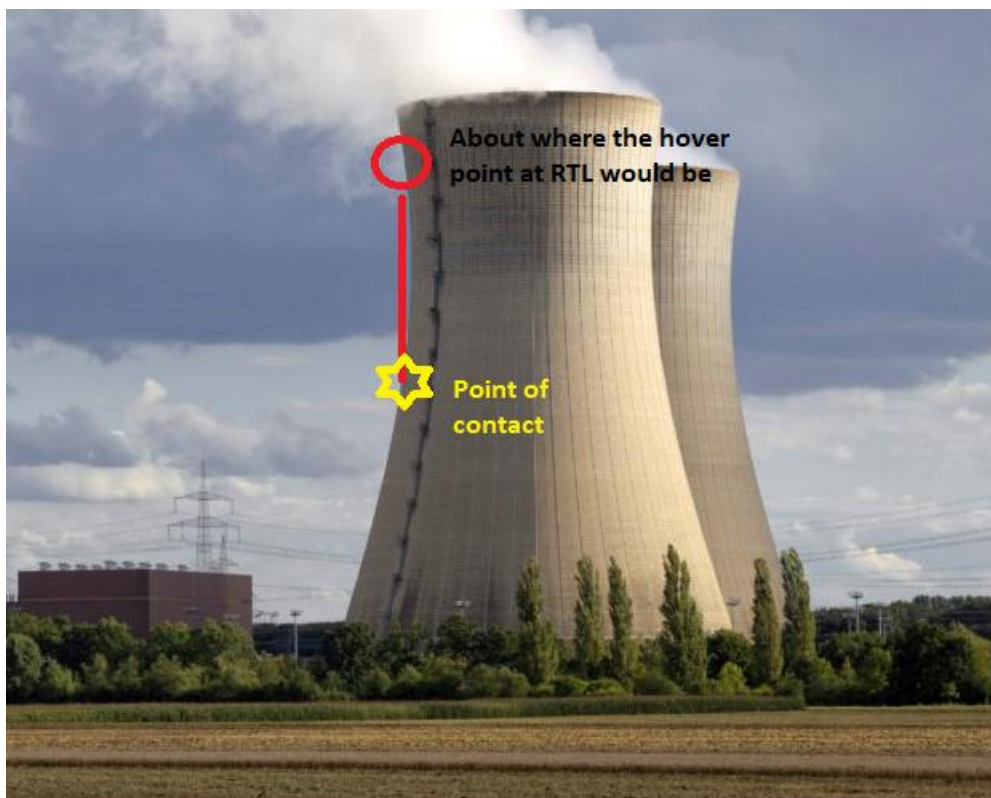
The drone's operating height was 400 feet (ft) above ground level (AGL). The cooling tower height is approximately 460ft (140m) AGL (see Figure 4).

**Figure 4:** The cooling tower and the point of impact. (Source: Operator)

<p><b>Probable cause:</b></p> <p>The drone lost communication link with the pilot during flight and, whilst returning to base, it is suspected that it may have collided with the cooling station structure.</p>
<p><b>Safety Message and/or Safety Recommendation/s</b></p> <p>None.</p>
<p><b>Purpose of the Investigation</b></p> <p><i>In terms of Regulation 12.03.1 of the Civil Aviation Regulations (CAR) 2011, this report was compiled in the interest of the promotion of aviation safety and the reduction of the risk of aviation accidents or incidents and <b>not to apportion blame or liability.</b></i></p>
<p><b>About this Report</b></p> <p><i>Decisions regarding whether to investigate, and the scope of an investigation are based on many factors, including the level of safety benefit likely to be obtained from an investigation. For this occurrence, no investigation has been conducted, and the Accident and Incident Investigations Division (AIID) has relied on the information submitted by the affected person/s and organisation/s to compile this brief report. The report has been compiled using information supplied in the initial notification, as well as follow-up information to bring awareness of potential safety issues to the industry in respect of this occurrence, as well as possible safety action/s that the industry might want to consider in preventing a recurrence of a similar accident.</i></p> <p><i>This report provides an opportunity to share safety message/s in the absence of an investigation.</i></p> <p><i>All times given in this report are Co-ordinated Universal Time (UTC) and will be denoted by (Z). South African Standard Time is UTC plus 2 hours.</i></p>
