LIMITED ACCIDENT INVESTIGATION REPORT

Reference Number	CA18/3/2/10099						
Classification	Accident	Date	7 January 2022	Time	1600Z		
Type of Operation	Operation of Non-type (Part 94)						
Location							
Place of Departure	Dorchester Farm, Bray, North West Province		Place of Intended Landing	Dorchester Farm, Bray, North West Province			
Place of Occurrence	Klein Bray Farm						
GPS Co-ordinates	Latitude	25°28'48.9" S	Longitude	23°39'32.6" E	Elevation	6 480ft	
Aircraft Information							
Registration	ZU-DHA						
Model/Make	Raven (Serial Number: CBU-004)						
Damage to Aircraft	Substantial			Total Aircraft Hours	1 486.8		
Pilot-in-command							
Licence Type	Private Pilot Licence (PPL)		Gender	Male	Age	60	
Licence Valid	Yes						
Total Hours on Type	11.9			Total Flying Hours	4 271		
People On-board	1+1	Injuries	0	Fatalities	0	Other (on ground)	0
What Happened							
<p>On Friday afternoon, 7 January 2022, a pilot and a passenger on-board a Raven aircraft with registration ZU-DHA took off from Dorchester Farm in Bray, North West province, with the intention to return to the same farm. This was a sightseeing flight conducted under visual meteorological conditions (VMC) by day and u

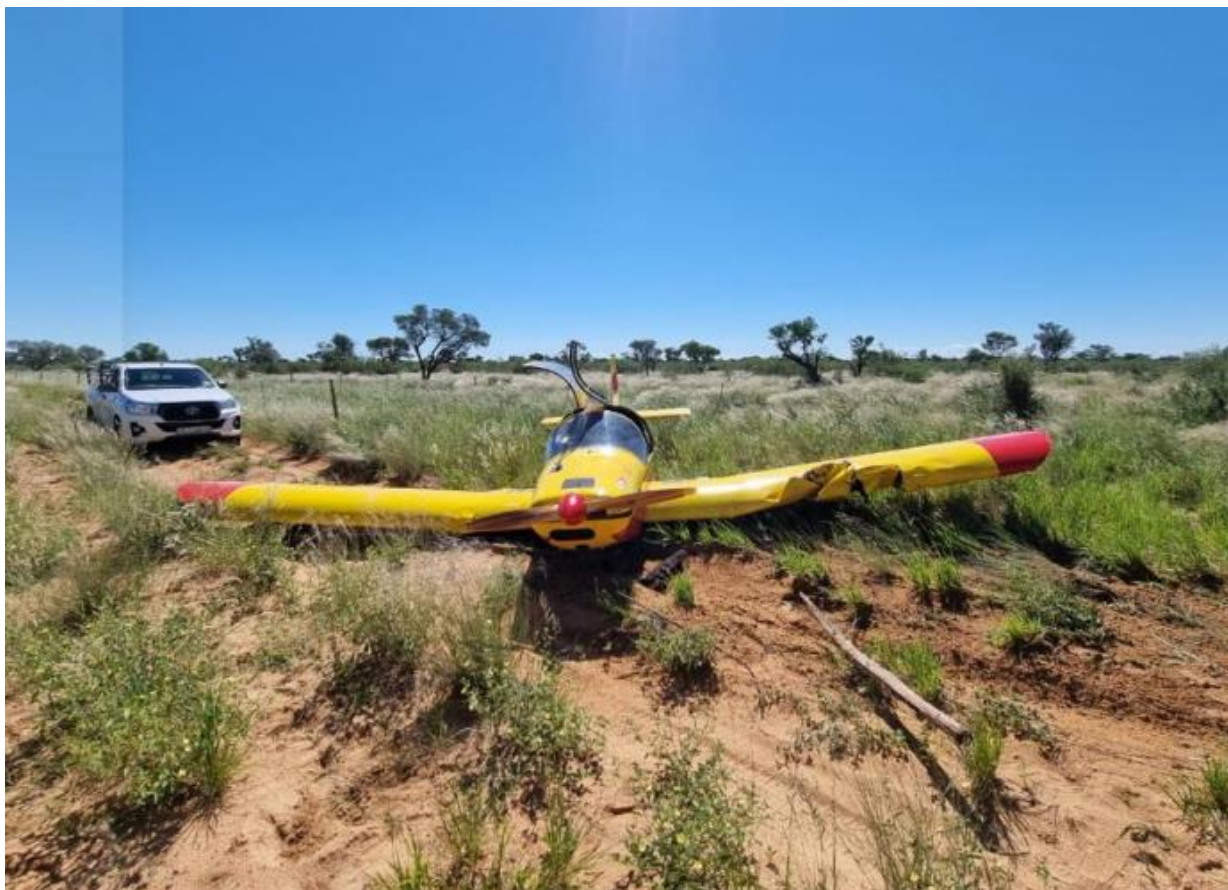
ground looping. The aircraft was substantially damaged during the accident, however, both occupants on-board were not injured.

Figure 1: The aircraft at the accident site. (Source: Pilot)

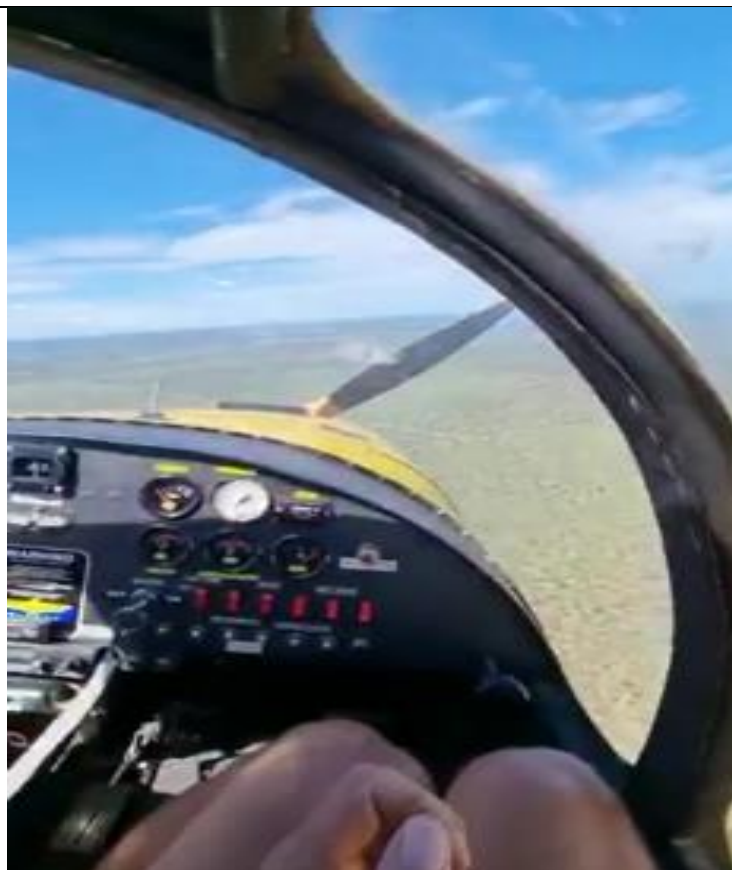
From the passenger's video footage, *the propeller blades are seen spooling down until they come to a stop; then the pilot switches on the fuel pump and selects the engine start on the master switch. The propeller turns momentarily and then stops (suggesting that the starter motor was just turning the engine). The pilot tries to restart several times without success. He then glides the aircraft, aiming for the gravel road. The aircraft touchdown on main wheels before ground looping.*

Figure 2: A still picture of the video footage following engine failure. (Source: Pilot)

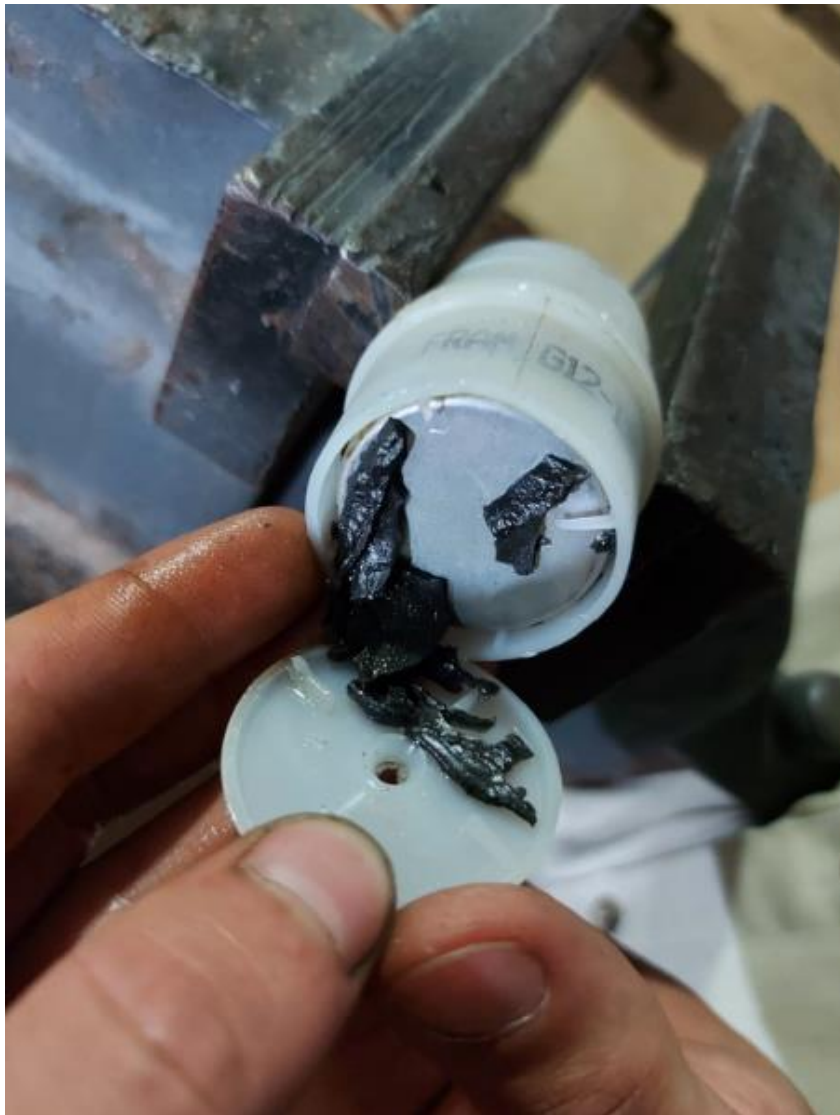
- A post-inspection by the aircraft maintenance organisation (AMO) revealed that the fuel filter was clogged with a silicon-like substance. This resulted in fuel starvation to the engine during flight. The AMO cleaned the filter and performed an engine run with no issues detected.

Figure 2: A clogged fuel filter. (Source: AMO)

Engine stopped in-flight as a result of fuel starvation caused by a clogged fuel filter; this was followed by an unsuccessful forced landing on the gravel road.
