Section/division Accident and Incident Investigations Division

# LIMITED ACCIDENT INVESTIGATION REPORT

Reference Number		CA18/2/3/10102									
Classification	Acc	ident Date			5 January 2022		Time	Time		1511Z	
Type of Operation		Surveillance (Part 101)									
Location											
Place of Departure		Hartland Mountain Lodge in Brits, North West Province			Place of Intended Landing			Hartland Mountain Lodge in Brits, North West Province			
Place of Accident		Hartland Mountain Lodge in Brits North West Province, approximately 560m north- east of the launch position									
GPS Co-ordinates		Longitude				Latitude E 027°43'14.25			Elevation	4218ft	
Aircraft Information											
Registration		ZT-WYX									
Model/Make Multirotor Arace Sirin/ UAV (Serial number:SIR0009)											
Damage to Aircraft		Missing/Lost			Total Aircraft Hours			96			
Pilot-in-command											
Licence Type		RPAS		Gende	Gender Male			Age		32	
Licence Valid		Yes									
Total Hours on Type		17.42			Total Flying Hours			893.2

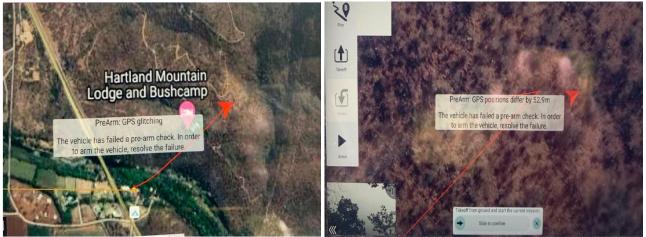
People 0 On-board		Injuri	Injuries 0		Fatalities		0	Other (on ground)		0	
What Happened							L			-	
On 5 January 2022 at about 1511Z, a Multirotor Arace Sirin drone with registration ZT-WYX was being operated for surveillance at Impala Platinum mines in the North West province. The drone was operated remotely by a pilot stationed at Impala Platinum mines factory near Hartland Mountain Lodge in Brits, also in the North West province. The factory is located approximately 55 kilometres (km) east of Impala Platinum mines. The operation was conducted under visual meteorological conditions (VMC) by day and under the provisions of Part 101 of the Civil Aviation Regulations (CAR) 2011 as amended. According to the pilot, the drone was launched from a factory located at Global Positioning System (GPS) S 25°33'1.00" E 027°42'55.75" at a field elevation of 3475 feet (ft) above mean sea level (AMSL). The drone took off using the planned route along the mountain. Approximately 10 minutes into the flight, about 560 metres (m) from the launch position whilst heading in a north-east direction, the drone control signal disconnected from the pilot's control unit. The last position of the

drone was indicated at the following GPS coordinates: S 25°32'50.69" E 027°43'14.24" whilst flying at an altitude of 292ft AGL and at a field elevation of 3929ft AMSL. The highest point of the mountain peak around the area where the drone lost signal is 3980ft AMSL.

Figures 1 & 2: The drone route from launch to where it lost communication with the pilot.

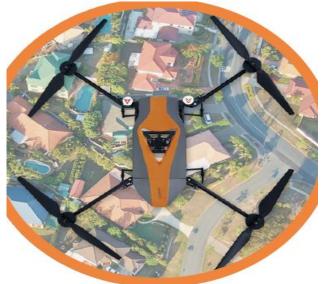
Figure 3: Multirotor Arace Sirin/ UAV missing drone. (Source: Operator)

The drone pilot lost communication with the drone, and the drone did not return to launch position as per its design characteristics upon loss of signal.
