LIMITED ACCIDENT INVESTIGATION REPORT

Reference Number	CA18/2/3/10103						
Classification	Accident	Date	20 January 2022	Time	0630Z		
Type of Operation	Commercial Operation (Part 96)						
Location							
Place of Departure	Groutville Private Airstrip, KwaZulu-Natal Province		Place of Intended Landing	Shongweni Private Airstrip, KwaZulu-Natal Province			
Place of Accident	Shongweni, KwaZulu-Natal Province						
GPS Co-ordinates	Latitude	29°48' 7.22"S	Longitude	30°45' 48.81"E	Altitude	2 070.4 feet	
Aircraft Information							
Registration	ZU-IMN						
Model/Make	Micro Crafts Africa Windlass Aquilla 912 (Serial Number: WA 1234)						
Damage to Aircraft	Substantial		Total Aircraft Hours	1061.2			
Pilot-in-command							
Licence Type	National Pilot Licence (NPL)	Gender	Male		Age	29	
Licence Valid							
Total Hours on Type	1600		Total Flying Hours	1649.9			
People On-board	1+0	Injuries	1	Fatalities	0	Other (on ground)	0
What Happened							
<p>On 20 January 2022 at 0630Z, a pilot on a Windlass Aquilla 912 microlight with registration mark ZU-IMN took off from Groutville Private Airstrip, near Stanger, to Shongweni Private Airstrip, near Durban, to spray crops on a farm. The two areas

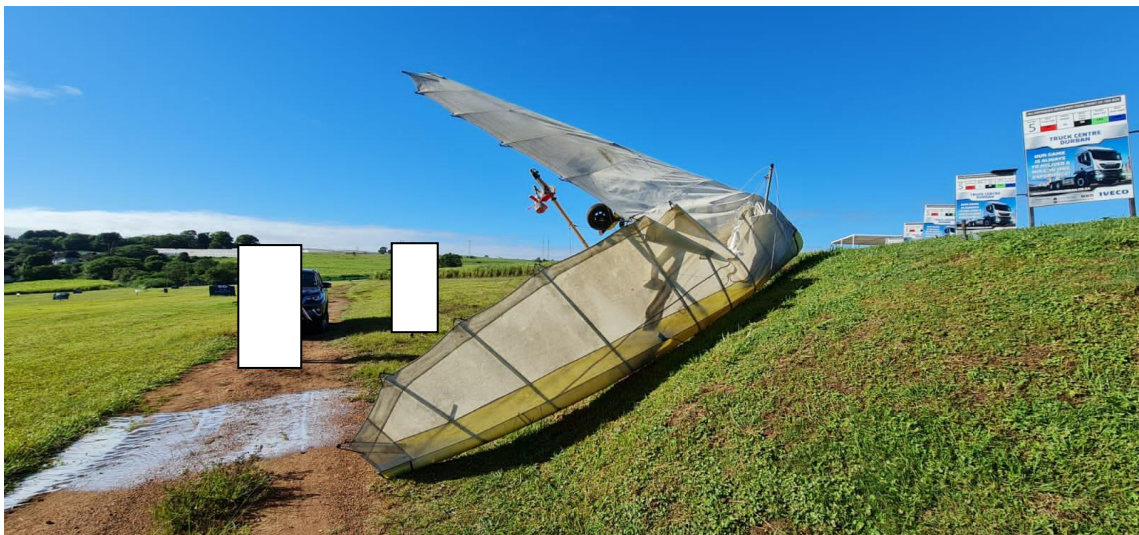
Figure 2: The final resting position of the microlight on the embankment. (Source: Pilot)

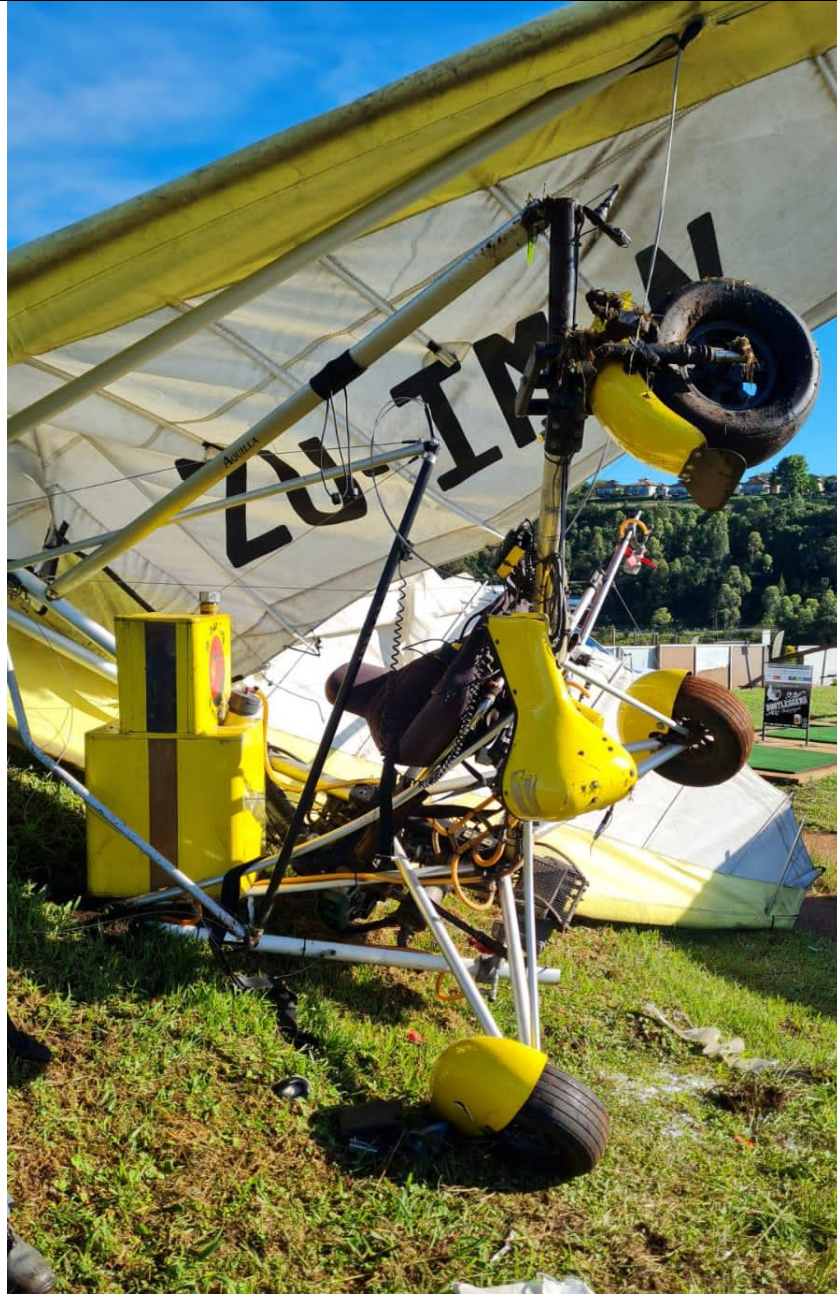
Figure 3: Microlight wreckage faced north post-accident. (Source: Pilot)

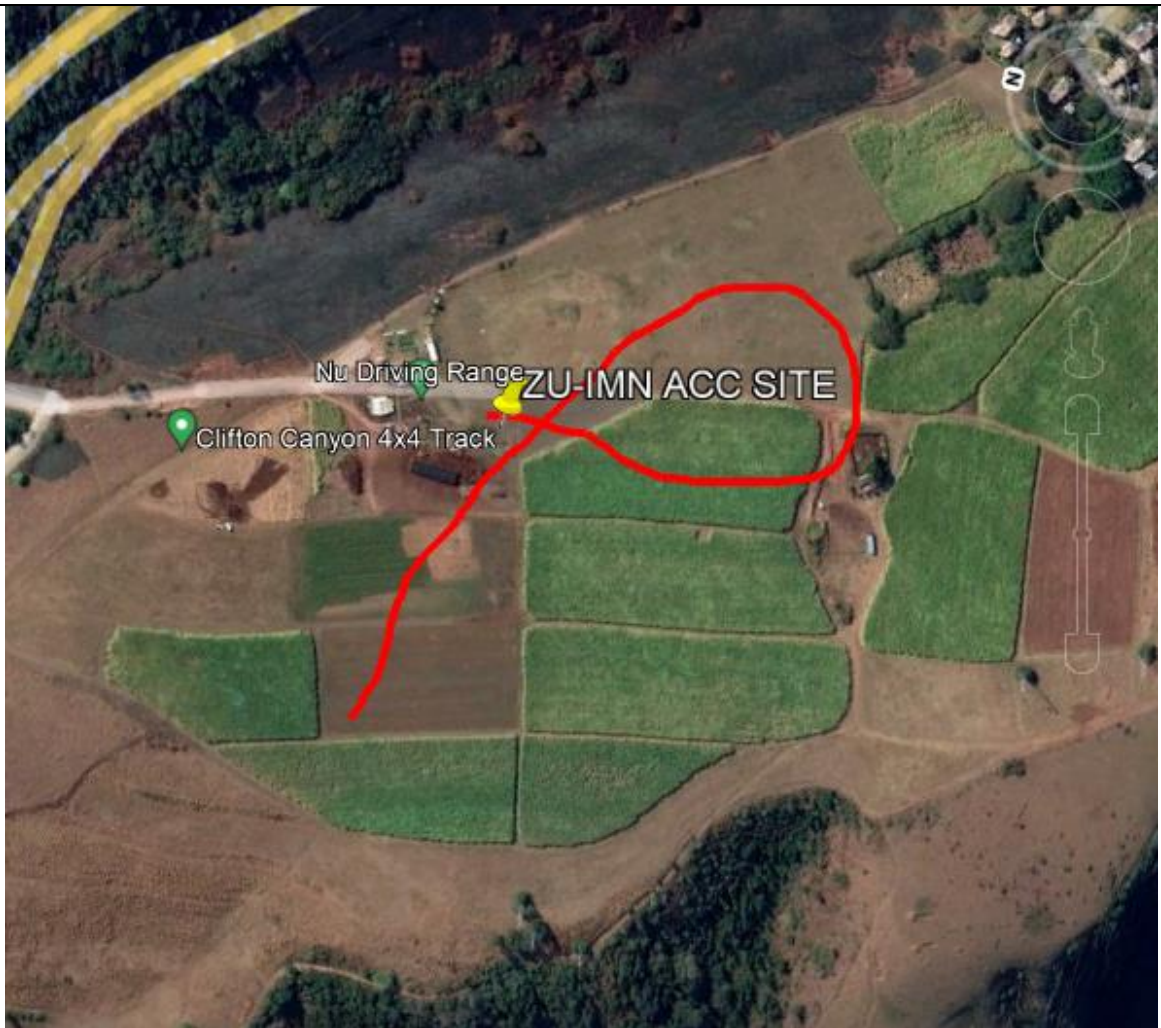
Figure 4: The microlight's flight path, according to the pilot. (Source: Google Earth)
