**LIMITED ACCIDENT INVESTIGATION REPORT**

<b>Reference Number</b>	CA18/2/3/10104						
<b>Classification</b>	Accident	<b>Date</b>	16 January 2022	<b>Time</b>	2003Z		
<b>Type of Operation</b>	Remotely Piloted Aircraft (Part 101)						
<b>Location</b>							
Place of Departure	Glencore Goedgevonden Near Ogies, Mpumalanga Province			Place of Intended Landing	Glencore Goedgevonden Near Ogies, Mpumalanga Province		
Place of Accident	Goedgevonden Mine near Ogies						
GPS Co-ordinates	Latitude	S 26°03'31.4"	Longitude	E029°03'26.9"	Elevation	5 200 feet	
<b>Aircraft Information</b>							
Registration	ZT-WUL						
Model/Make	DJI Matrice-200 (Serial Number: M200-27)						
Damage to Aircraft	Destroyed			Total Aircraft Hours	211.4		
<b>Pilot-in-command</b>							
Licence Type	Remote Pilot Licence (RPL)	Gender	Male		Age: 24		
Licence Valid	Yes						
Total Hours on Type	136.05			Total Flying Hours	1 455.32		
People On-board	N/A	Injuries	0	Fatalities	0	Other (on ground)	0

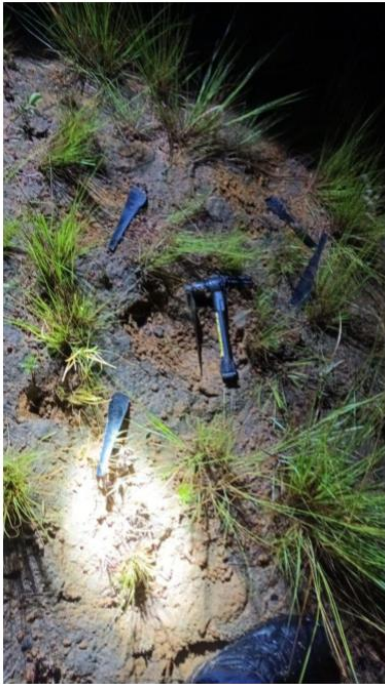
the tracking unit; however, the aircraft was not found at the crash site. The aircraft had 60% battery power remaining at the time of accident.

**Figure 1:** Retrieved parts of the RPA. *Note that the core of the remotely piloted aircraft was missing, presumably stolen.* (Source: Operator). **Figure 2:** A Matrice M200 picture taken from the DJI website.

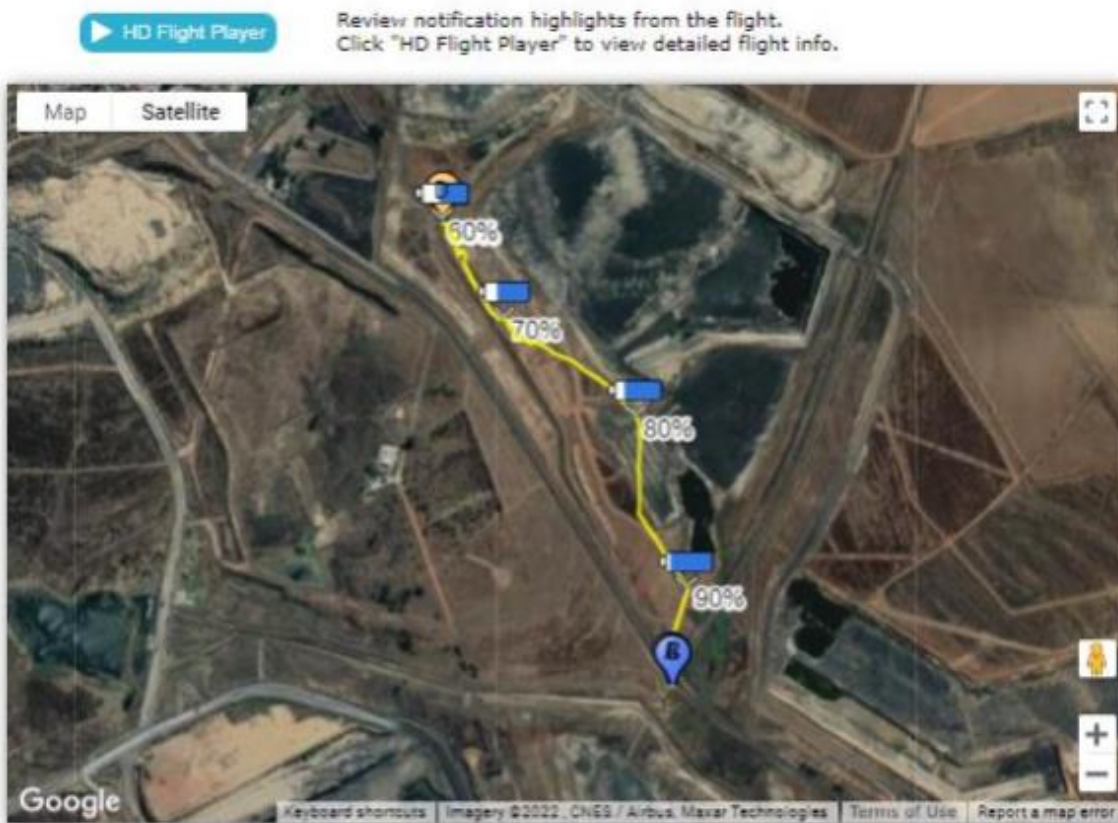
Flight time	Altitude	Home Dist	Type	Notification
00m 00s	0.0 m	0 m	Mode	Mode changed to Motors Started
00m 00s	0.0 m	0 m	Tip	Log filename: FLY811.DAT
00m 01s	0.0 m	0 m		100% Battery
A 00m 02s	0.0 m	0 m	Mode	Mode changed to Motors Started
B 00m 03s	0.0 m	4 m	Mode	Mode changed to Assisted Takeoff
C 00m 07s	0.0 m	4 m	Mode	Mode changed to P-GPS
03m 08s	112.3 m	256 m		90% Battery
06m 17s	112.4 m	703 m		80% Battery
09m 38s	84.1 m	1,046 m		70% Battery
12m 41s	57.1 m	1,345 m		60% Battery
D 12m 52s	41.1 m	1,348 m	Low Risk	Not Enough Force/ESC Error (repeated 6 times)
12m 53s	33.8 m	1,348 m		60% Battery at maximum distance

**Figure 3:** Airdata – a notification tab shows that the RPA gave an ESC warning during flight. (Source: Operator)

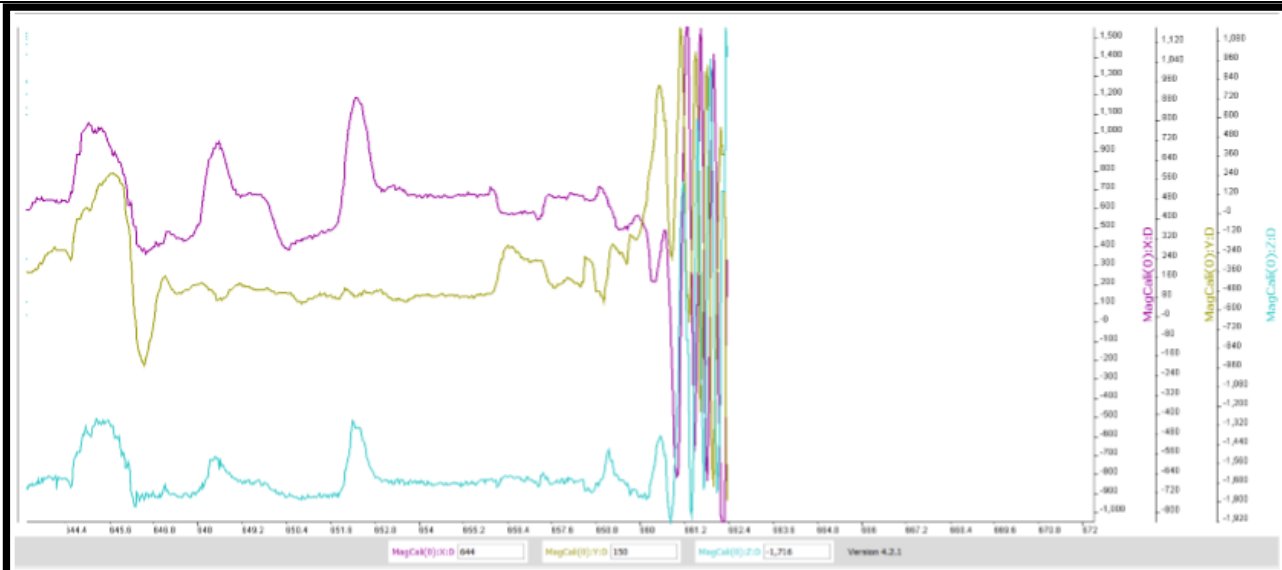
According to the operator, a comma-separated values (CSV) in Figure 4 shows a compass interference normally caused by a motor spooling up and interfering with internal compass of the RPA. During the compass interference, the left front motor failed, causing the aircraft to spin and crash.

**Figure 4:** CSV View – Compass interference normally caused by a motor spooling up and interfering with the internal compass of the RPA.

- The investigation found that there was compass interference which was caused by a motor spooling up and interfering with the internal compass of the RPA.

It is most likely that the accident was caused by the failure of the left front motor of the RPA, resulting in the RPA spiralling out of control and, subsequently, crashing.
