**LIMITED ACCIDENT INVESTIGATION REPORT**

<b>Reference Number</b>	CA18/2/3/10105						
<b>Classification</b>	Accident	<b>Date</b>	23 December 2021	<b>Time</b>	0038Z		
<b>Type of Operation</b>	Remotely Piloted Aircraft (Part 101)						
<b>Location</b>							
Place of Departure	Sibanye, Westonaria, Gauteng Province		Place of Intended Landing	Sibanye, Westonaria, Gauteng Cape Province			
Place of Accident	Sibanye, Westonaria, Gauteng Province						
GPS Co-ordinates	Latitude	S 26° 21' 28"	Longitude	E 27° 36' 33"	Elevation	5 370 ft	
<b>Aircraft Information</b>							
Registration	ZT-WVS						
Model/Make	DJI Matrice 200 (Serial Number: M200-38)						
Damage to Aircraft	Destroyed		Total Aircraft Hours	266.0			
<b>Pilot-in-command</b>							
Licence Valid	Yes		Gender	Male		Age	50
Licence Type	Remote Pilot Licence (RPL)						
Total Hours on Type	1 516.5		Total Flying Hours	1 516.5			
Pilots Controlling	1	Injuries	0	Fatalities	0	Other (On Ground)	0
<b>What Happened</b>

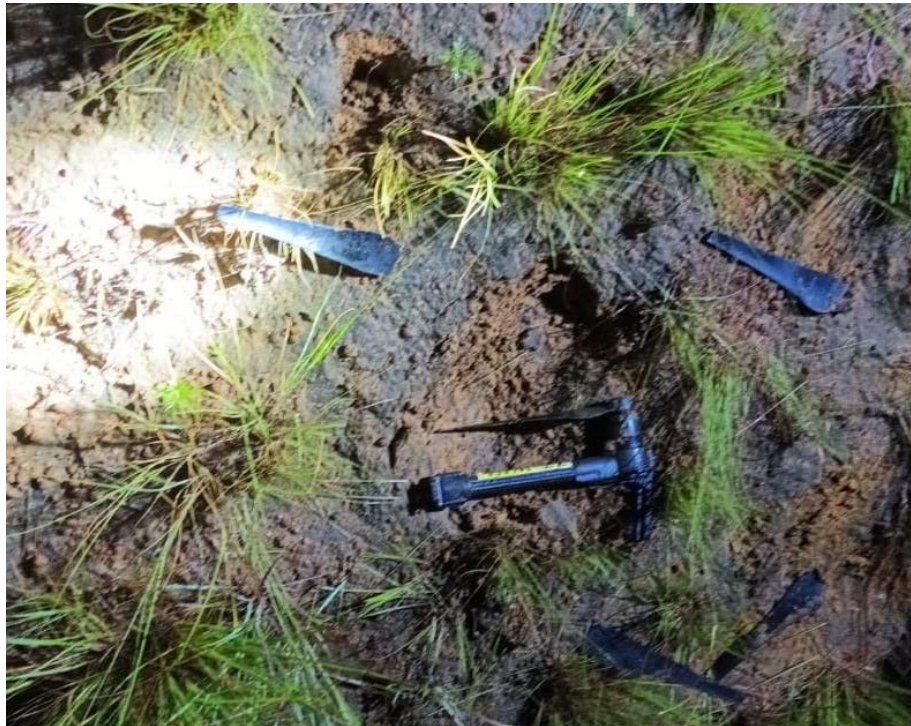
drone. The drone was located 174 metres (m) from the pilot's (departure) position. It had collided with a tree that was approximately 50ft tall. The drone was destroyed after it collided with the tree; no damage to property was reported.

**Figure 1:** The wreckage of the drone as found on site. (Source: Operator)

- According to the post-accident log analysis report, one of the back motors bearing ceased, and the drone experienced an electronic speed control (ESC) failure during operation which caused the back motor to overspeed, resulting in the drone spiralling down. (Source: Operator)

The drone experienced an electronic speed control (ESC) failure on one of the back motors of the propeller which failed during flight and caused an imbalance that subsequently caused the drone to spin uncontrollably until it impacted a tree.

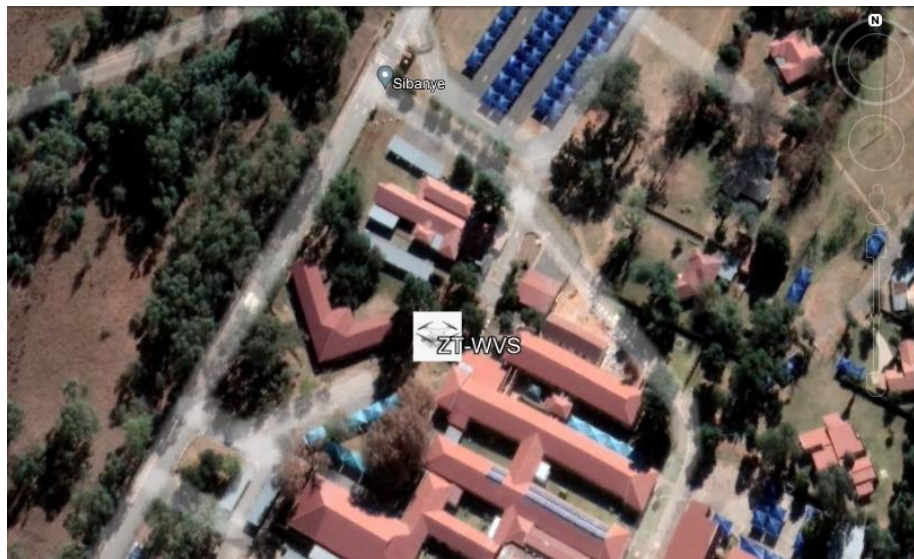
**Figure 2:** Aerial view of the accident site, surrounded by trees and buildings. (Source: Google Earth)
