**LIMITED ACCIDENT INVESTIGATION REPORT**

<b>Reference Number</b>		CA18/2/3/10106					
<b>Classification</b>	Accident	<b>Date</b>	24 January 2022	<b>Time</b>	1043Z		
<b>Type of Operation</b>		Private (Part 94)					
<b>Location</b>							
Place of Departure		Krugersdorp Airport (FAKR)		Place of Intended Landing		Krugersdorp Airport (FAKR)	
Place of Accident		Unprepared field next to the runway at FAKR					
GPS Co-ordinates	Latitude	S26°04'53.9"	Longitude	E27°43'32.4"	Elevation	5499ft	
<b>Aircraft Information</b>							
Registration		ZU-DFP					
Model/Make		Jabiru J400 (Serial Number: 109)					
Damage to Aircraft		Substantial		Total Aircraft Hours		3871.1	
<b>Pilot-in-command</b>							
Licence Valid		Yes	Gender		Male	Age	28
Licence Type		Commercial Pilot Licence (Aeroplane)					
Total Hours on Type		97.2		Total Flying Hours		1666.7	
People On-board	1+1	Injuries	0	Fatalities	0	Other (On Ground)	0
<b>What Happened</b>							
<p>On Monday, 24 January 2022, a pilot and a passenger on-board a Jabiru J400 with registration ZU-DFP were conducting circuit flights and touch-and-go landings at Krugersdorp Airport (FAKR) in Gauteng province. The pilot was testing the aircraft's performance fo

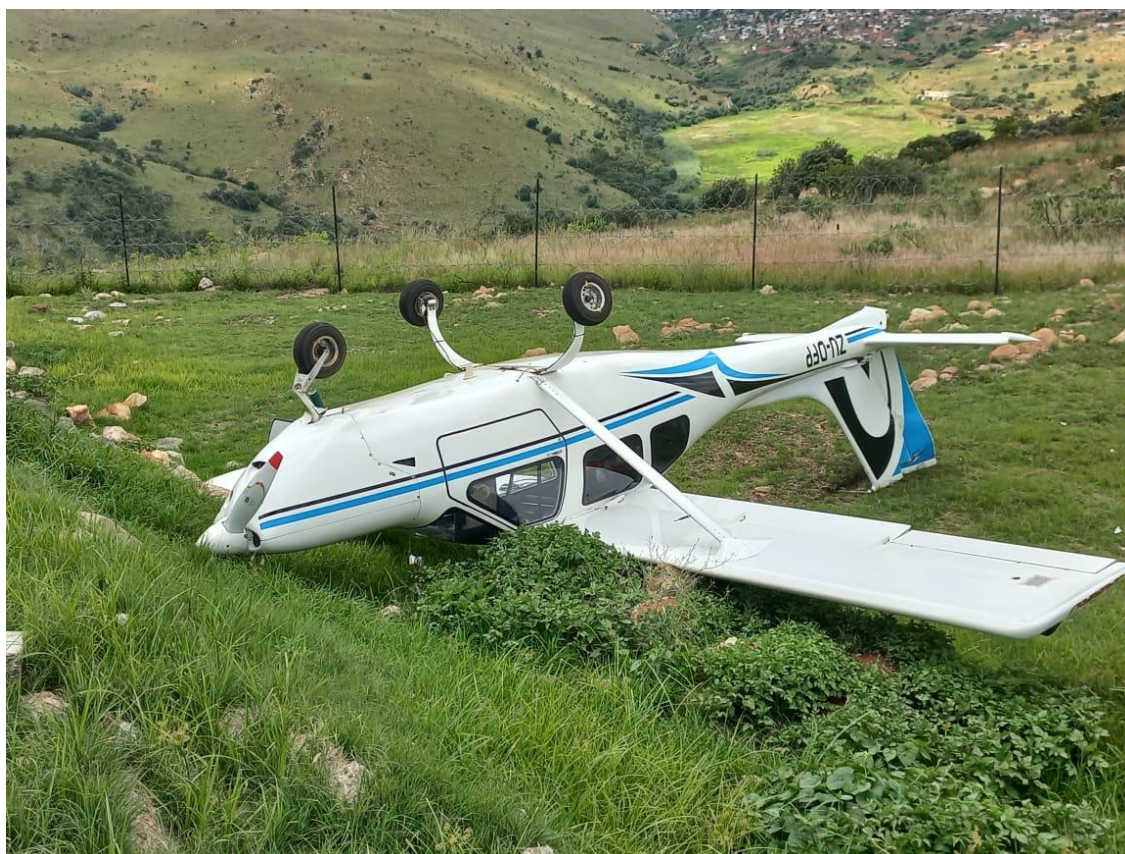
The occupants of the aircraft were not injured during the accident sequence; the aircraft sustained substantial damage.

**Figure 1:** The aircraft as it came to rest. (Source: Pilot)

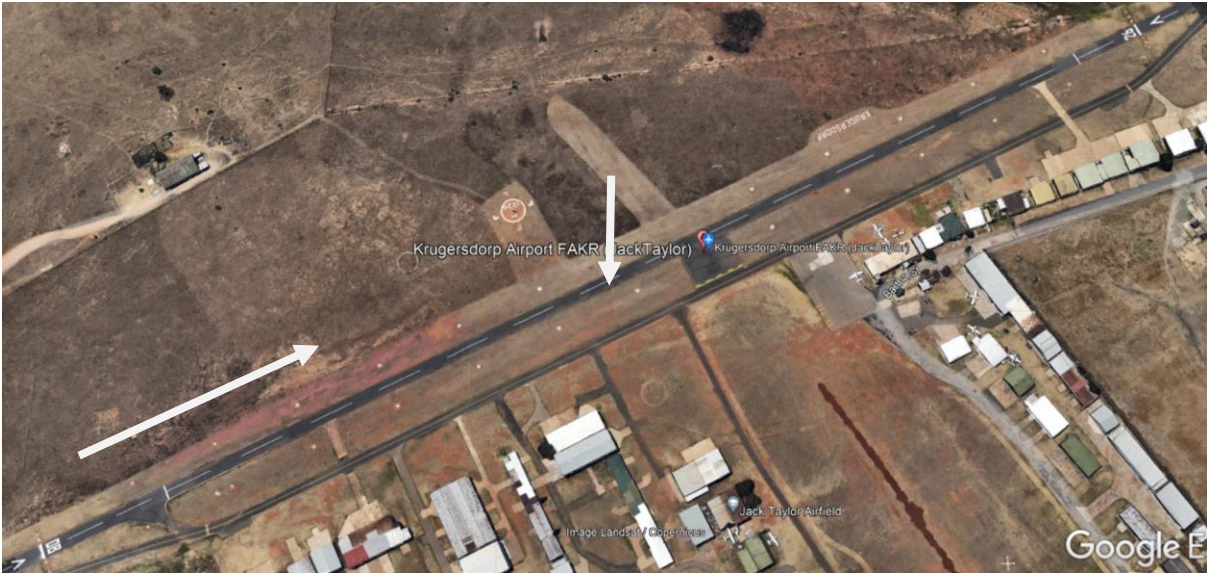
**Figure 2:** Arrows showing landing direction and touchdown point at FAKR Runway 08. (Source: Google Earth)

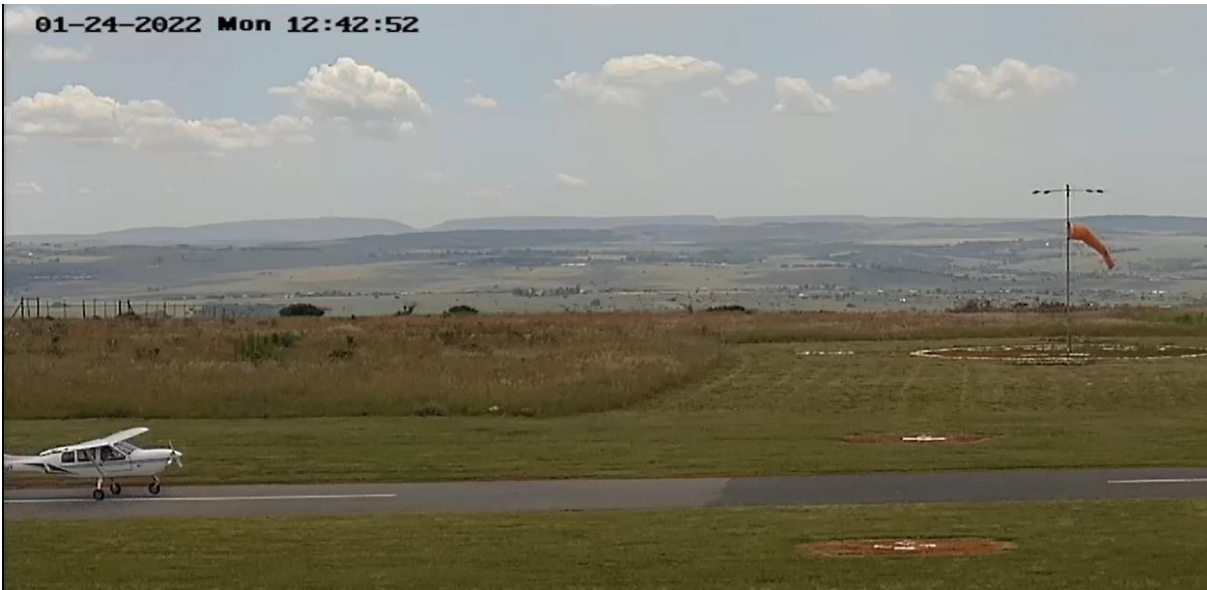
- The passenger stated that during the landing phase, the aircraft seemed to 'float' down the runway and touched down before the halfway mark on the runway surface (Figure 3).
- Runway 08 is 848 metres (m) in length. The aircraft landed approximately 384 metres from the threshold, which left approximately 464m to the threshold of Runway 26. The landing distance required for a Jabiru is 520m. The aircraft needed an additional 56m to come to a safe stop.
- The pilot had about 70m still remaining after the threshold (Runway 26) for a safe stop. But because the aircraft landed just before the halfway mark on Runway 08, the pilot was unable to bring the aircraft to a safe stop. The pilot elected to turn right to avoid overshooting the runway.

**Figure 3:** The aircraft with the main landing gears on the ground. (Source: Pilot)
