**LIMITED ACCIDENT INVESTIGATION REPORT**

<b>Reference Number</b>	CA18/2/3/10107						
<b>Classification</b>	Accident	<b>Date</b>	25 January 2022	<b>Time</b>	1020Z		
Type of Operation	Aerial Work Operations (Part 137)						
<b>Location</b>							
Place of Departure	Vlakfontein Farm near Sedibeng, Gauteng Province		Place of Intended Landing		Vlakfontein Farm near Sedibeng, Gauteng Province		
Place of Accident	Farm Vlakfontein, near Sedibeng, Gauteng Province						
GPS Co-ordinates	Latitude	26°19'54.63" S	Longitude	028°32'20.44" E	Elevation	5 209 ft	
<b>Aircraft Information</b>							
Registration	ZS-OMK						
Model/Make	Air Tractor AT 502B (Serial Number: 502B-2583)						
Damage to Aircraft	Substantial		Total Aircraft Hours		6 016.8		
<b>Pilot-in-command</b>							
Licence Type	Commercial Pilot Licence (CPL)	Gender	Male		Age: 55		
Licence Valid	Yes						
Total Hours on Type	7 875		Total Flying Hours		16 057		
People On-board	1 + 0	Injuries	0	Fatalities	0	Other (on ground)	0

<b>What Happened</b>

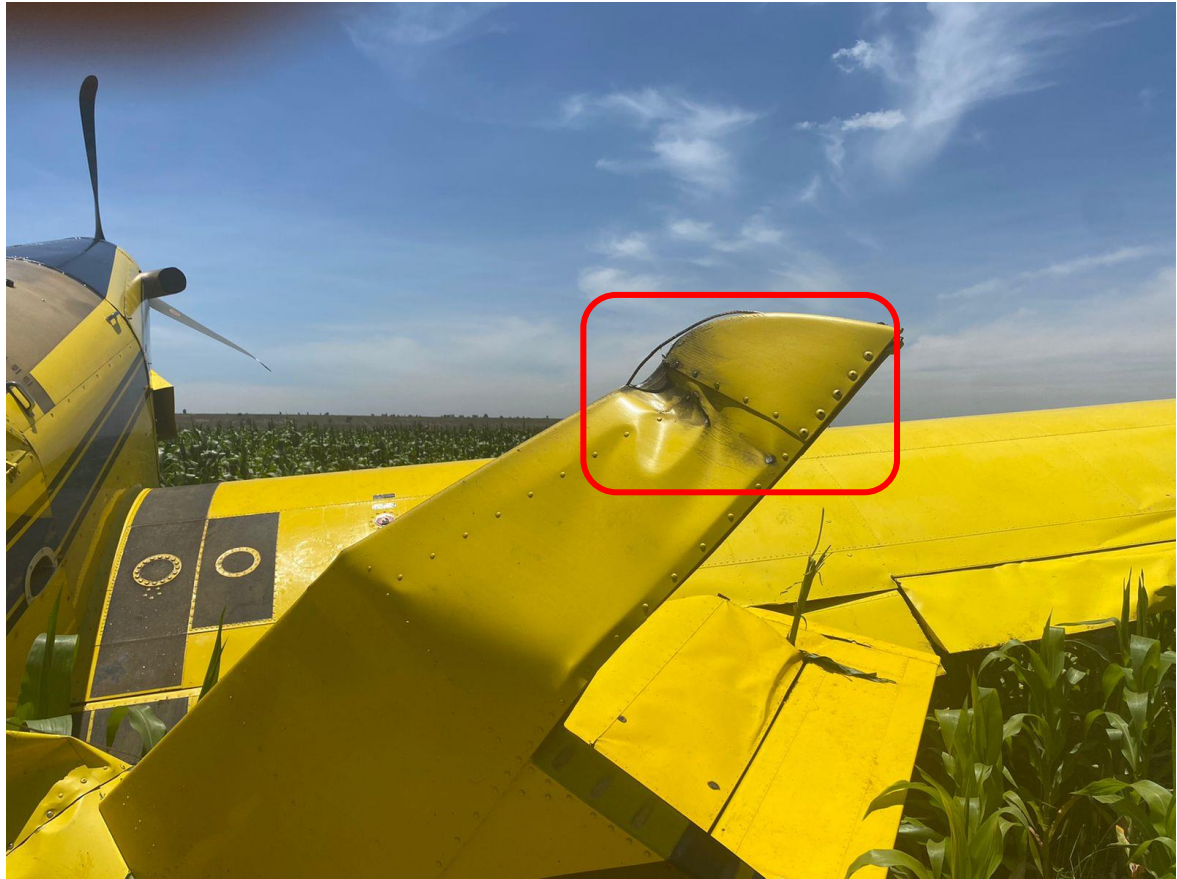
The pilot stated that he had conducted several spray runs on the accident day. While he positioned the aircraft for another spray run, he descended, aiming to fly below the high-tension cables when the top section of the vertical stabiliser collided with one of the electrical cables. This caused the rudder to jam (see Figure 1). The pilot was unable to maintain lateral or longitudinal control of the aircraft and opted to reduce the throttle to idle and performed a forced landing on the maize field approximately 600m from where the collision occurred. During an interview with the pilot, he stated that he misjudged the electric cables during a critical phase of the flight as he normally flew the aircraft below the high-tension cables. There was no fault with the aircraft prior to the collision. The aircraft was substantially damaged; the pilot was not injured.

**Figure 1:** The area on the vertical stabiliser where it impacted the electrical cables.

While manoeuvring the aircraft for a spray run, the vertical stabiliser of the aircraft collided with an electrical cable because the pilot misjudged their height (cables). This caused the rudder to jam, resulting in the pilot executing a forced landing.

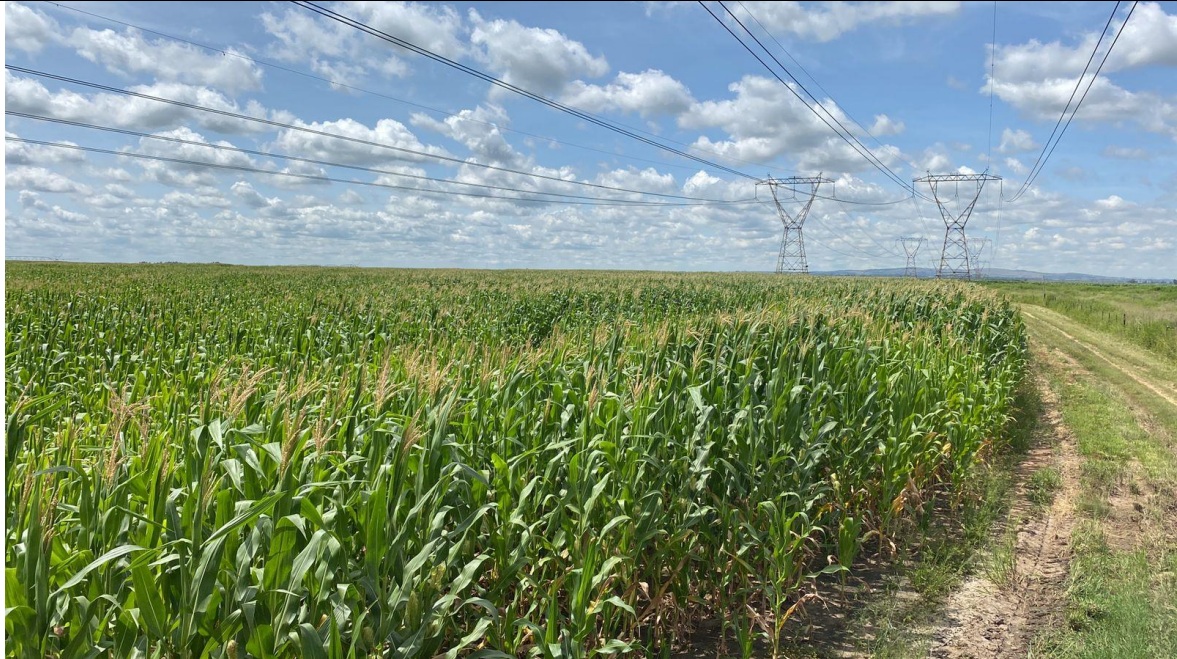
**Figure 2:** The high-tension cables above the maize field that the aircraft collided with during crop-spraying. (Source: Pilot)

The Director of Civil Aviation to develop flight minimums or limitations for all aerial work operations under CAR 2011, Part 137.

Operators are to define the flight minimums for all operations conducted under the provisions of CAR 2011, Part 137.

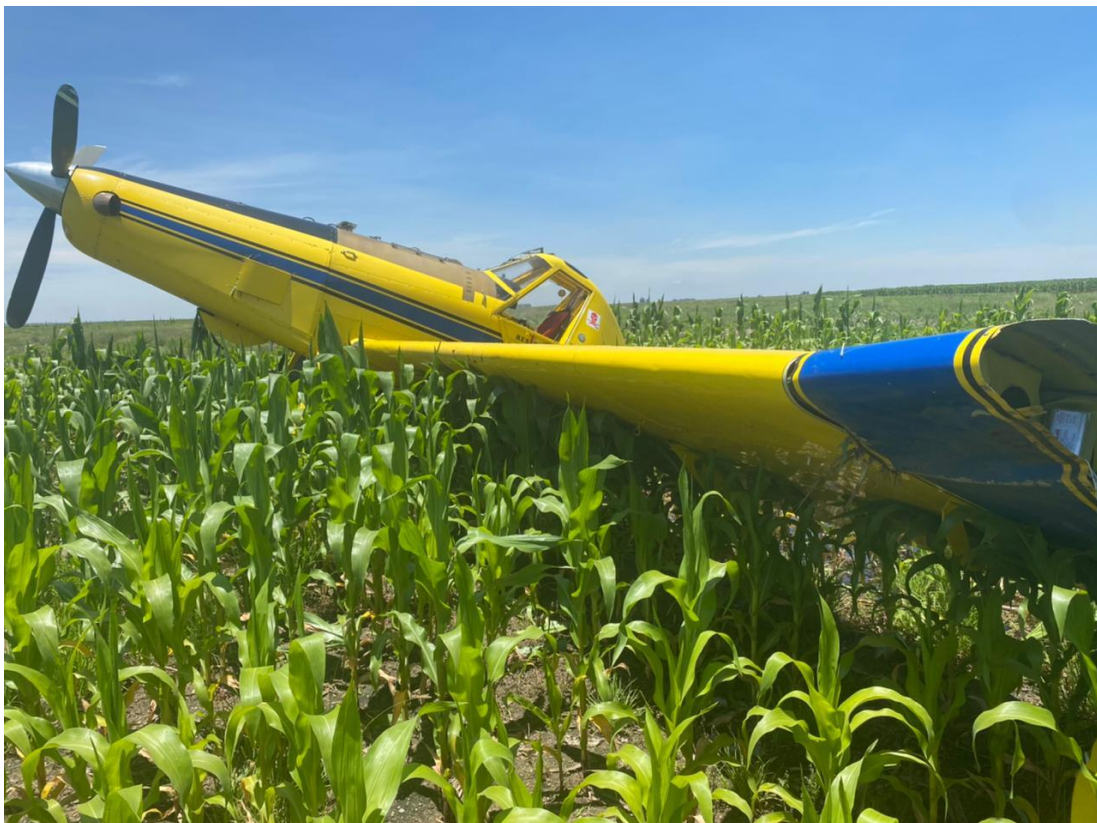
**Figure 3:** The aircraft at its resting position post-accident. (Source: Pilot)

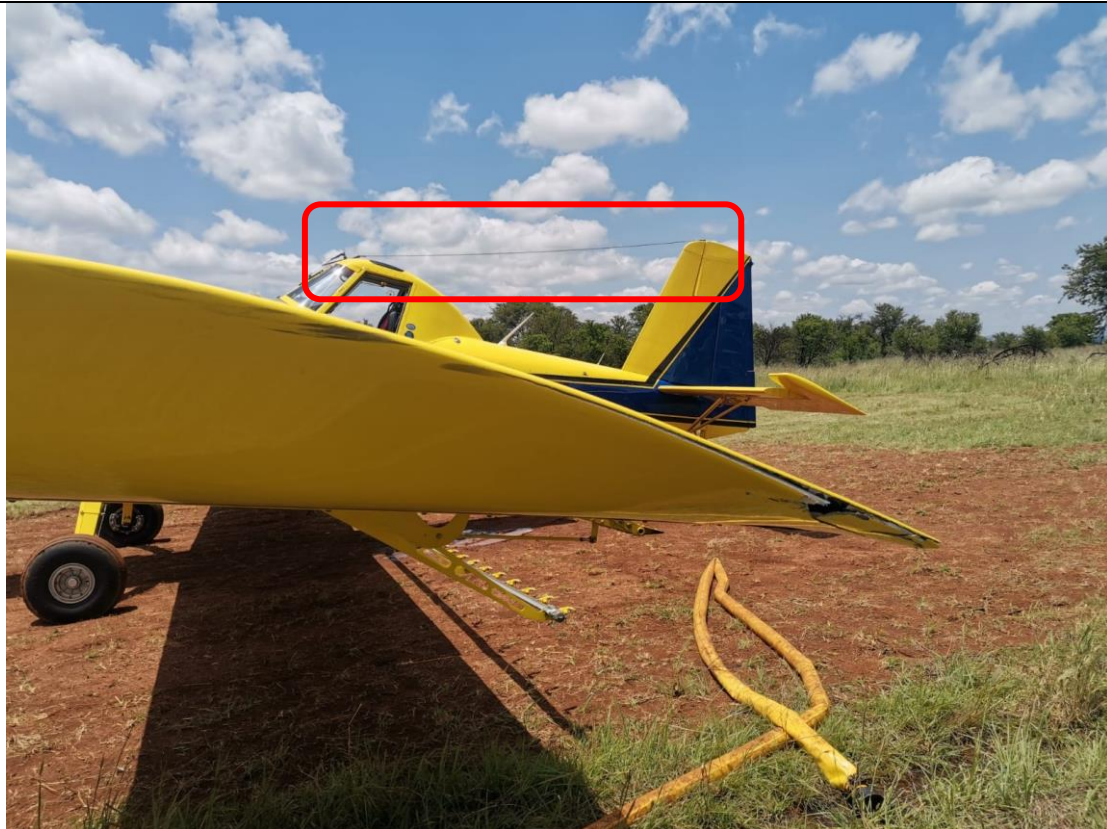
**Figure 4:** A similar type of aircraft with the cable deflector in the red window.

- The ZS-OMK aircraft was factory fitted with a cable deflector (see Figure 4), but it had no effect in deflecting the electrical cable from the high-tension power cables.
