**LIMITED ACCIDENT INVESTIGATION REPORT**

<b>Reference Number</b>	CA18/2/3/10110						
<b>Classification</b>	Accident	<b>Date</b>	31 January 2021	<b>Time</b>	1400Z		
<b>Type of Operation</b>	Training (Part 141)						
<b>Location</b>							
<b>Place of Departure</b>	Port Alfred (FAPA), Eastern Cape Province		<b>Place of Intended Landing</b>		Port Alfred (FAPA), Eastern Cape Province		
<b>Place of Accident</b>	A grass field 44 Nautical Miles north-east of FAPA						
<b>GPS Co-ordinates</b>	<b>Longitude</b>	S 33°11'46.0"	<b>Latitude</b>	E 027°35'35.6"	<b>Elevation</b>	450 feet	
<b>Aircraft Information</b>							
<b>Registration</b>	ZS-SYJ						
<b>Model/Make</b>	Piper Archer PA 28 R (S/N:28-43208)						
<b>Damage to Aircraft</b>	Substantial		<b>Total Aircraft Hours</b>		19157		
<b>Pilot-in-command</b>							
<b>Licence Type</b>	Student Pilot Licence (Aeroplane)		<b>Gender</b>	Male	<b>Age</b>	29	
<b>Licence Valid</b>	Yes						
<b>Total Hours on Type</b>	16.6		<b>Total Flying Hours</b>		101.3

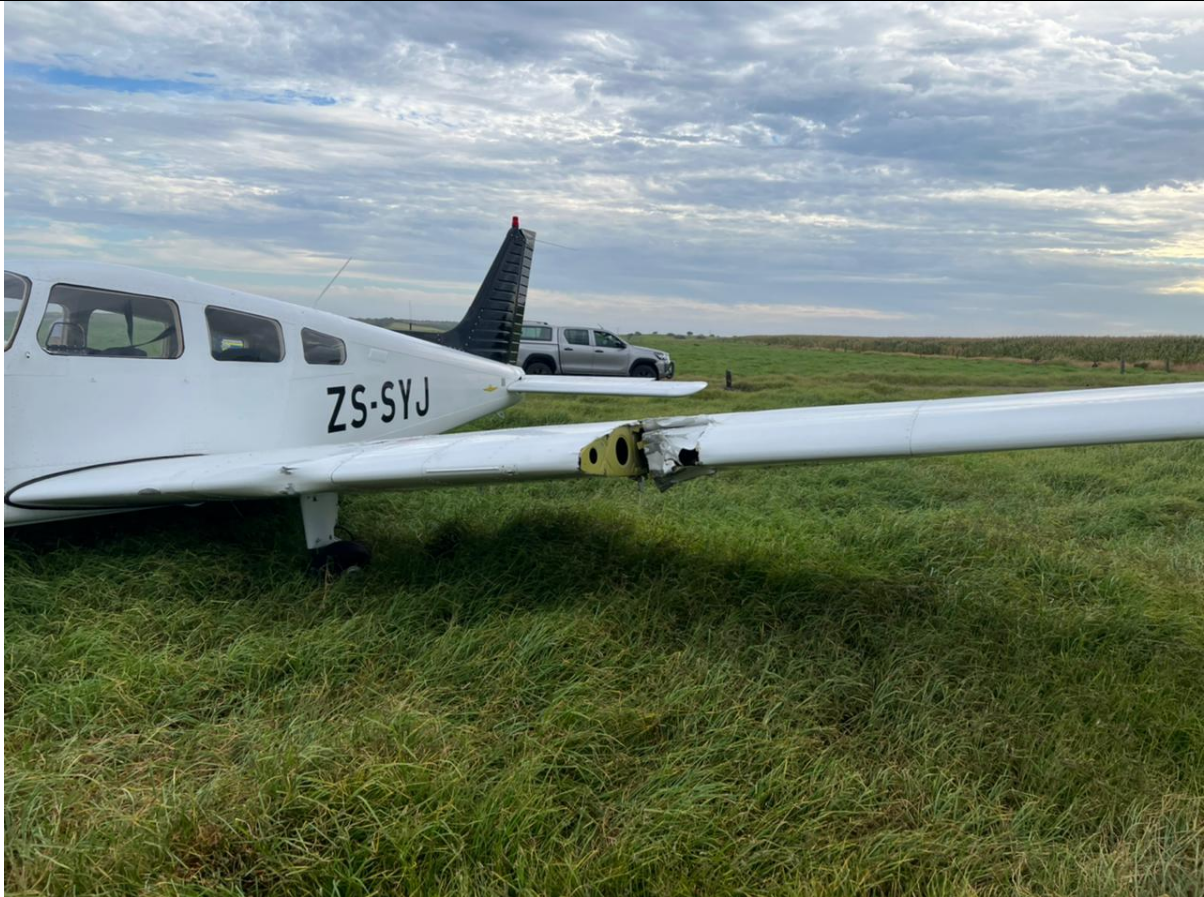
4. During the landing roll, the aircraft's left wing leading edge collided with a fence pole before the aircraft came to a stop. The pilot did not sustain any injuries; the aircraft sustained damage to the left wing.

**Figure 1:** Picture of ZS-SYJ aircraft. (Source: 43 Air school)
